FINAL REPORT

**PAPUA NEW GUINEA
ACCIDENT INVESTIGATION COMMISSION
AIRCRAFT SERIOUS INCIDENT REPORT**

P2-TAH and P2-MCT

Breakdown of separation

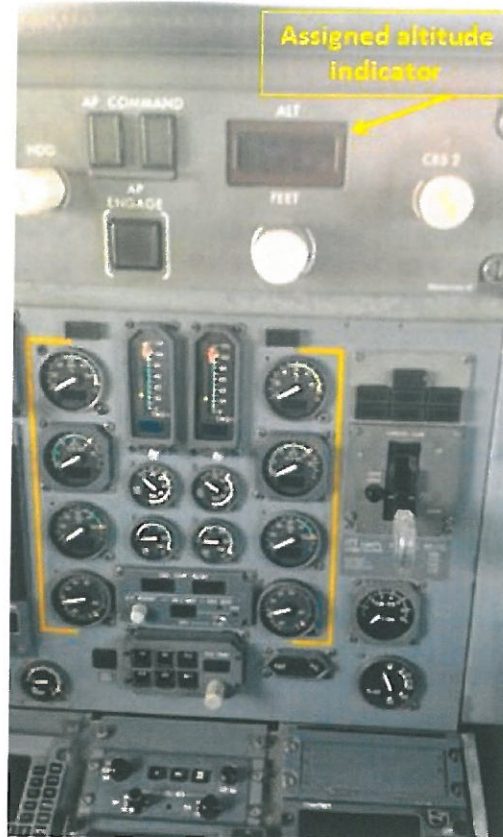
Figure 4: TAH assigned altitude indicator

The TAH flight plan also showed the cruising level to be 18,000 ft. The copilot read the clearance back correctly to ATC. However, although he had acknowledged 18,000 ft in his read-back³ he subsequently entered 19,000 ft in the assigned altitude indicator on the instrument panel. He did not notice this error.

The assigned altitude indicator in TAH required alternating current (AC) power. TAH does not have an auxiliary power unit (APU), and a ground power unit (GPU) is not available for use by Travel Air at Port Moresby. Therefore at least one engine must be operating and the generator on line to obtain AC power before an altitude can be set in the assigned altitude indicator.

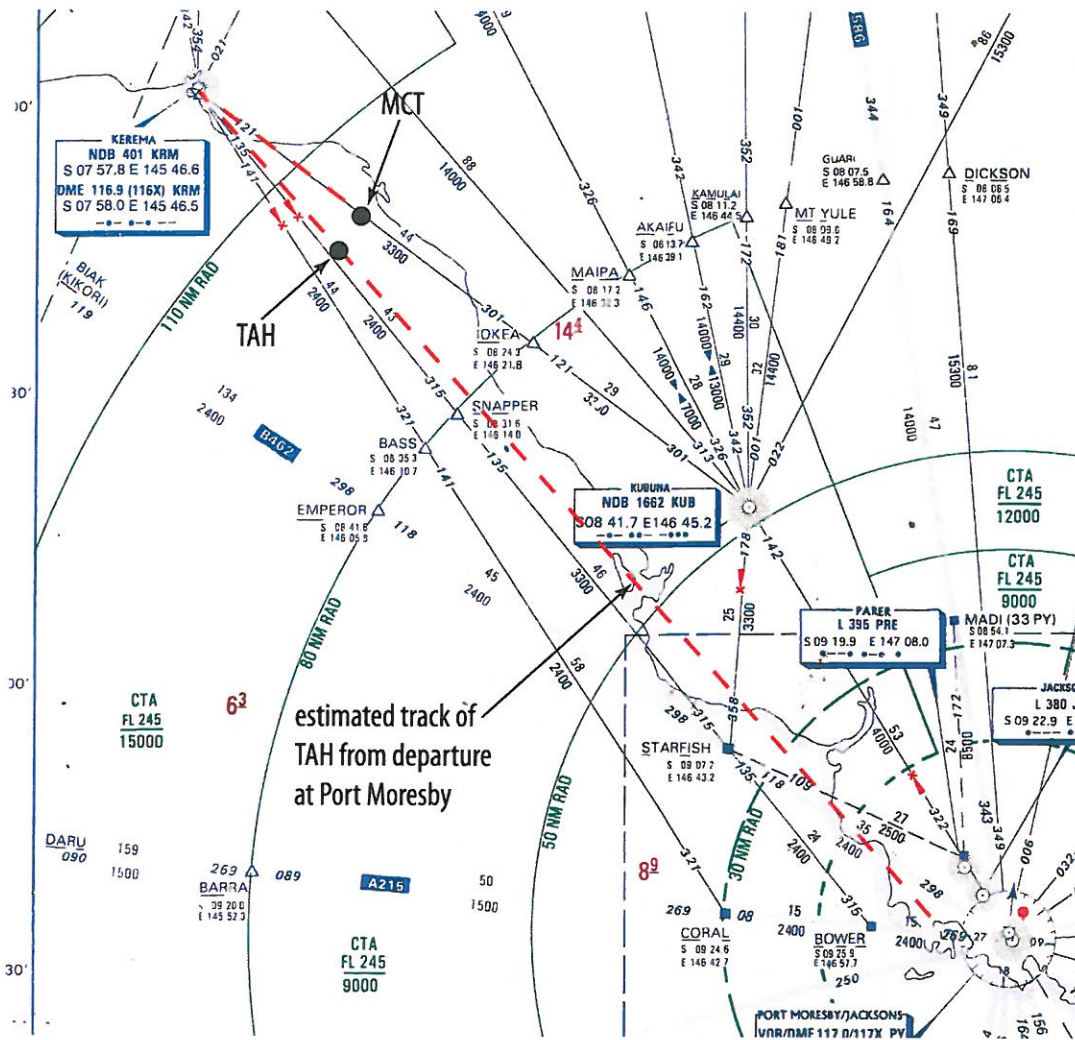
Figure 7: Radio navigation chart extract showing estimated flight track of TAH and estimated positions of the two aircraft at the time of the occurrence

As shown on the following extract from the radio navigation chart (RNC) (Figure 7), MCT was observed on radar to be tracking according to its airways clearance AXXM (Komo) – MOR (Moro) – (KRM) Kerema – KUB (Kubuna), thence direct AYPY (Port Moresby).

Initially, TAH was issued with a clearance AYPY – SFI (Starfish) – SAP (Snapper) – KRM (Kerema) – PRV (Purari River) – AYMH (Mt Hagen). On departure from Port Moresby, TAH was re-cleared (from a position estimated to be on the runway centreline approximately 2 to 3 nm from the departure point) to track direct to Kerema.

The chart also depicts the estimated positions of each aircraft at the time of the occurrence, based on times of passing Kerema (KRM) and Snapper (SAP) and estimated aircraft groundspeeds.

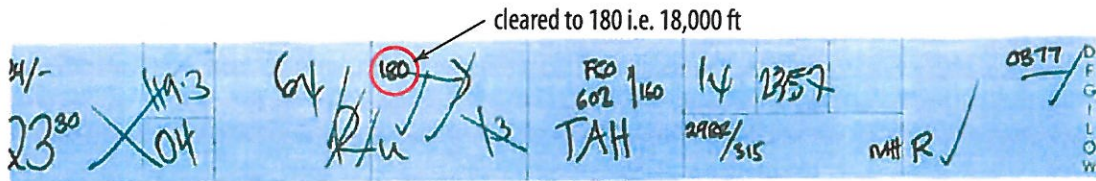
Figure 8: ATC flight progress strip for TAH - Approach

Both controllers placed a ‘tick’ on the respective flight progress strips adjacent to the correct cleared altitude (‘180’ representing 18,000 ft). Placing a ‘tick’ in this position is the ATC procedure which indicates that the flight crew of an aircraft have reported being on climb to the correct altitude.

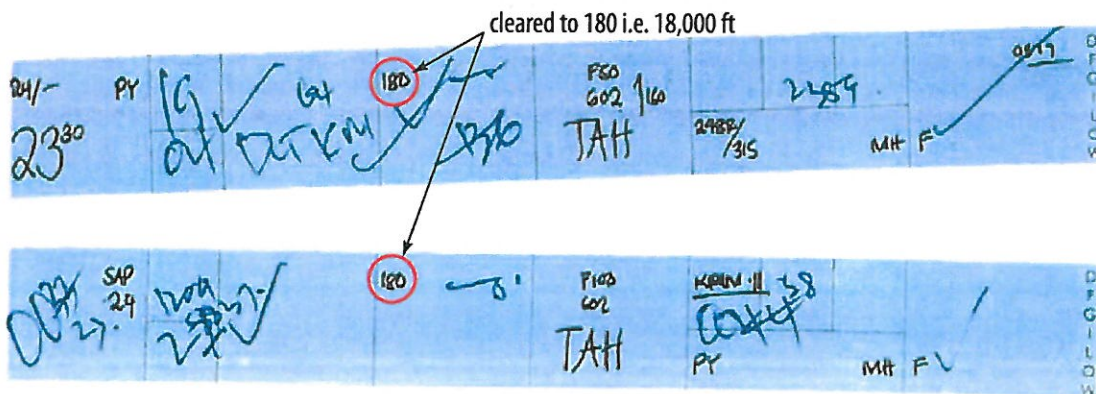
Figure 9: ATC flight progress strip for TAH – En-route radar

Again the altitude error (19,000) stated by the crew of TAH was not detected by the radar controller, who placed a 'tick' next to '180' on the flight progress strip (Figure 9).

The arrivals controller was counselled and assigned 2 days simulator training listening to pilot read-backs and monitoring radar tracks. It was noted by the simulator instructor that all simulated incorrect read-backs were picked up by the controller. The controller underwent a performance check on the Arrivals position on the third day and was found to be competent and returned to duty.
