**AIC 14-2518**

**PAPUA NEW GUINEA  
ACCIDENT INVESTIGATION COMMISSION  
SHORT SUMMARY REPORT**

**P2-NHW**

**Engine failure**

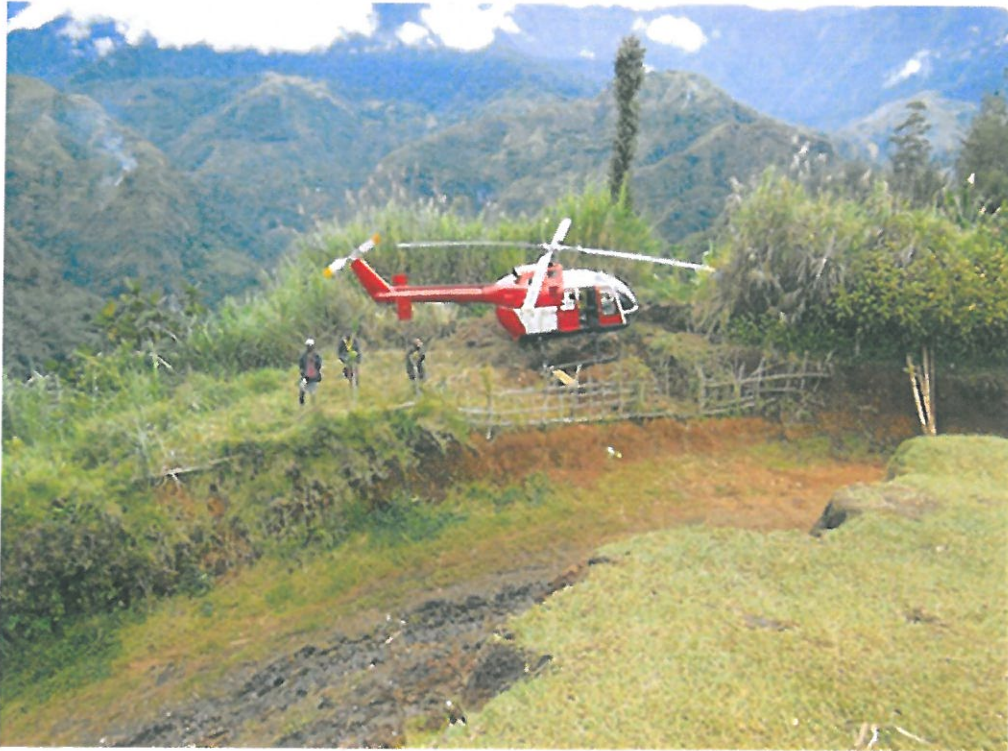
At about 0015 UTC<sup>2</sup> while still accelerating and prior to reaching translational lift, the pilot heard a loud noise. He said he saw a caution light and there was an increased sink rate, with the helicopter not responding to increased collective inputs. The pilot lowered the collective to maintain rotor RPM<sup>3</sup>, however being too slow and with low altitude for the planned go-around route, the pilot made a turn to the right towards an area suitable for a forced landing, clear of buildings and people. The touchdown was made with a low residual forward speed and the helicopter sank into the soft ground up to the underside of the fuselage. The landing gear skids were damaged by the hard landing, with the left skid fractured forward of the left front strut (see Figure 3).

**Figure 2: NHW at occurrence site viewed from intended landing area. Valley towards Dawat in immediate background.**

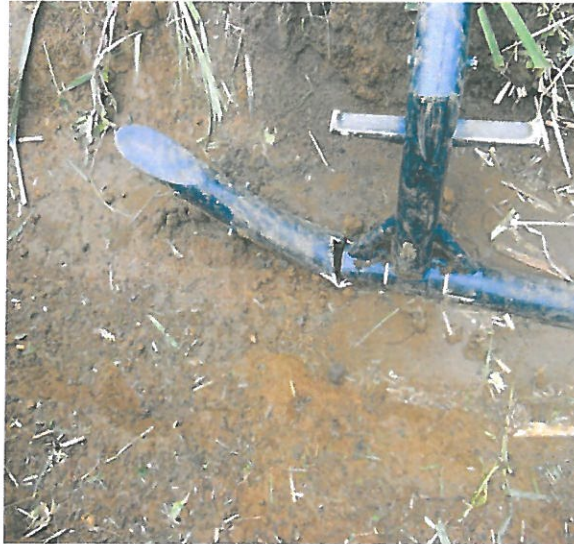
**Figure 3: Left landing gear skid damaged as a result of the hard landing**

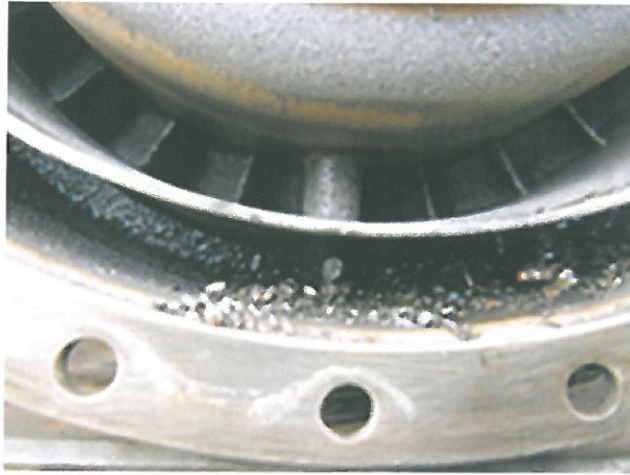
Investigators from the AIC went to Onggake where an initial examination of the left engine revealed a substantial quantity of metallic shavings at the turbine outlet duct, originating from the liberated compressor turbine and stator blades. The compressor casing was punctured in several places. The left engine and its accessories were removed from the helicopter and the compressor was removed and shipped to the AIC office in Port Moresby.

**Figure 4: Metallic shavings of the disintegrated turbine**

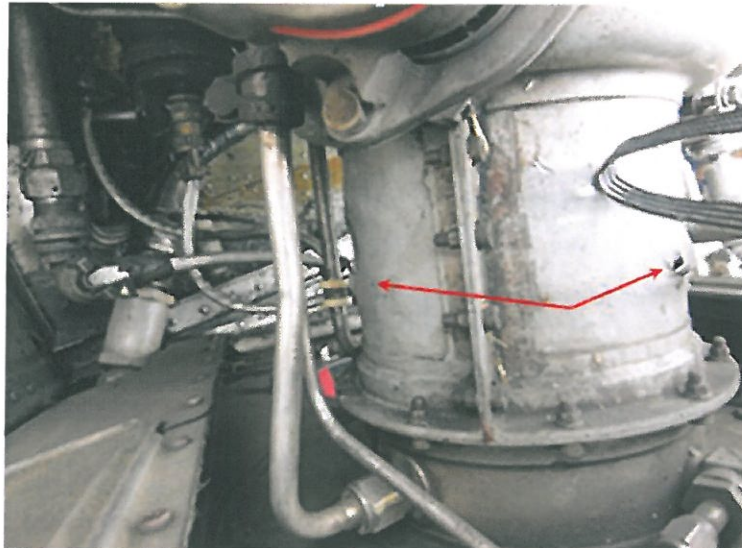
**Figure 5: Compressor casing red arrows point to punctures through the case**

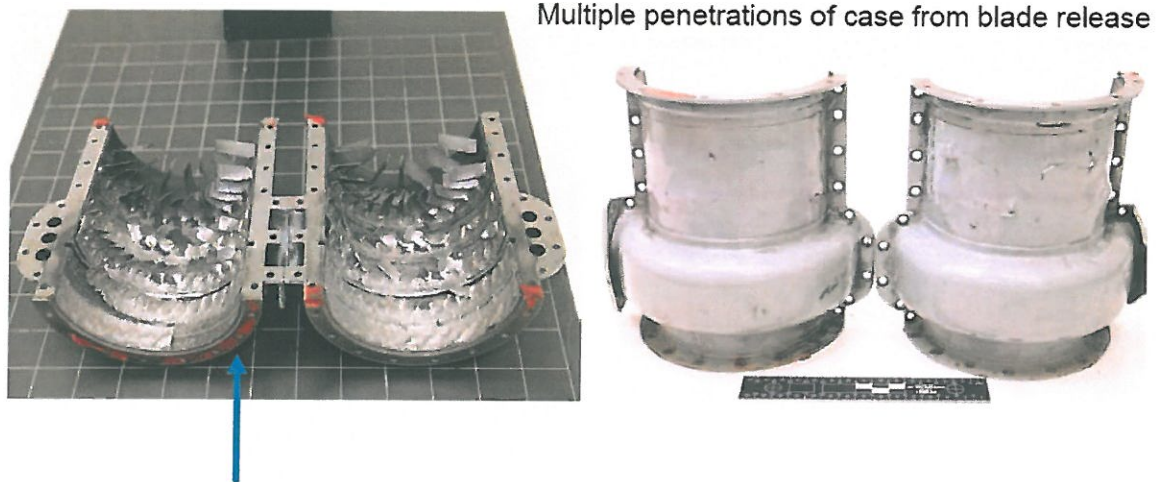
**Figure 6: Compressor case flanges showing sealant on flanges (photo ATSB)**

The ATSB engineering laboratory in Canberra examined the compressor and found that a high temperature sealant had been applied to the sealing surfaces of the compressor case halves. The use of a sealant on the

flanges of the compressor is not recommended by the engine manufacturer.

High temperature sealant applied to sealing surfaces of compressor case halves  
The use of sealant at that location is not recommended practise by Rolls-Royce North America

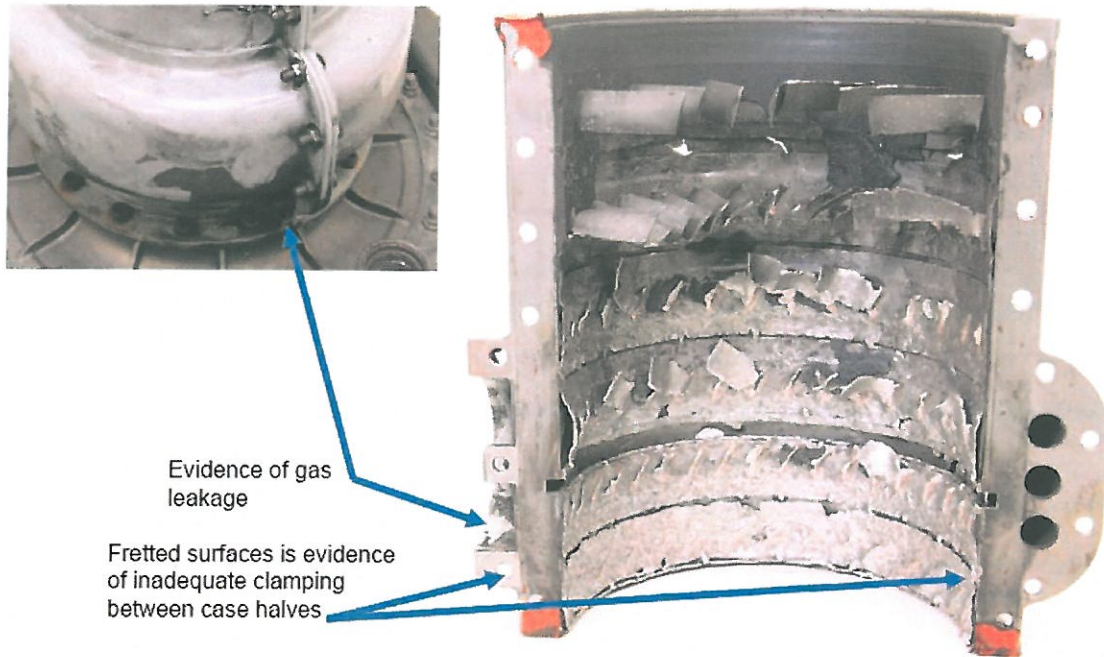
**Figure 7: Compressor flange showing fretted surfaces (photo ATSB)**

The compressor case flanges showed evidence of fretting indicating that they had been inadequately clamped. This was probably as a result of the sealant on the mating surfaces.

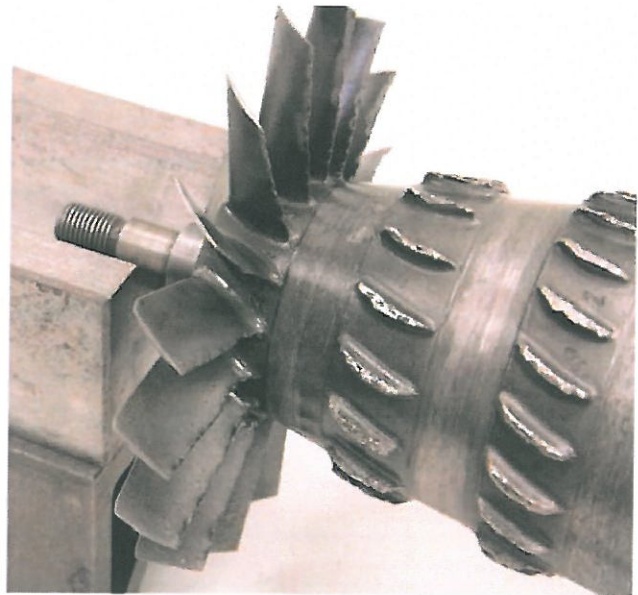
The blades on all stages of the compressor had failed with stage one showing evidence of trailing edge damage and erosion damage on the tips. The blade bending was found to be consistent with failure under engine power loads.

- Damage confined primarily to trailing edge of blade surface
- Damage is consistent with hard body impact from liberated downstream engine fragments
- Erosion of leading edge tips noted
- Bending of aerofoils was opposite to direction of rotation, consistent with failure under engine power

**Figure 8: Stage 1 damaged blades (photo ATSB)**

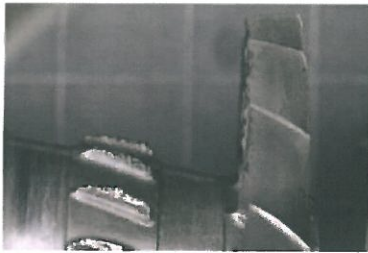
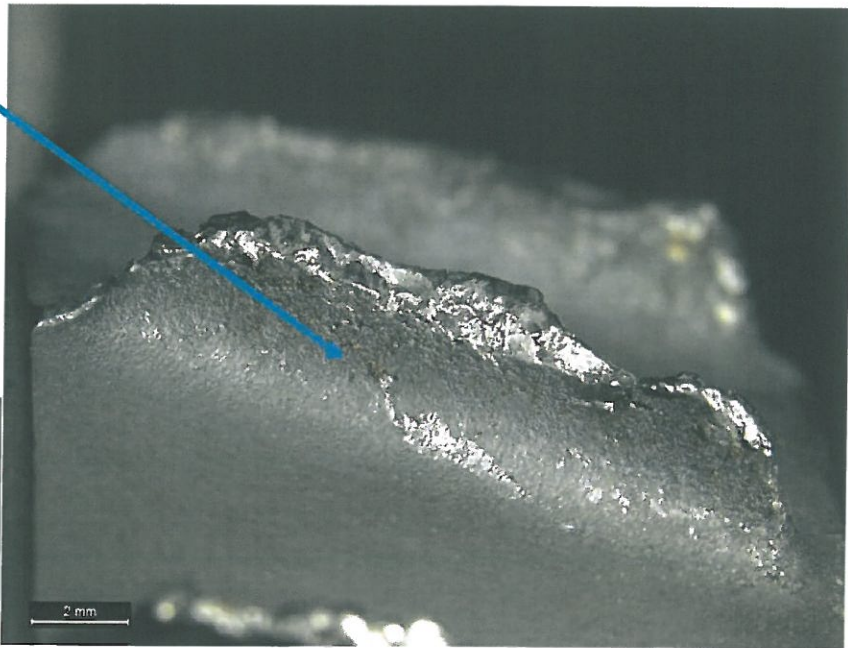
The blades on stages two to five showed evidence of corrosion. The ATSB report picture explains.

- Corrosion damage evident across many of the blades
- Many of the remnant blade stubs are bent opposite to the direction of rotation
- All fracture surfaces have been smeared over from metal-to-metal contact
- Rumpling (cracking) of the blade aerofoil coating evident

**Figure 9: Indicative of compressor blade corrosion stages two to five (photo ATSB)**

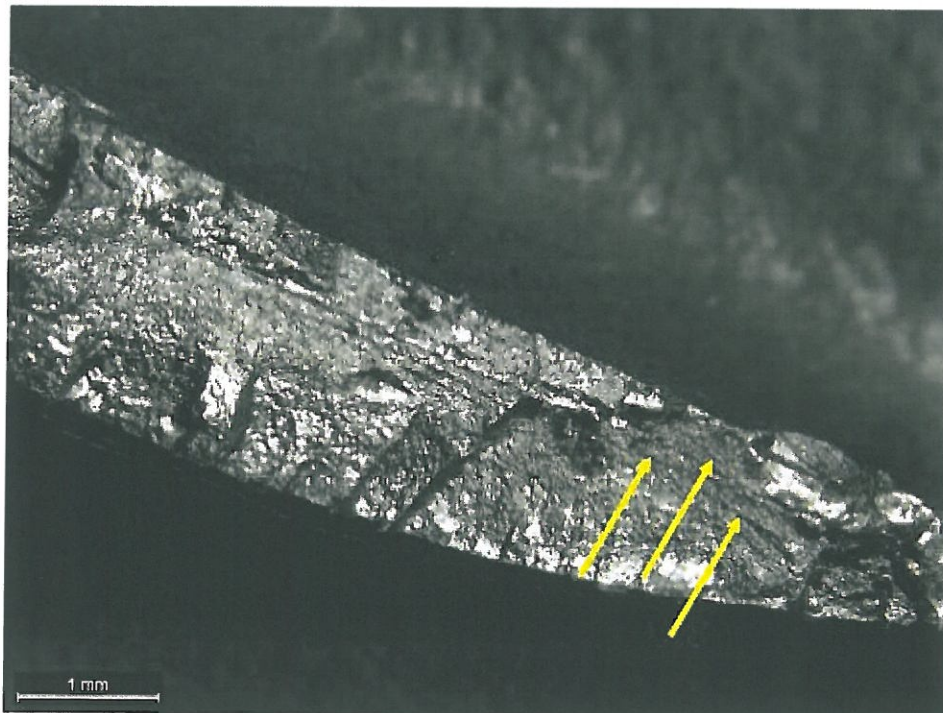
**Figure 10: Stage six compressor blade failure (photo ATSB)**

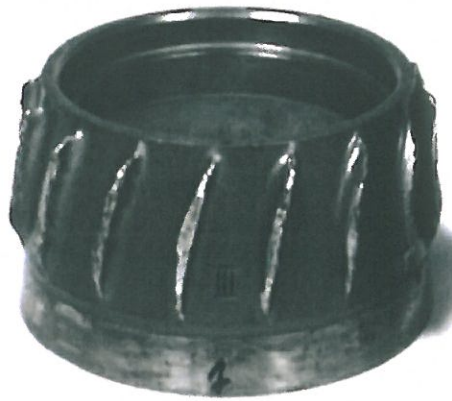
1. Damage observed on the compressor rotor (Figure 1) [Figure 6 AIC report] is consistent with primary release of 2<sup>nd</sup> stage airfoils. Damage to the fracture surfaces of the 2<sup>nd</sup> stage airfoil remnants precluded identification of a primary failed airfoil, a specific fracture origin, and a fracture mode prior to airfoil separation.

The cause of the loss of power associated with the subject event was determined to be 2<sup>nd</sup> stage compressor blade failure. The damage to the blade fractures precluded identification of a primary failed airfoil, a specific fracture origin, and a fracture mode prior to airfoil separation. However, in view of corrosion pitting found on the 2<sup>nd</sup> stage rotor hub, 1<sup>st</sup> stage compressor rotor and that the aircraft was operating in an area that has been designated as a severe environment (Ref. CSL 1135), the root cause of the event is judged to be improper compressor maintenance during operation in a corrosive environment.

**Figure 6: Second stage compressor rotor** (Photograph courtesy of Rolls Royce Corporation)

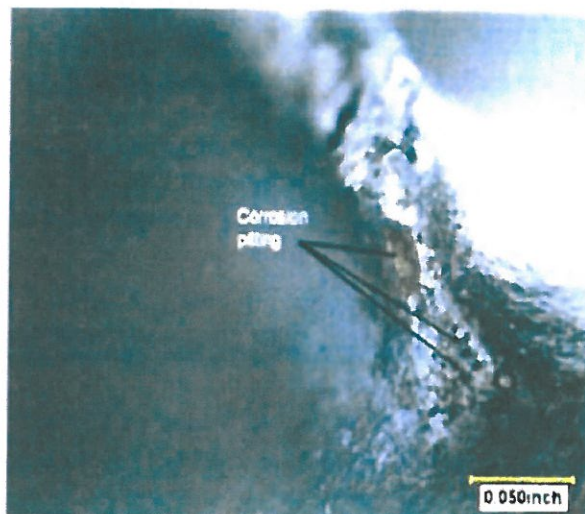
2. Corrosion damage was found in the airfoil to hub fillet area of most 2<sup>nd</sup> stage airfoils. Figure 2 [Figure 7 AIC report] shows representative damage found in this area.

**Figure 7: Representative corrosion pitting** (Photograph courtesy of Rolls-Royce Corporation)

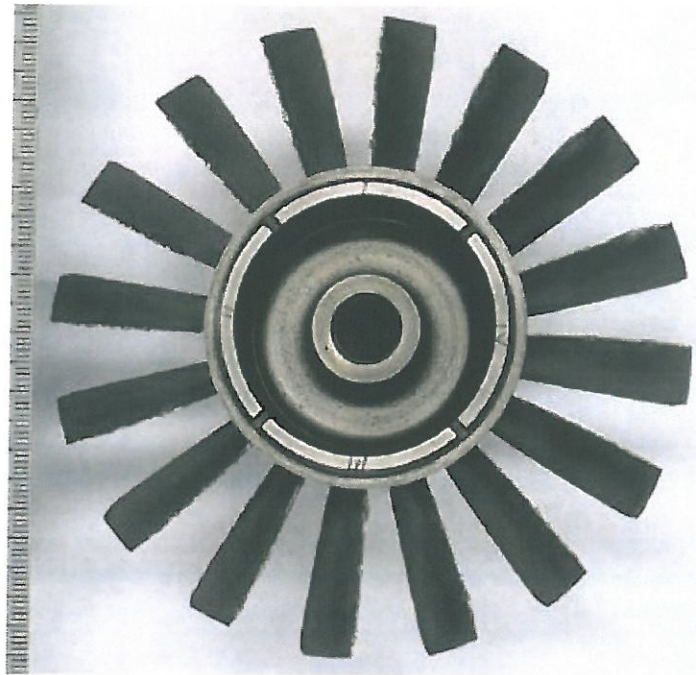
**Figure 8: 1st stage compressor rotor impact damage to the trailing edges of the blades. Divisions = mm**

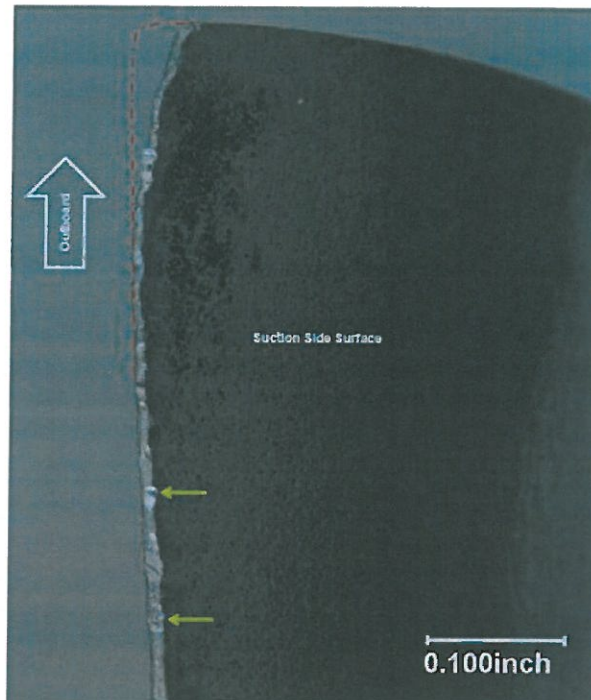
**Figure 9: Representative erosion of the outboard tip leading edge of a 1st stage compressor blade. The red dashed line indicates a typical leading edge profile. Impact damage to the leading edge is indicated by yellow arrows.** (Photograph courtesy of Rolls-Royce Corporation)

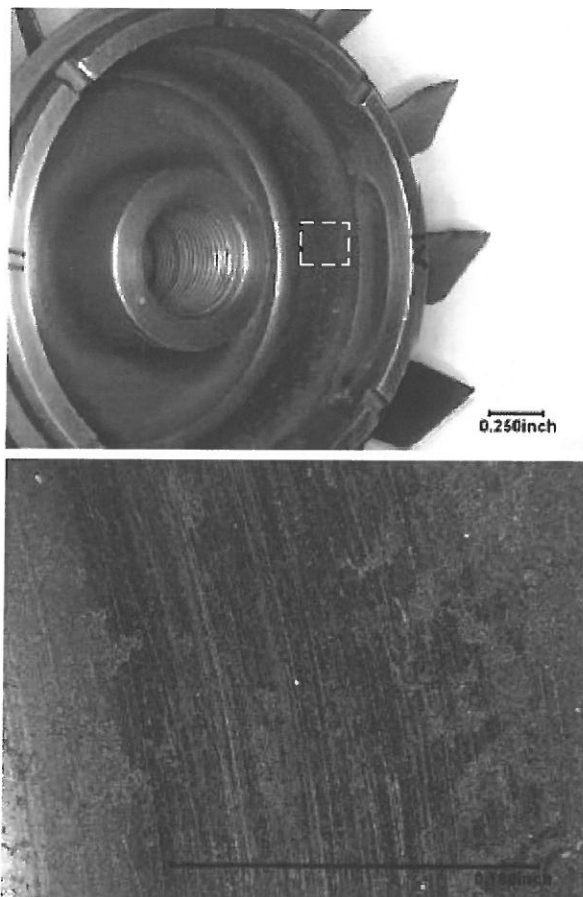
4. Corrosion damage was also observed on the 1<sup>st</sup> stage compressor. This level of corrosion damage is consistent with improper compressor maintenance when operating in a severe corrosive environment.

**Figure 10: Corrosion damage on the inner diameter surface of the 1st stage compressor rotor.**
