**FINAL REPORT**

**AIC 13-1002**

**Cessna Aircraft Company 172SP**

**Loss of directional control – overturned on soft flight strip**

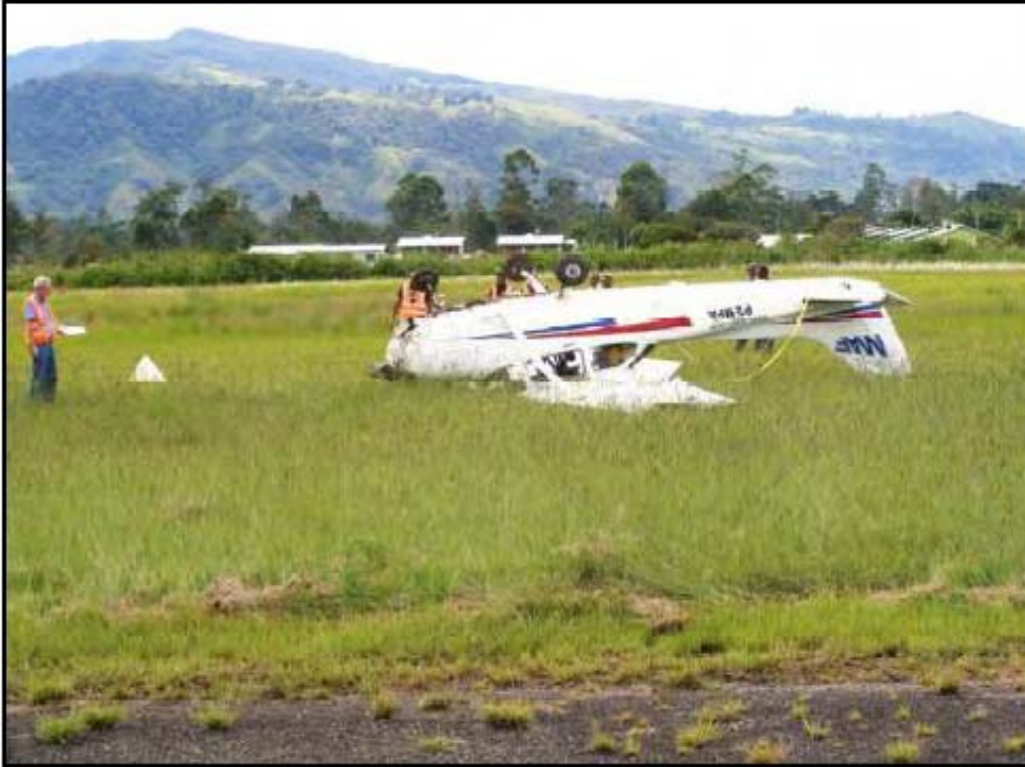
**The accident site at Kagamuga Airport Mount Hagen**  
The aircraft came to rest within the cone markers of the flight strip.

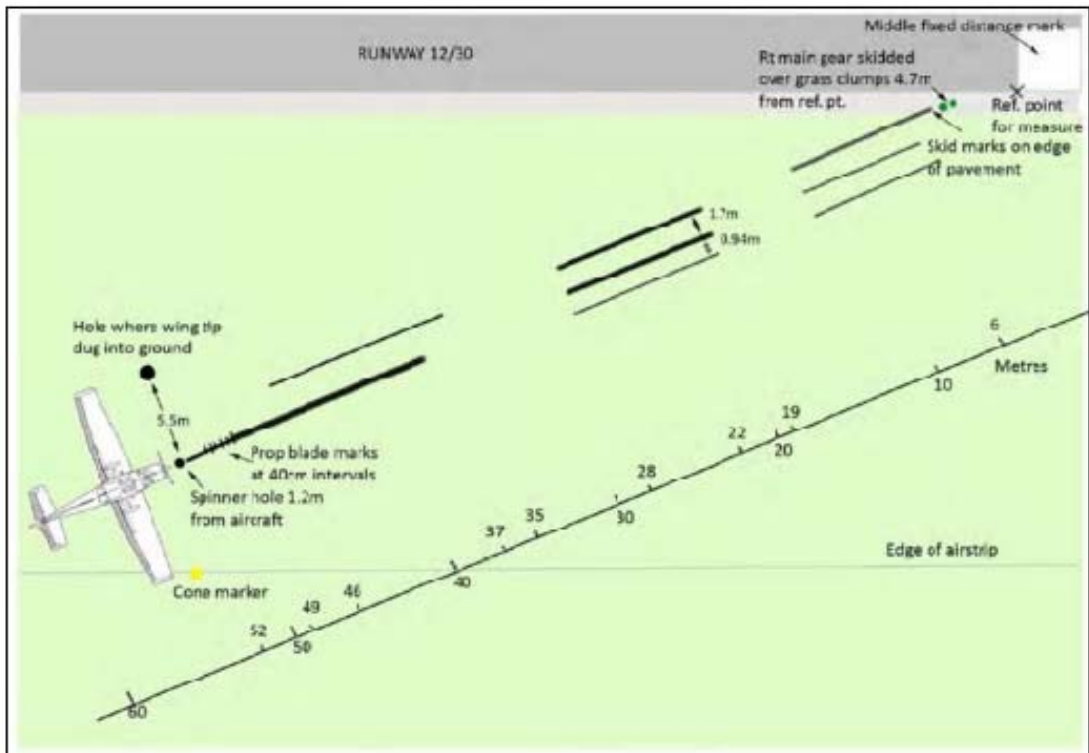
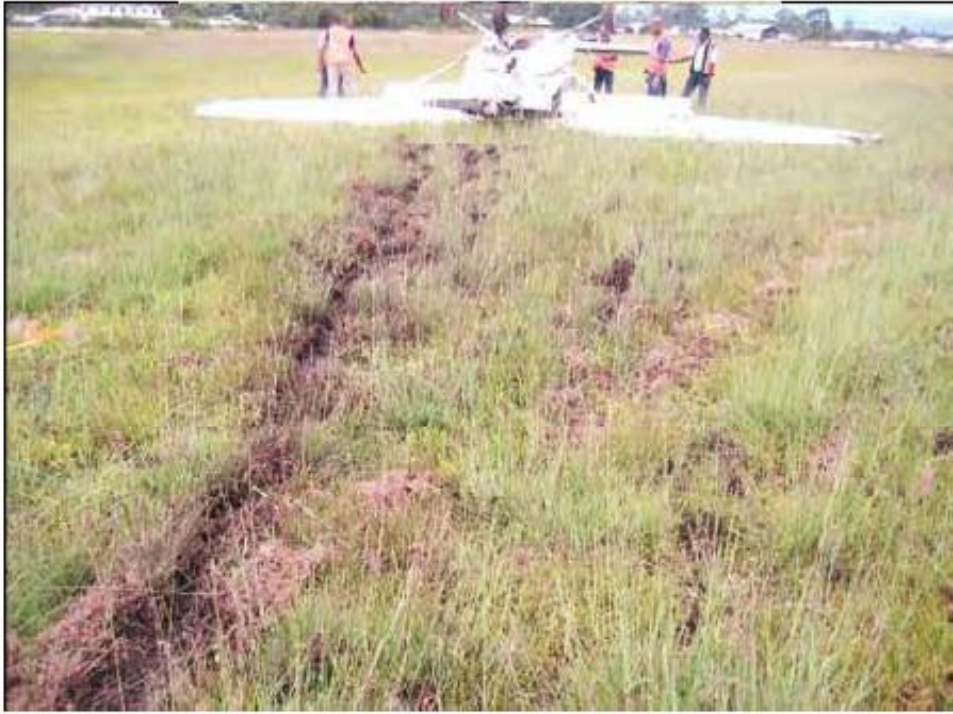
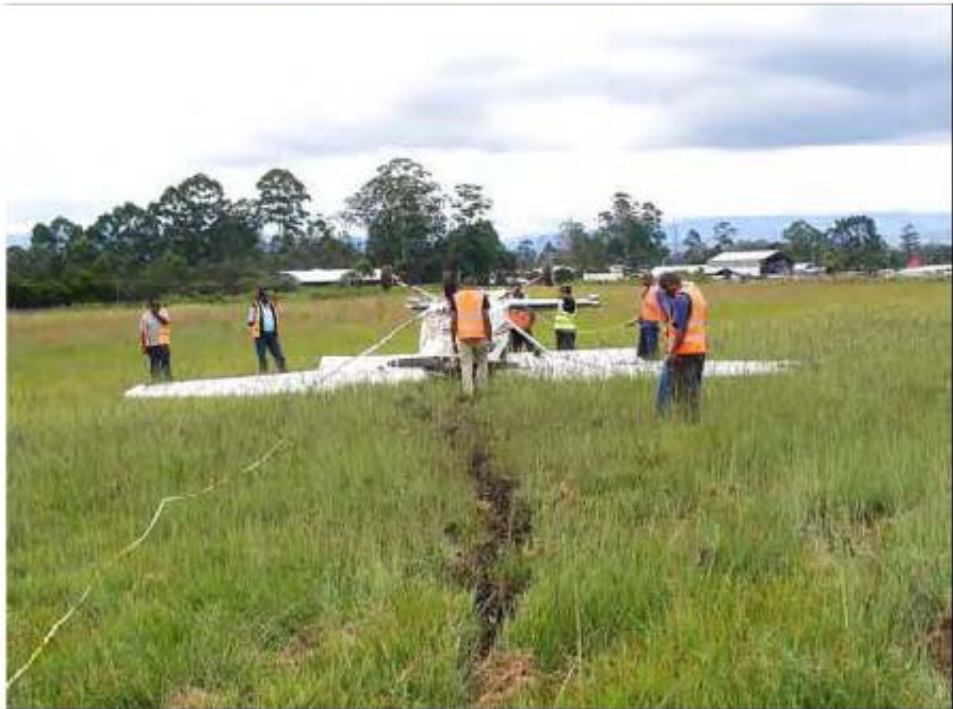
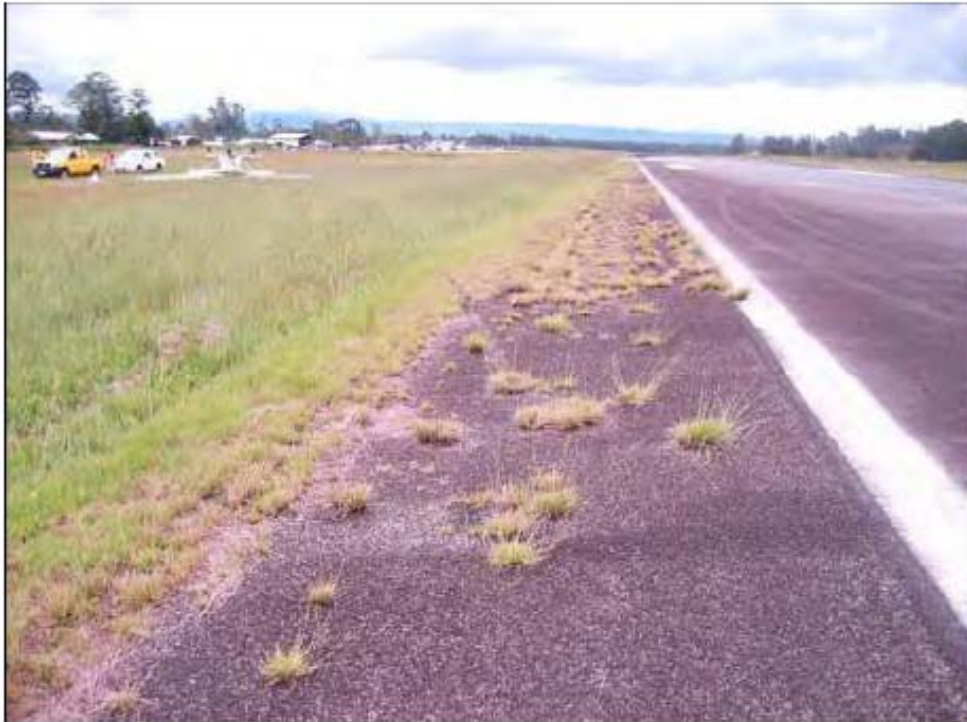
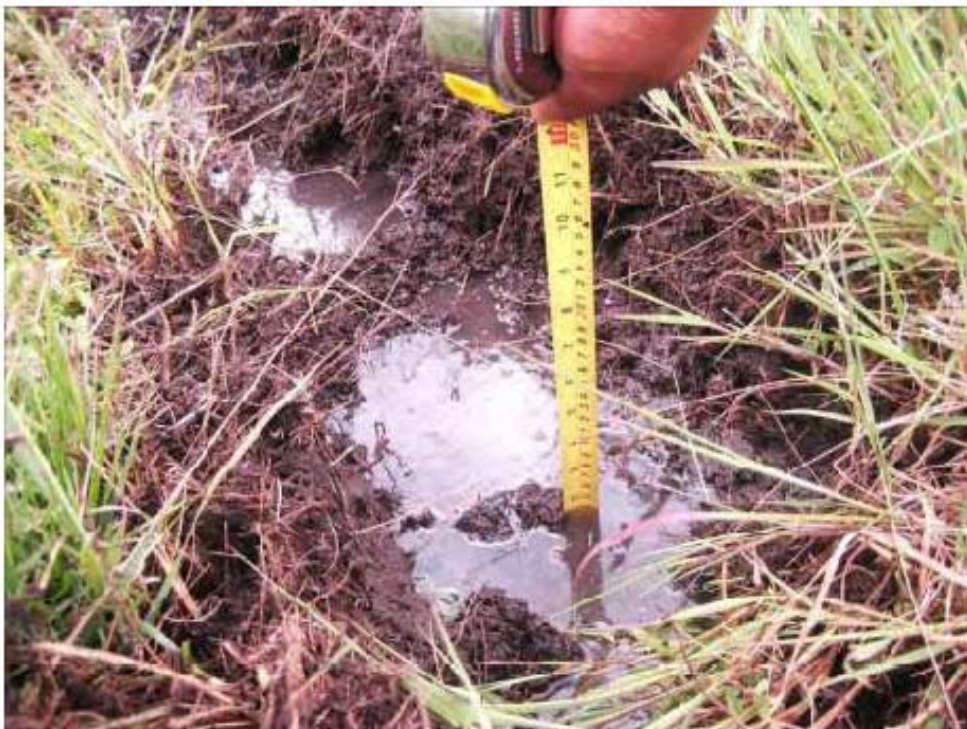
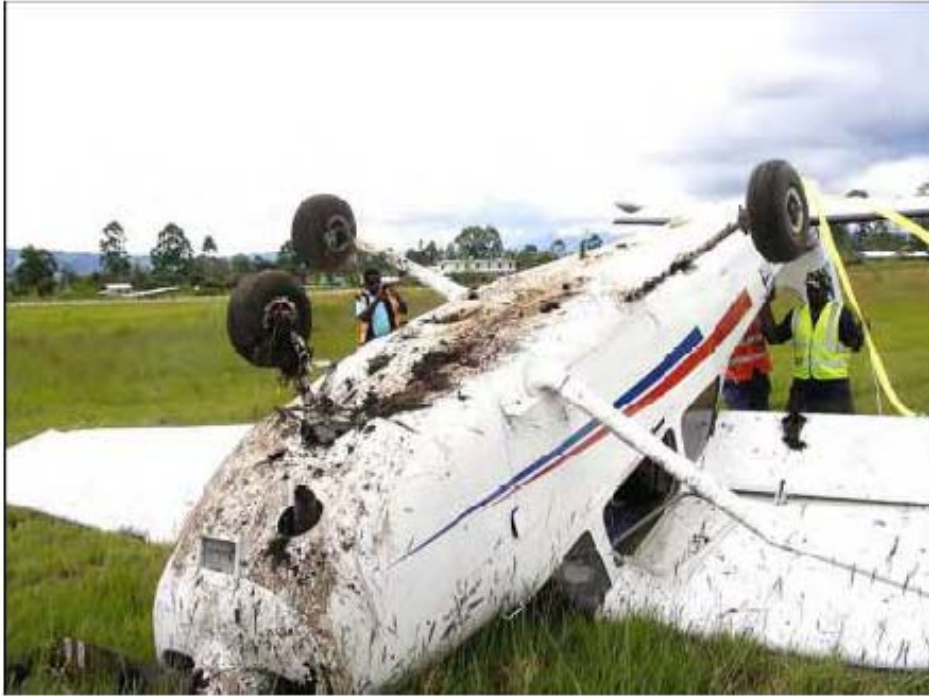
**Appendix 1.**

The surface of the grass edge strip overrun area inside the cone markers was inadequately maintained and not drained appropriately, and was extremely soggy after some days of heavy rain. Approximately 4 cm of standing water was measured in the ground scours that the aircraft made during the accident.

*The soft state of the grass strip on the side of the runway inside the cone markers contributed to the aircraft damage. Had the grass surface been kept well-drained and the grass well-cut, it is more likely than not that the nose wheel would not have dug into the ground, the aircraft would not have overturned and the damage would have been significantly less.*

11. The inadequate maintenance of the aerodrome runway grass edge strip led to soft and soggy ground inside the cone markers, which allowed the nose wheel to dig in and the aircraft to overturn. The resulting damage to the aircraft was beyond economical repair.

Images showing the accident diagram, runway departure tracks, the nose wheel rut, the soft wet state of the runway edge grass strip and the final position of the aircraft.

1. Standard ...
2. The ...
3. That ...
4. That the PNG National Airports Corporation is made aware that the inadequate maintenance of the aerodrome at Kagamuga Airport Mount Hagen and the consequent soft and soggy edge strip inside the cone markers was the main contributor to the extensive aircraft damage.
5. The procedures for solo training circuits and the use of non-standard circuits at Kagamuga Airport Mount Hagen, and the state of its Tower telephone facilities, are discussed with PNG Air Services Limited.
