**PAPUA NEW GUINEA
ACCIDENT INVESTIGATION COMMISSION
SHORT SUMMARY REPORT**

Bell 407

Engine power loss and forced landing

22 July 2015

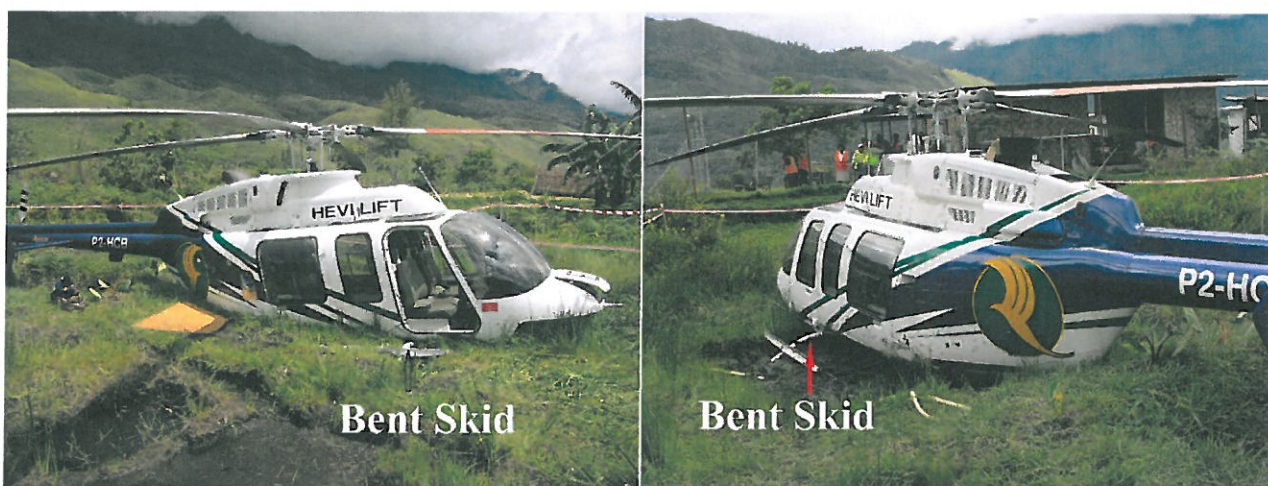
The helicopter sustained substantial damage to both of its landing-gear skids and substantial cracks on right the windshield and the right chin bubble during the impact with the soft dirt area. (Ref Fig 3, 4 &5). The fuselage belly panels and the bottom of the fin had minor damage.

Fig 3: Helicopter resting on its belly with bent skids

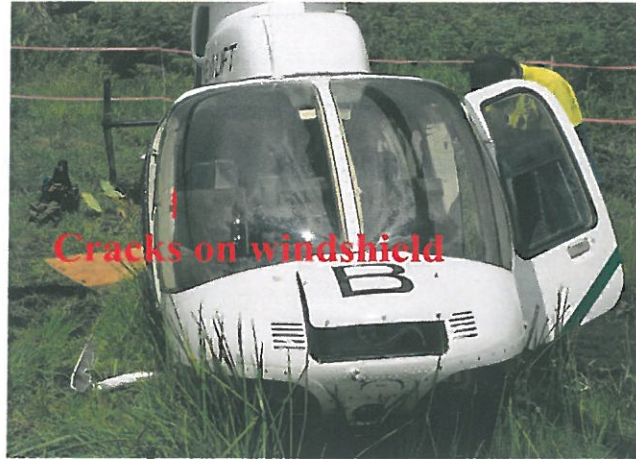
Fig 4: Substantial crack on right windshield

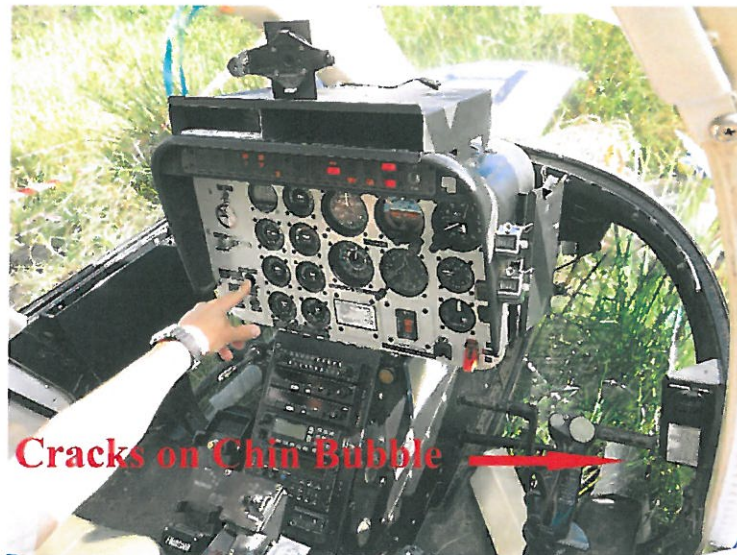
Fig 5: Cracks on chin bubble - right side

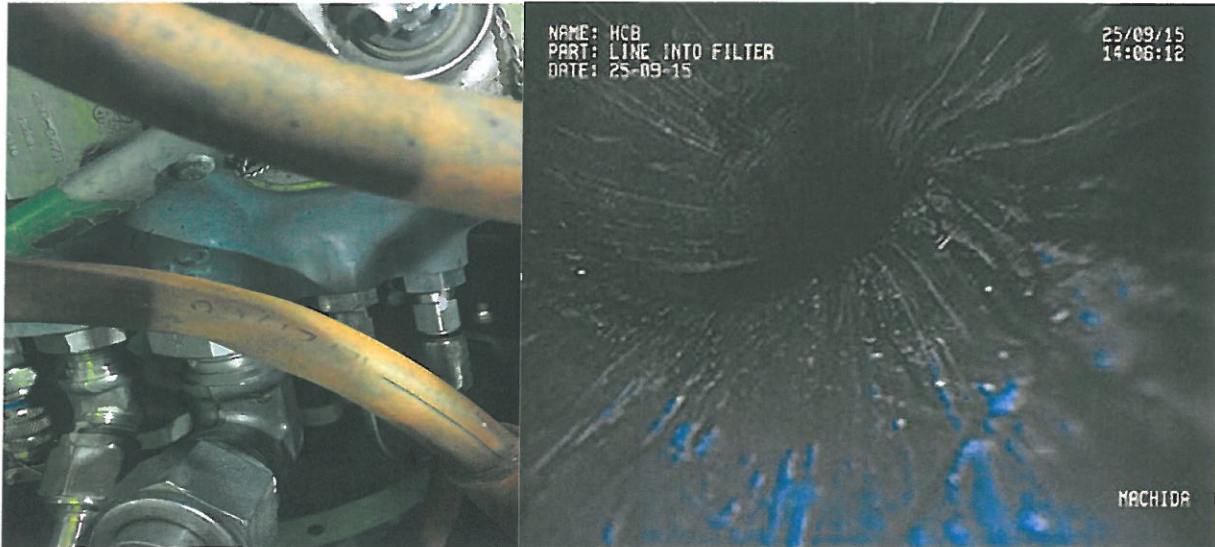
The Rolls-Royce Corporation investigator recommended that the Operator should examine the fuel lines leading into and out of the aircraft mounted fuel filter, due to similar cases in the past where these fuel lines were twisted as a result of servicing the filter element. The Operator's borescope inspection found kinks on the hose P/N: 70-079H000Y150, which is the fuel line from the fire wall to the airframe fuel filter.

Fig 6: Hose P/N: 70-079H000Y150 KINK ON LINE AND BORESCOPE VIEW

1. The fuel was not a contributing factor. It was free of contaminants and met the required specifications.
2. No engine defect was found and engine performance was within the manufacturer's specifications.
3. The fuel hose P/N: 70-079H000Y150 was kinked, which may have caused a slight restriction in fuel flow.

The reason for the engine malfunction could not be conclusively determined. However, it is possible that the kink in the fuel hose may have caused a slight fuel flow restriction, contributing to a loss of power. The operator reported that they replaced the hose before putting the helicopter back into service.
