Final Report

AIC 15-2028

Fokker F27 Mk 050 and Bombardier DHC-8-102

Breakdown of Separation

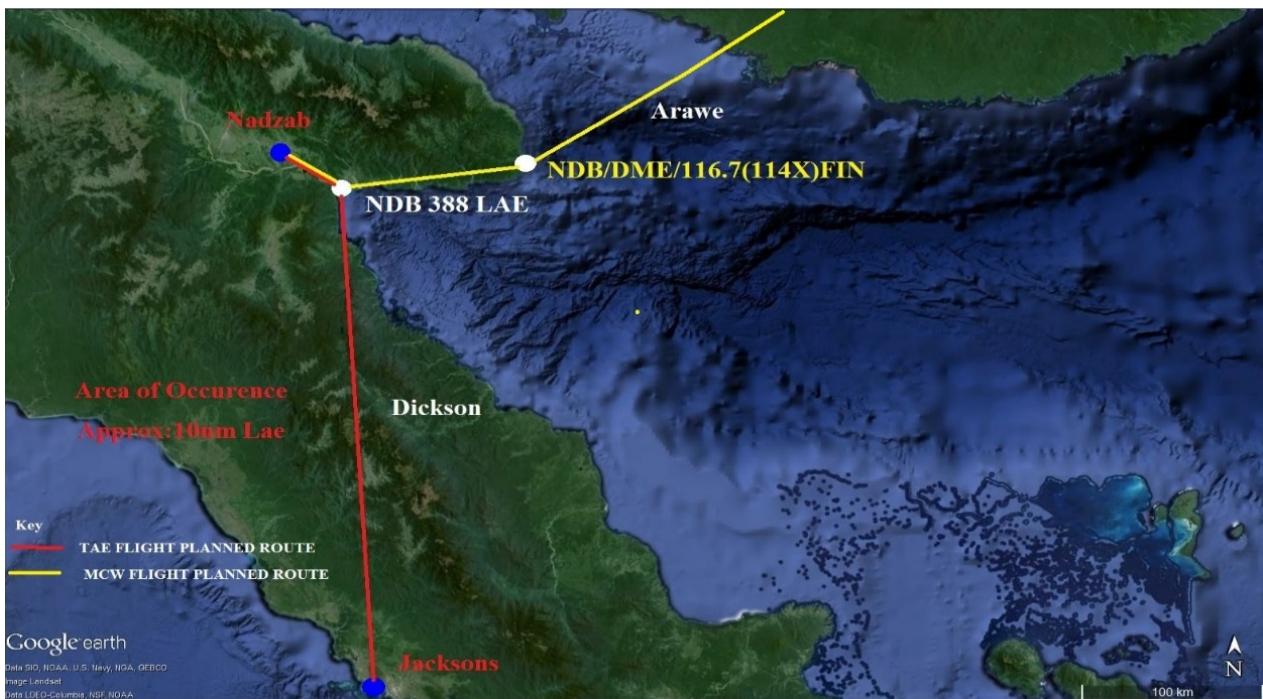
Figure 1: P2-MCW and P2-TAE flight plan route

Both aircraft were on reciprocal tracks (114° radial of Nadzab VOR). MCW was outbound, cleared to 8000 ft, while TAE was inbound, cleared to 9000 ft when the TCAS TA followed by a RA⁷ was received by MCW. The crew of MCW subsequently reported that they were still on climb passing 7,600 ft when they received a TA and their TCAS showed TAE still descending towards them. A RA soon followed with instructions to descend. The crew of MCW stated that they believed that TAE had descended through 9,000 ft and was showing 600 ft vertical separation on MCW's TCAS, and the indication was that it was continuing to descend towards MCW. They also reported that the aircraft passed each other so close that they could read the F50's tail number P2-TAE. The crew of TAE reported sighting and passing MCW. They subsequently informed the AIC that their TCAS did not activate, thus giving them the impression that adequate separation was being maintained.

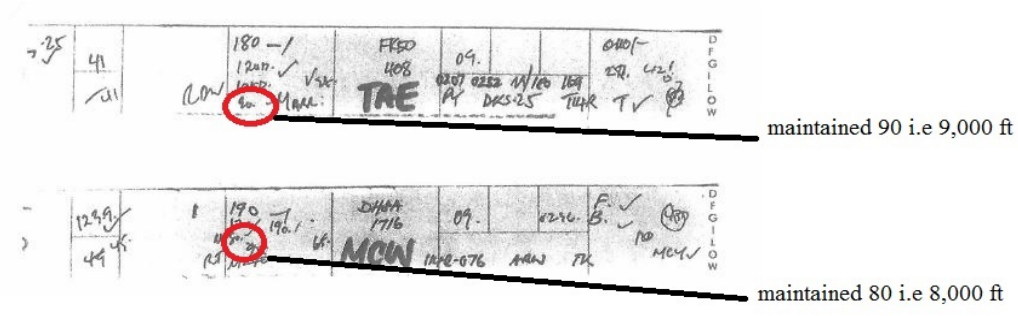
Figure 2: ATC flight progress strip

The approach controller placed a ‘tick’ on the respective flight progress strips adjacent to the correct maintained altitude, ‘90’ representing 9,000 ft for P2-TAE and ‘80’ representing 8,000 ft for P2-MCW. Placing a tick to the right of the assigned level was the controller’s annotation that a correct read back of the level had been made by the pilot.

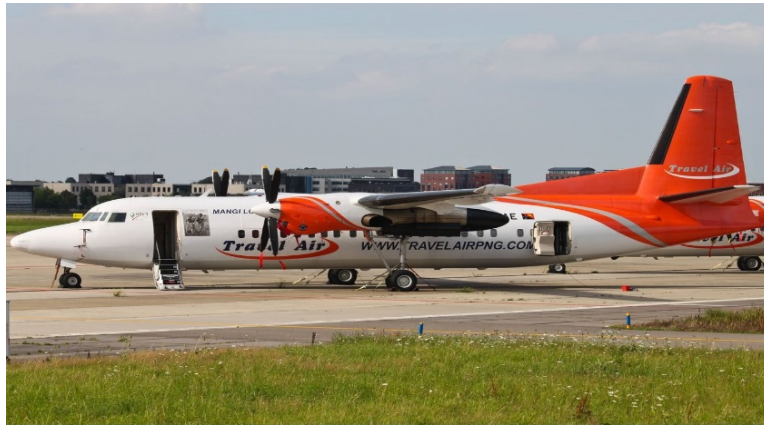
Figure 8: Fokker 27 Mk 050 (F50) P2-TAE

The TCAS equipment installed in TAE at the time of the incident was removed 65 days after the incident due to significant defects. It was replaced with a reportedly "serviceable" unit, however, further defects were reported through November and December 2015. The TCAS unit installed in MCW was determined to have been serviceable at the time of the incident.

The TCAS defect rectification testing and maintenance on the Travel Air fleet of Fokker F27 Mk 050 aircraft was not robust, and was not conducted in accordance with the approved Travel Air *Maintenance Control Manual*, and the aircraft manufacturer's *TCAS Functional Test Instructions*.
