**FINAL REPORT**

**AIC 11-1008**

**P2-RUH**

**Eurocopter Canada Bo 105LS A3**

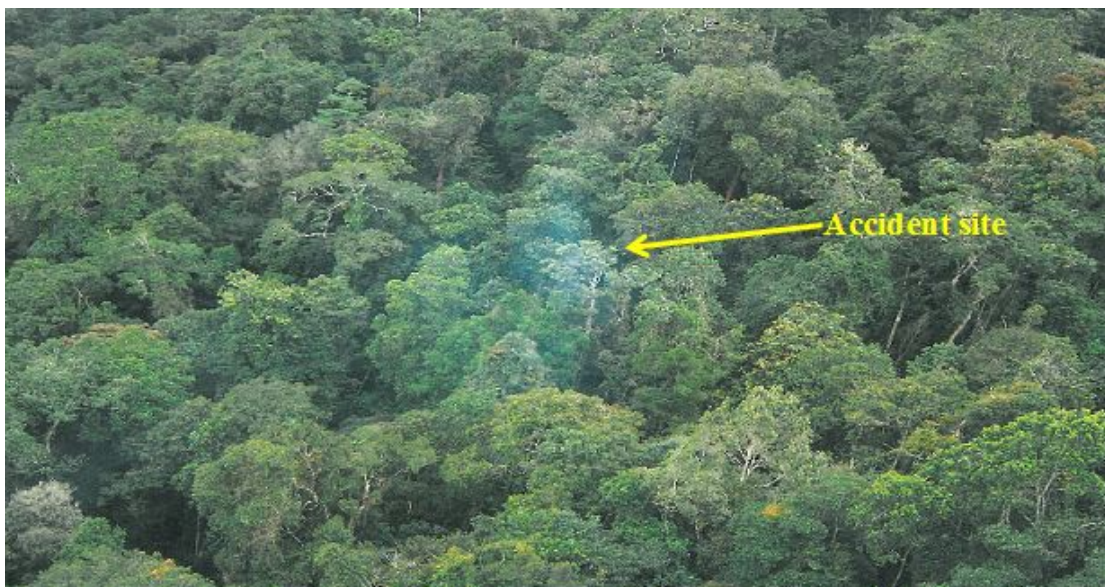
## Figure 2: P2-RUH accident site

The wreckage was spread through jungle vegetation with some components 80 m from the main wreckage. The occupants had not survived the impact.

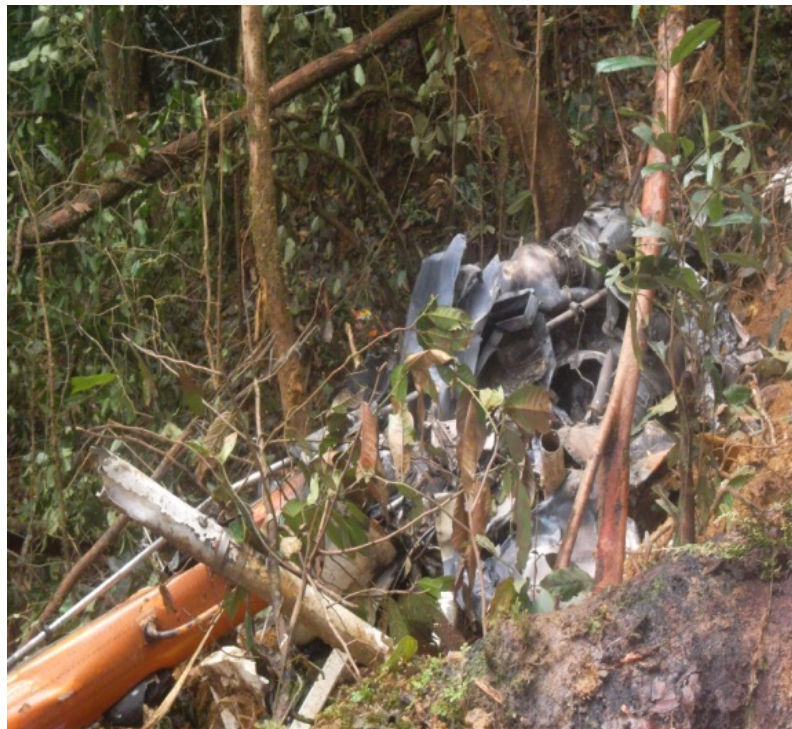
**Figure 3: Part of the burnt Fuselage and tail boom**

The helicopter was destroyed by the impact forces and a post-impact fire,

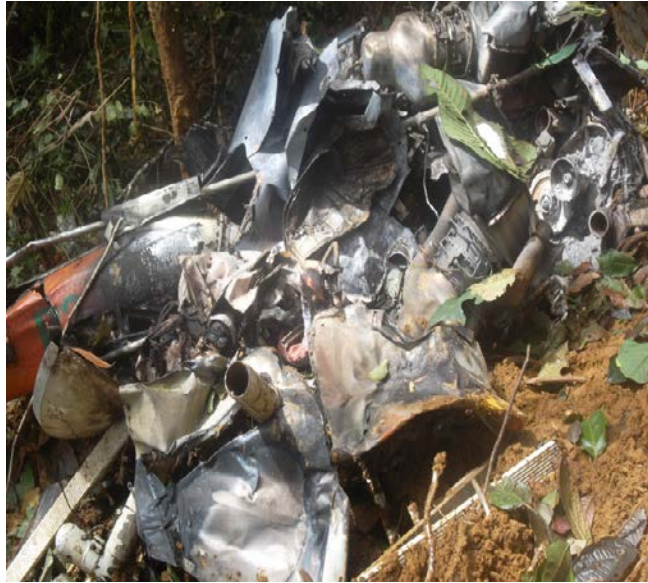
**Figure 5: Both engines**

Both engines remained attached to the airframe. Power-train components, including the main rotor gear-box were partially burnt during the post-impact fire.

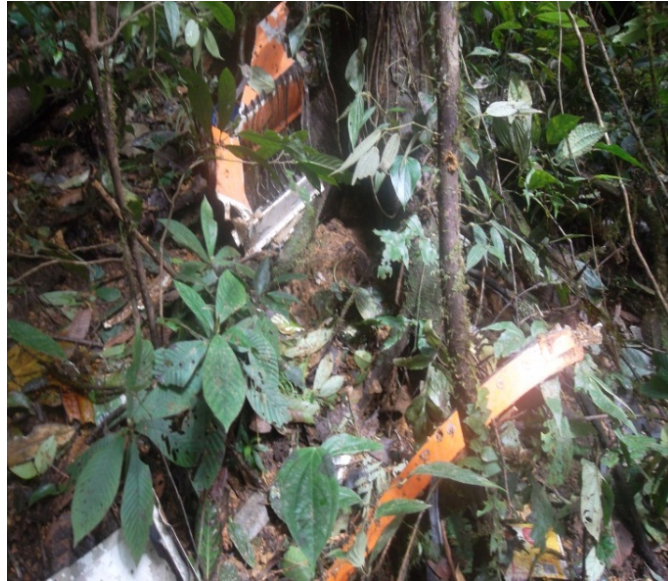
**Figure 7: Shows destruction to panels and cowls**

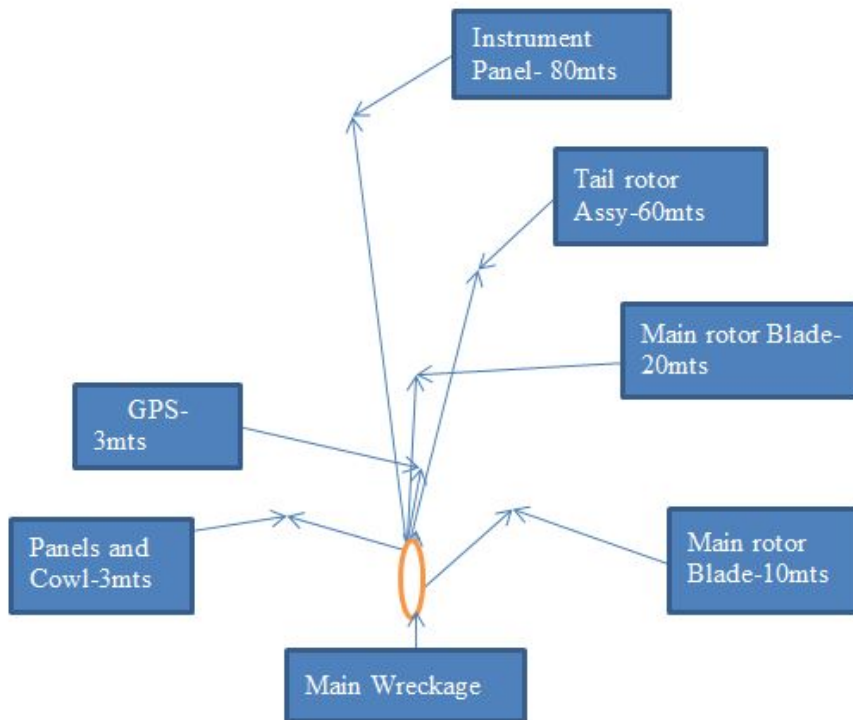
**Figure 10: Wreckage sketch**

The accident was a high velocity event in adverse weather conditions. The impact forces were such that the helicopter was totally destroyed by the impact with trees and the steep terrain. A post-impact fire further damaged sections of the fuselage. Aircraft wreckage was dispersed through thick jungle vegetation, with some components up to 80 metres from the main wreckage.

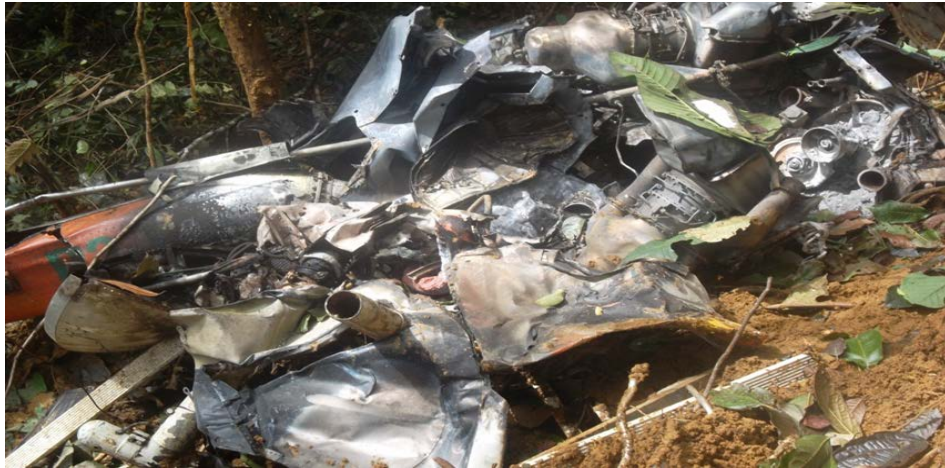
**Figure 11: The burnt engine area of the fuselage**

The helicopter sustained post-impact fire damage, from the fuselage mid-section to the cockpit and cabin area.
