# PRELIMINARY REPORT AIC 18-1001

Lynden Air Cargo and Air Niugini

Lockheed Hercules L-382 and Boeing 737-800

Collision during taxiing

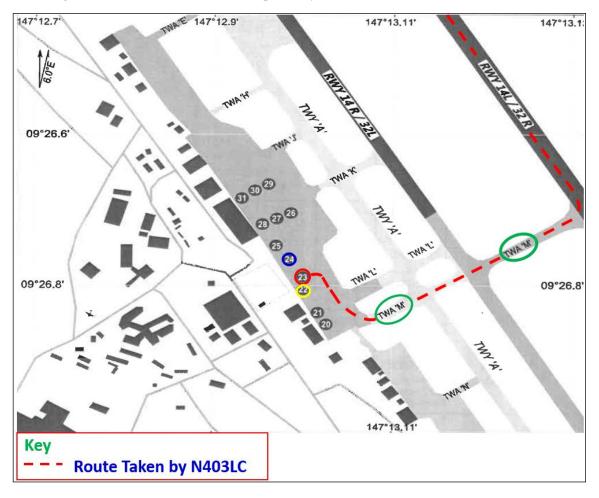
Figure 1: Route Taken by N403LC

The Hercules landed on runway 14 Left at 05:10 UTC¹ (15:10 local), turned right onto taxiway M and continued taxiing to Bay 23, crossing runway 14 Right and taxiway A. The adjacent bays, Bay 22 and Bay 24 were occupied by a Boeing 737-800, registered P2-PXE, operated by Air Niugini and a Canadian registered Basler BT-67 aircraft² respectively.

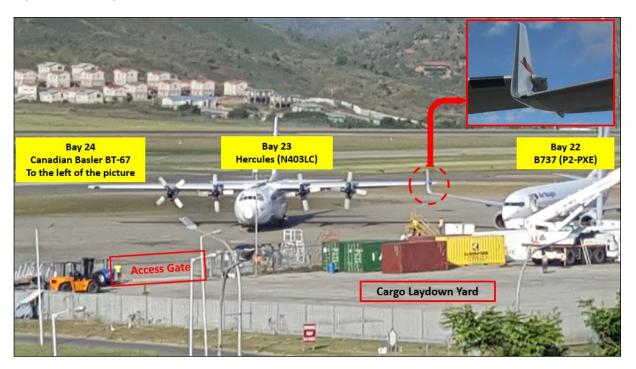
Marshalling guidance was provided at Bay 23 by the Operator's ground personnel. At 05:15, as the Hercules PIC was manoeuvring the aircraft slightly to the left to prepare the aircraft to make a right turn and position its aft end to face the airport access gate to the cargo yard, the radius of turn took it past the wing tip of the Boeing 737. The Boeing 737 was stationary and unoccupied on the apron. The leading edge of the left wing of the Hercules impacted the right winglet of the Boeing 737 causing significant damage to both aircraft.

Figure 2: Wings collision damage (Source: Eye witness)
