PRELIMINARY REPORT

AIC 21-1002

On 15 May 2021, at 11:14:06 local time (01:14:06 UTC¹), a MIL-8 MTV helicopter, registered P2-MHM, owned by Captston Aviation PTE² Limited and operated by Hevlift Aviation Limited, while conducting a VFR charter cargo flight from Gobo, Jiwaka Province to Mt. Hagen, Western Highlands Province, sustained a loss of control in-flight, during take-off from hover and impacted ground and rolled over.

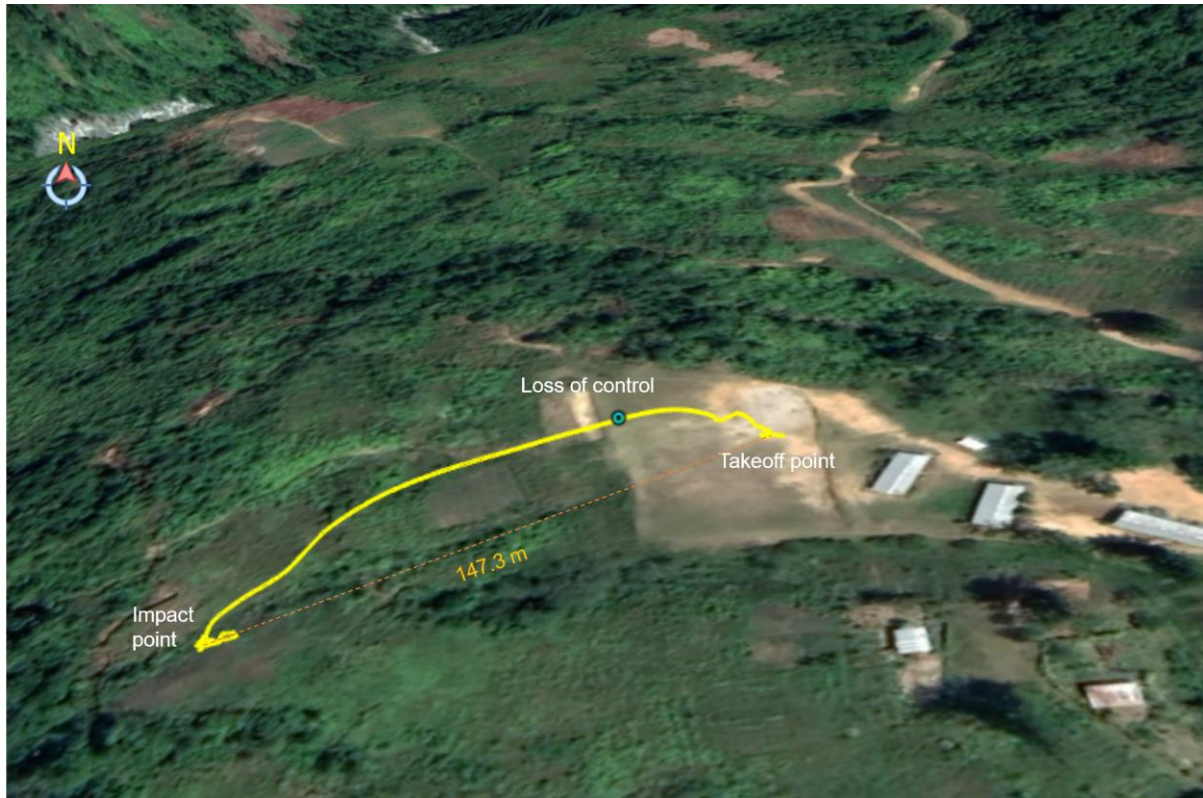
Figure 1: Depiction of P2-MHM flight path from Gobo to the crash site.

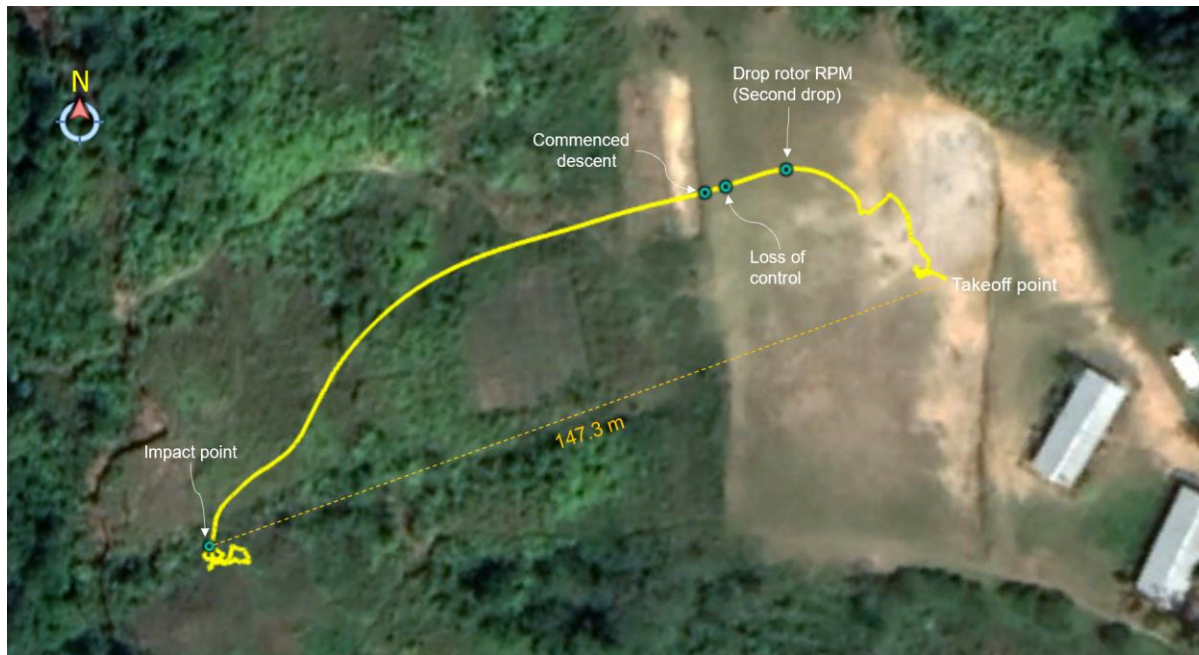
Recorded data indicated that at 11:13:17, the helicopter commenced its take-off to hover. The crew stated that as they continued with the take-off from hover to transition into forward flight, they noticed a drop in the indication of Rotor RPM³. They immediately brought the helicopter back to hover. They

subsequently increased the RPM and lifted off again from hover, and as the helicopter transitioned into forward flight, the crew, again, noticed a drop in Rotor RPM, which immediately led to a loss of control of the helicopter.

The helicopter entered a spin to the left and began descending towards the West of its take-off position before impacting the ground and rolling over. The helicopter came to rest in the upside-down position.

Figure 2: Depiction of the flight path from Gobo with significant events.
