PRELIMINARY REPORT

AIC 22-1001

P2-BWE

Landing Gear Collapse during Landing Roll

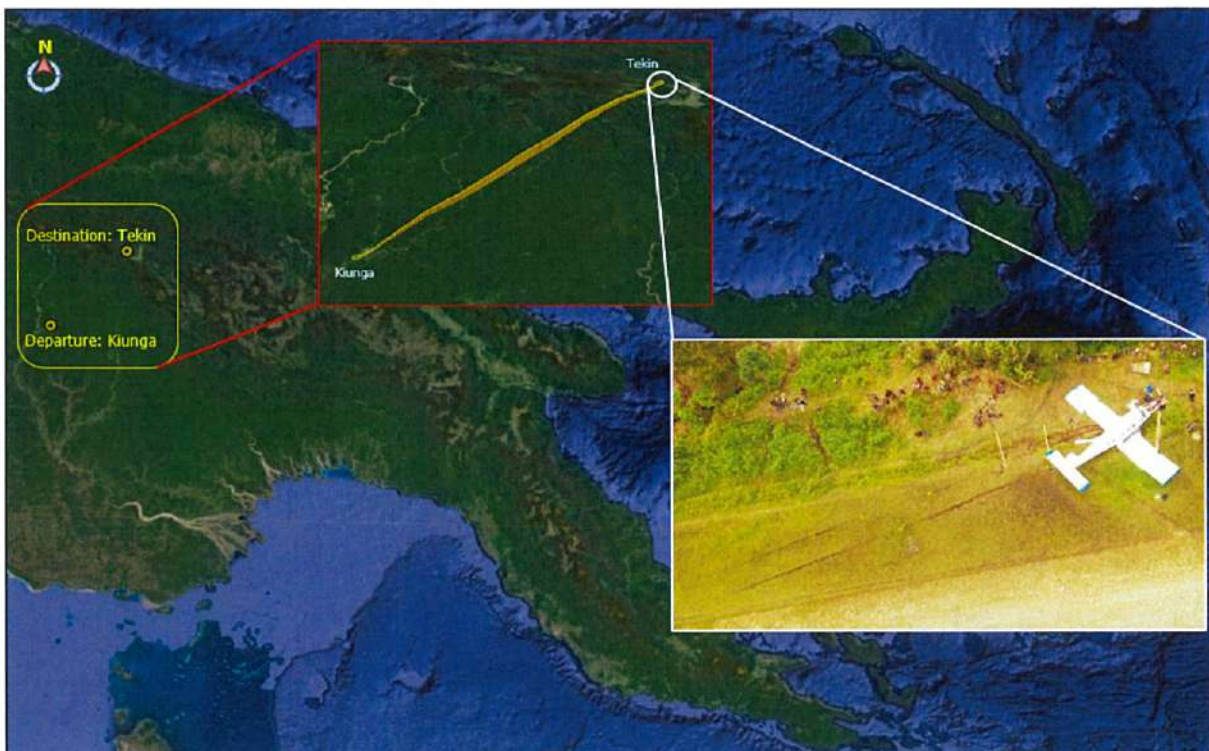
On 18 January 2022, at 09:26 local (23:26 UTC¹), a PAC 750XL aircraft, registered P2-BWE, owned and operated by Niugini Aviation Services, was conducting a single pilot VFR² charter flight from Kiunga Airport, Western Province to Tekin Airstrip, Sandaun Province, when during the landing roll at Tekin, the aircraft sustained a landing gear collapse and subsequently ran off the strip.

Figure 1: Overview of the accident flight path and the site

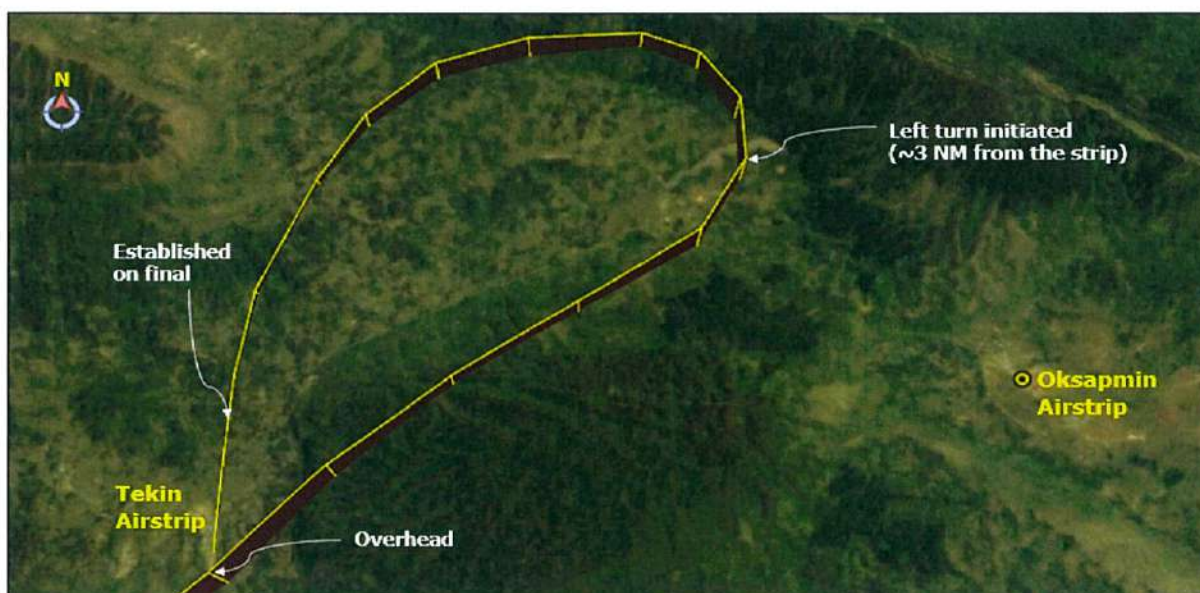
The pilot established the aircraft on the approach profile about 1 nm from the airstrip runway 18 threshold at a height of about 500 ft AGL.

Figure 2: Circuit area at Tekin

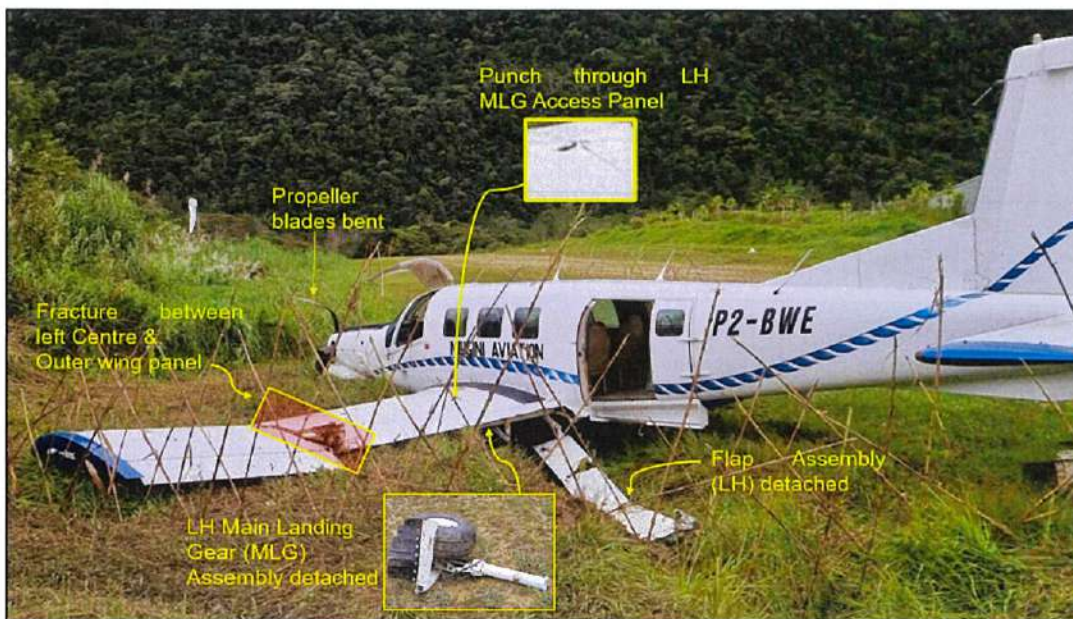
During the on-site investigation, the investigators identified significant damage to the left main landing gear assembly, nose landing gear assembly, left wing assembly and the propeller blades (see Figure 3).

Figure 3: Overview of the damage sustained during impact
