FINAL REPORT

AIC 20 - 2005

ATR 72 - 212A 600

Inflight engine fire warning indication

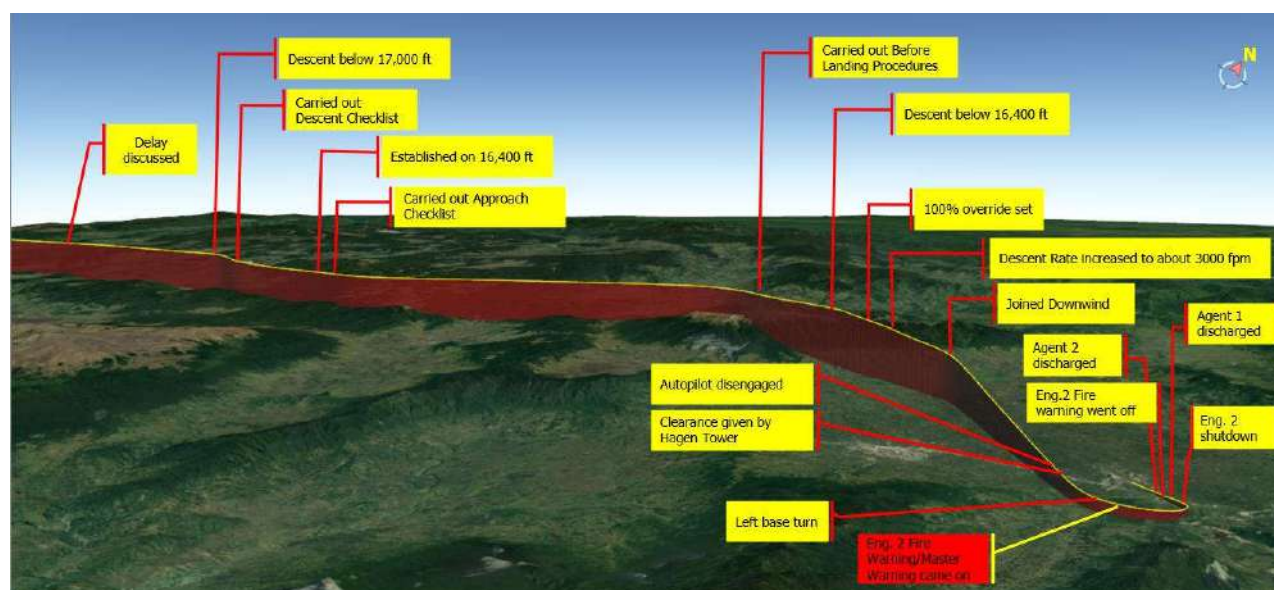
Figure 2: P2-ATB flight path with significant events.

At 13:52:31, about 2 nm south of runway 30, while initiating the turn onto left base, the Master Warning (MW) and fire warning⁷ alarm activated. Upon observing this warning, the crew immediately began their diagnosis while continuing the base turn.

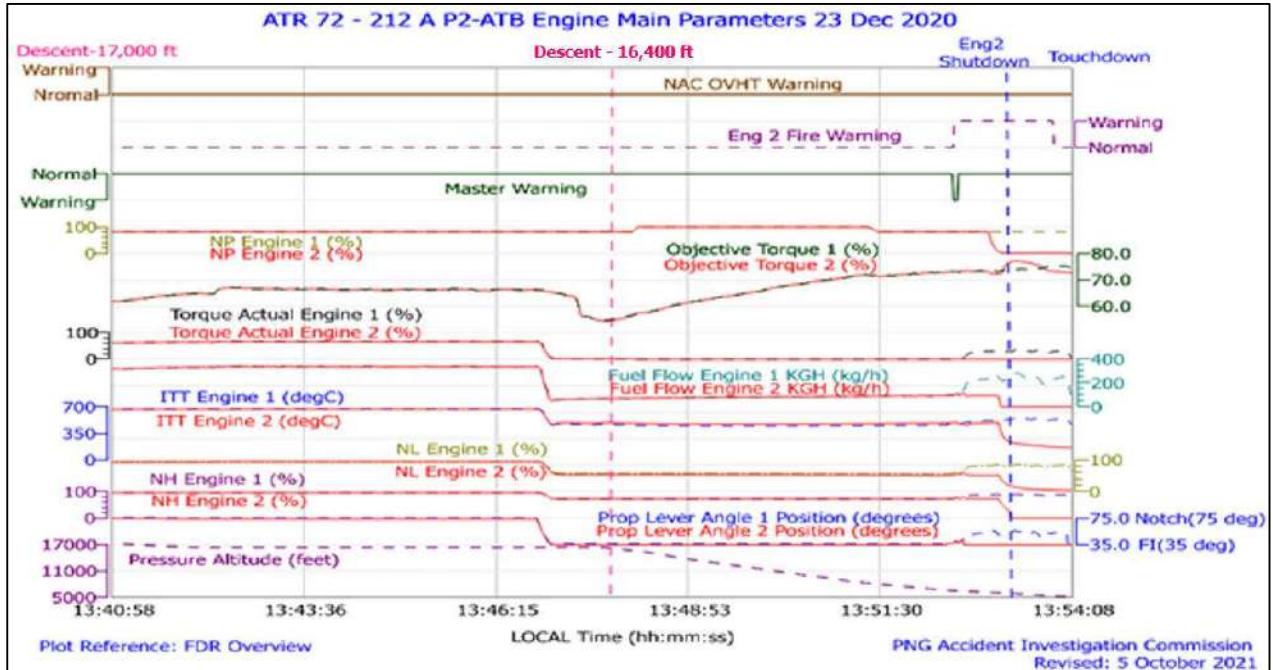
Figure 6: P2-ATB Engine Parameters readout

There were significant information or parameters of the engine recorded by the FDR. The engine parameters recorded by the FDR were plotted and analysed by AIC to see if there were any abnormalities during the time before, during, and after the warnings were activated (refer Figure 6). According to the FDR readout, the investigation observed no abnormal engine parameters.

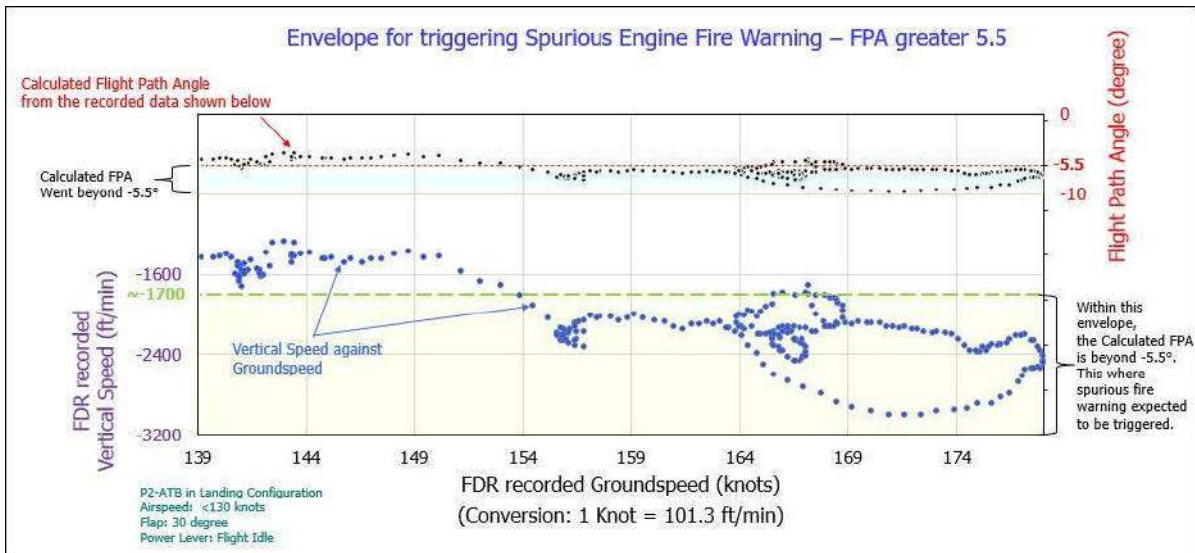
Figure 8: FPA greater than 5.5° envelope.

A plot was generated by AIC with vertical speed (ft/min) on the vertical axis and the groundspeed (m/s) on the horizontal axis to identify when the Flight Path Angle (FPA) went beyond -5.5° during this occurrence flight after landing configuration. From the plot shown in Figure 8, an envelope was identified consisting of upper and lower bounds of the vertical speed and groundspeed, generating FPA to go beyond -5.5° .

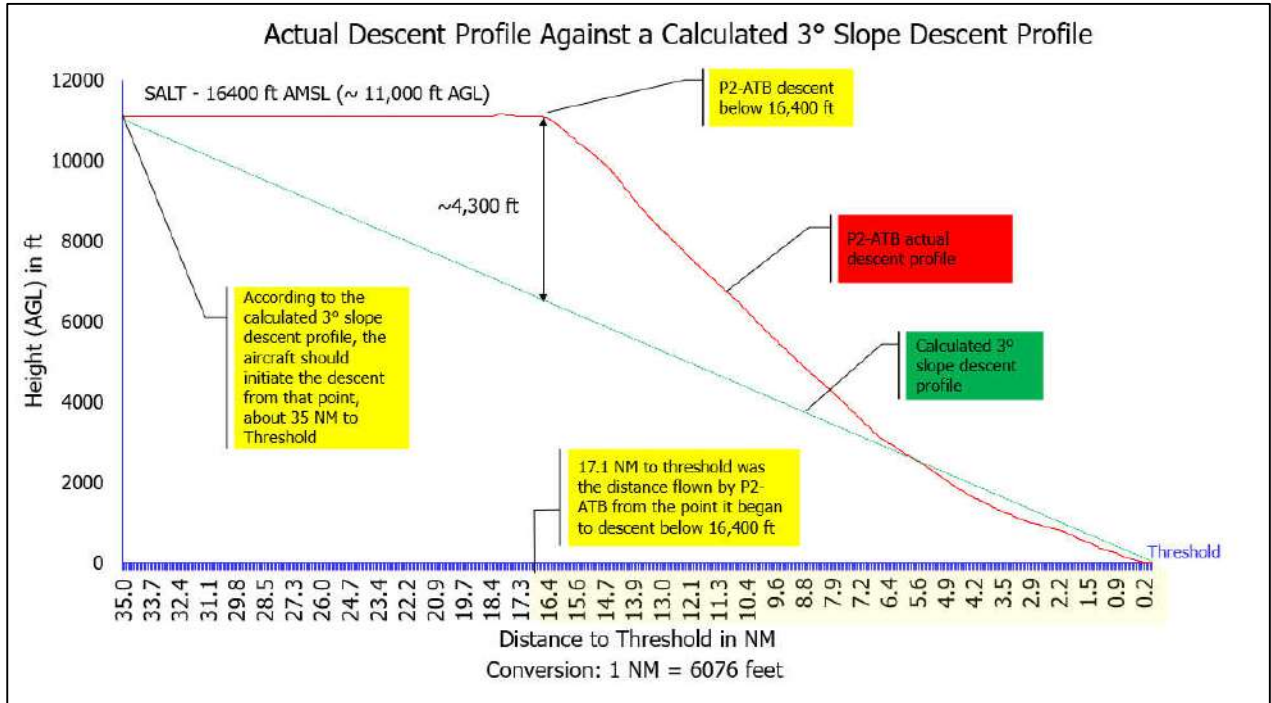
Figure 9: Calculated stable descent profile against the actual approach profile of P2-ATB.

The recorded FDR data was also used to derive and plot an estimate stable approach profile of 3° slope to compare against the actual approach profile which was conducted during the occurrence flight as shown in Figure 9 below.

When the crew reached the lower safe altitude (LSALT), they levelled off due to Instrument Meteorological Conditions and continued tracking at that altitude towards aerodrome. By the time the crew established visual reference, 12 nm from the aerodrome they resumed descent and the aircraft was about over 4,000 ft higher than the altitude it would have been at based on a 3° slope descent from the 36 nm point.
