**PRELIMINARY REPORT**

**AIC 22-1005**

**Airbus Helicopters MBB-BK117 D-2**

**Fenestron sustained substantial damage during landing**

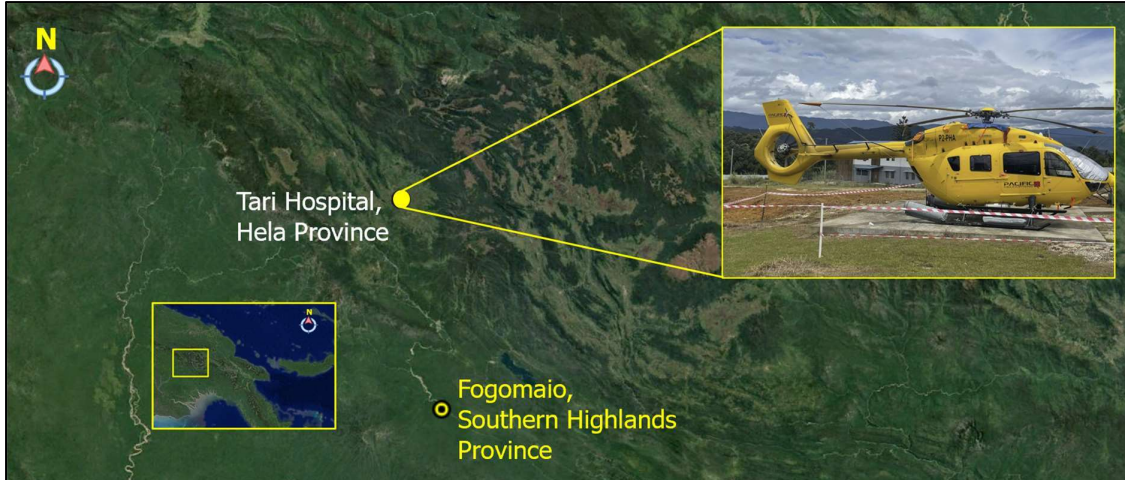
On 1 December 2022, at about 15:17 local time (05:17 UTC<sup>1</sup>) an Airbus Helicopters MBB-BK117 D-2, registered P2-PHA, owned by Javelin Aviation Ltd and operated by Pacific Helicopters was conducting a VFR<sup>2</sup> medical evacuation (Medivac) flight from Fogomaio Airstrip, Southern Highlands Province to Tari Hospital, Hela Province, when during landing, a foreign object debris (FOD) was ingested by the helicopter's fenestron and caused substantial damage.

**Figure 1: Overview of the occurrence**

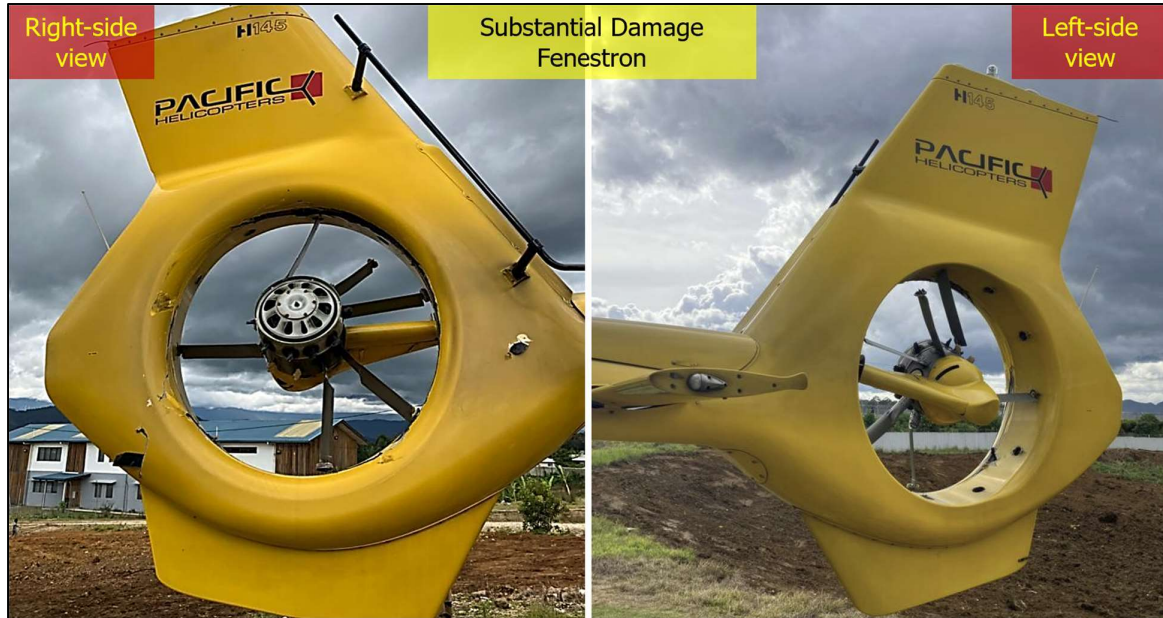
The helicopter sustained significant damage to its Fenestron.

Figure 4: Fenestron substantially damage
