PRELIMINARY REPORT

AIC 23-1001

Controlled Flight into Terrain during take-off

On 9 February 2023, at 12:50 local time (02:50 UTC¹), a PAC 750XL aircraft, registered P2-BJD, owned and operated by North Coast Aviation (NCA), was conducting a VFR² Charter flight from Giramben Airstrip, Jiwaka Province to Simbai Airstrip, Madang Province, when during takeoff, the aircraft impacted the terrain south of Giramben Airstrip.

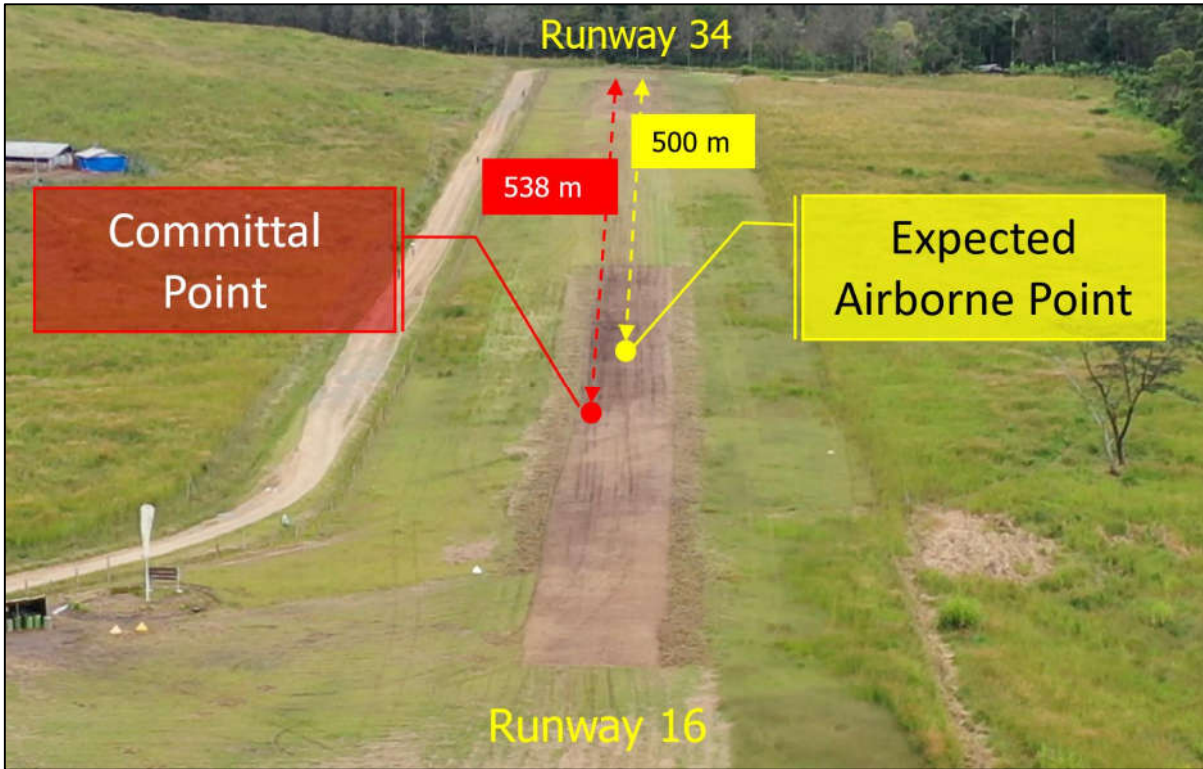
The pilot also stated that during the take-off roll, he expected the aircraft to become airborne about 500 m from the end of runway 34. However, the aircraft did not become airborne at this point and the pilot indicated that the speed was below 60 knots. The pilot decided to continue with the take-off roll with full power to regain speed and subsequently passed his nominated committal point about 538 m from the end of runway 34. The pilot recalled getting airborne with an airspeed between 55 to 60 knots.

Figure 2: P2-BJD committal point and expected airborne point

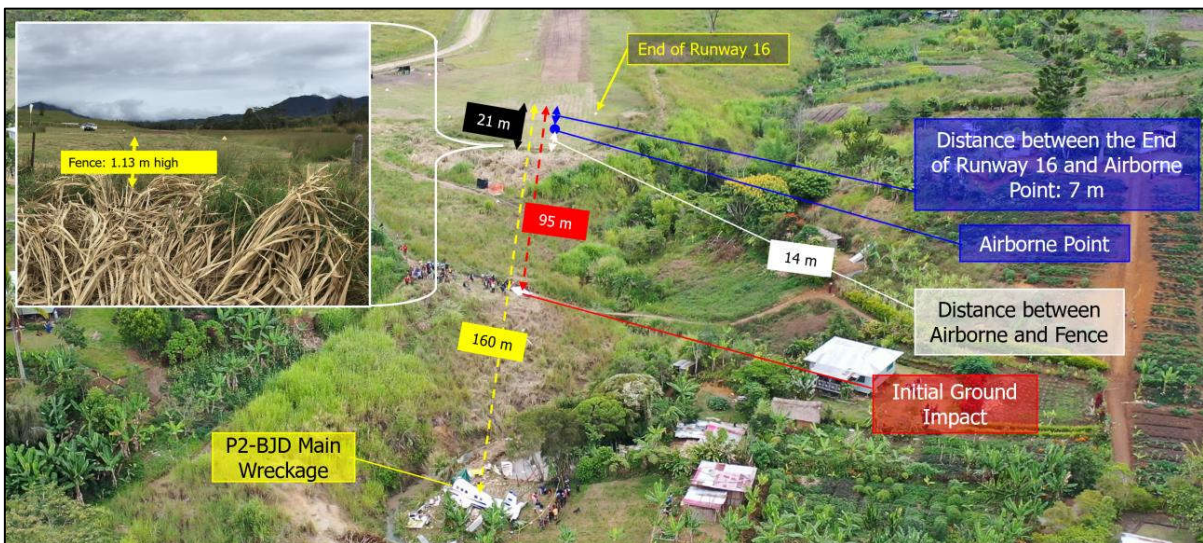
During the on-site activities, the AIC observed from the wheel track marks on the strip that the aircraft got airborne about 7 m past the end of runway 16. Once the aircraft was airborne, the aircraft main landing gears got caught on a 1.13 m high wire fencing located about 21 m from the end of runway 16. The aircraft subsequently impacted the terrain by its right main landing gear and wing about 95 m from the end of runway 16.

The right main landing gear and the outboard wing section detached from the aircraft as a result of the initial impact while the aircraft continued with the momentum and came to rest, in a local village garden 160 m from the end of runway 16.

Figure 3: Overview of P2-BJD from the end of runway 16 to the resting position of P2-BJD

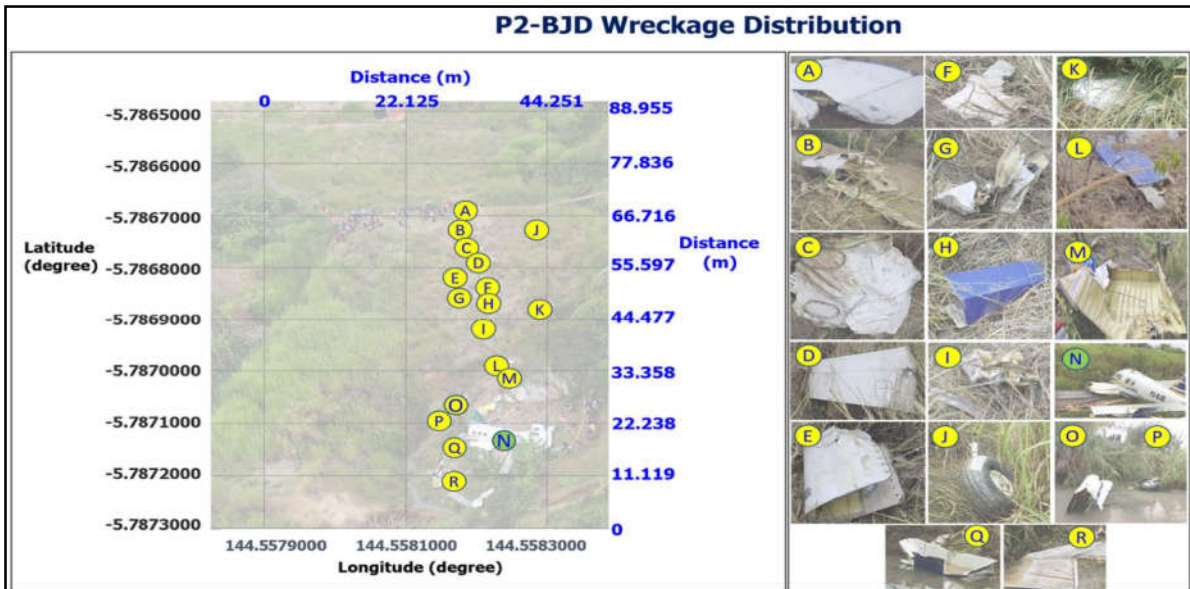
The wreckage distribution from initial impact to the resting position of P2-BJD.

Figure 4: P2-BJD wreckage distribution

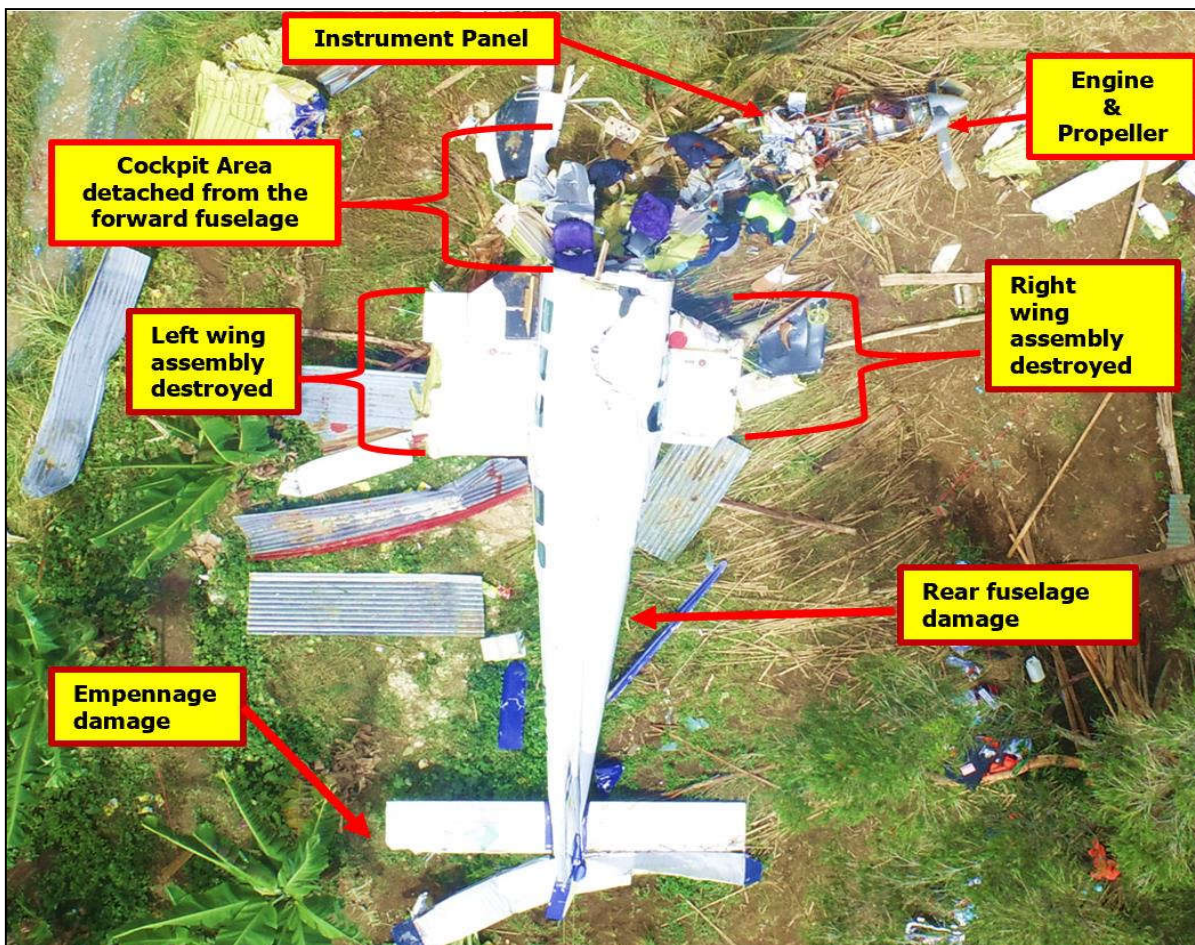
The cockpit section, the firewall and its attachments including the engine and propeller assemblies were separated at the forward fuselage. The aircraft also sustained significant damages to its wing assemblies, rear fuselage, and empennage.

Figure 5: Overview of the damages sustained by P2-BJD
