PRELIMINARY REPORT

AIC 16-1002

**PAPUA NEW GUINEA
ACCIDENT INVESTIGATION COMMISSION
AIRCRAFT ACCIDENT REPORT**

P2-SBC

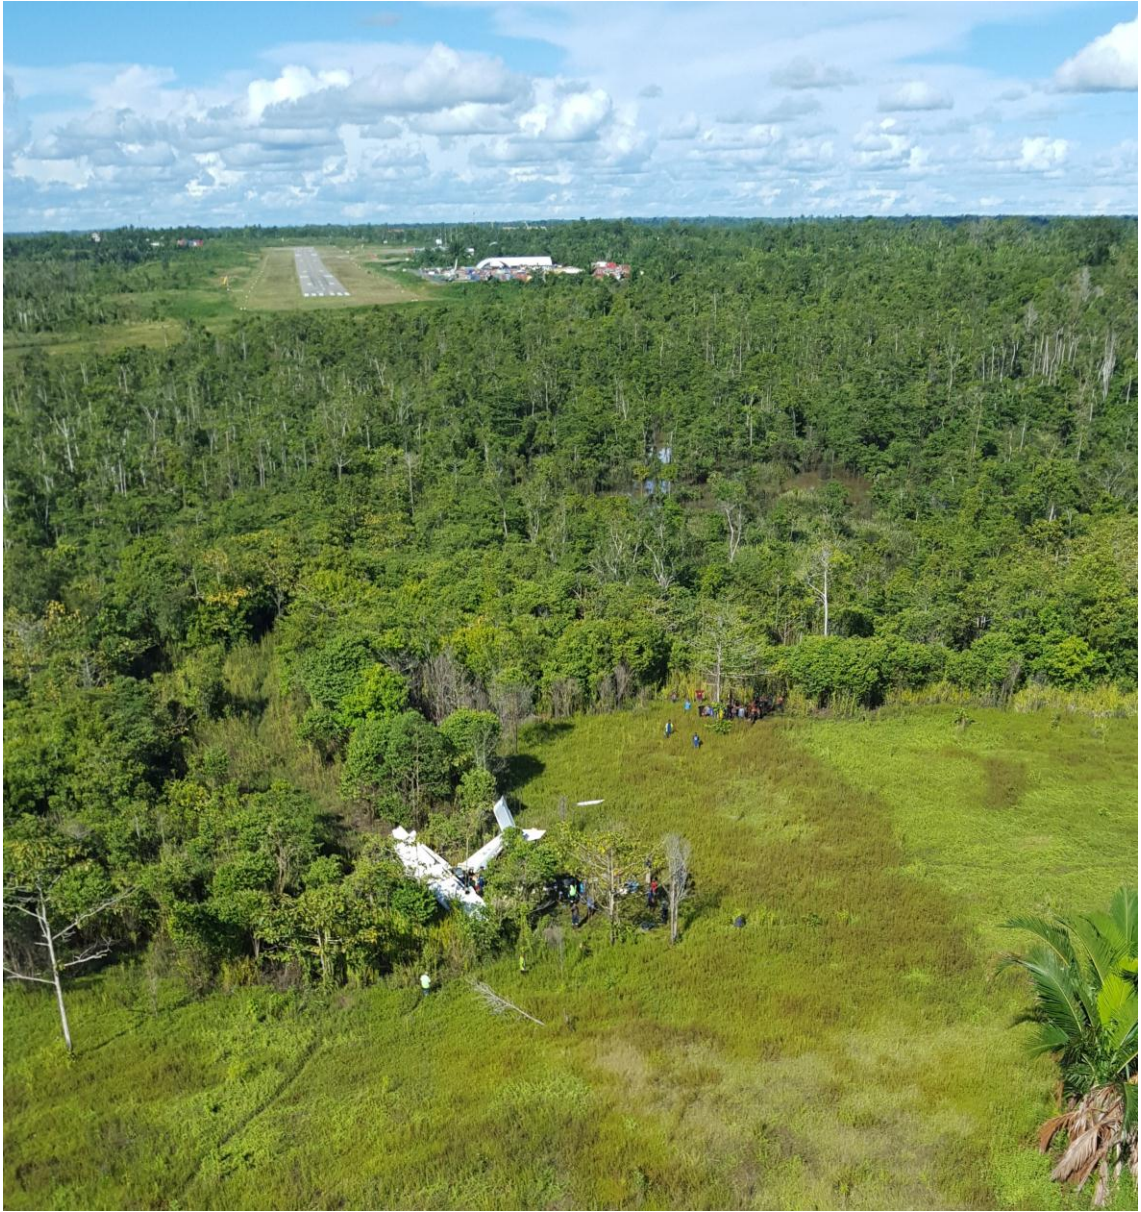
Figure 2: Accident site and wreckage looking in an easterly direction (taken 90 minutes after the accident)

Several witnesses reported that during its final approach the aircraft suddenly pitched up, almost to the vertical, after which the right wing dropped and the aircraft fell to the ground. It impacted the terrain vertically with almost no forward motion, about 1,200 metres west of the threshold of runway 07 (Figure 2), and was destroyed.

The wreckage was confined to a small area following the near-vertical impact. It was situated in mixed grassland and low swamp forest, and there was no damage to the surrounding environment.

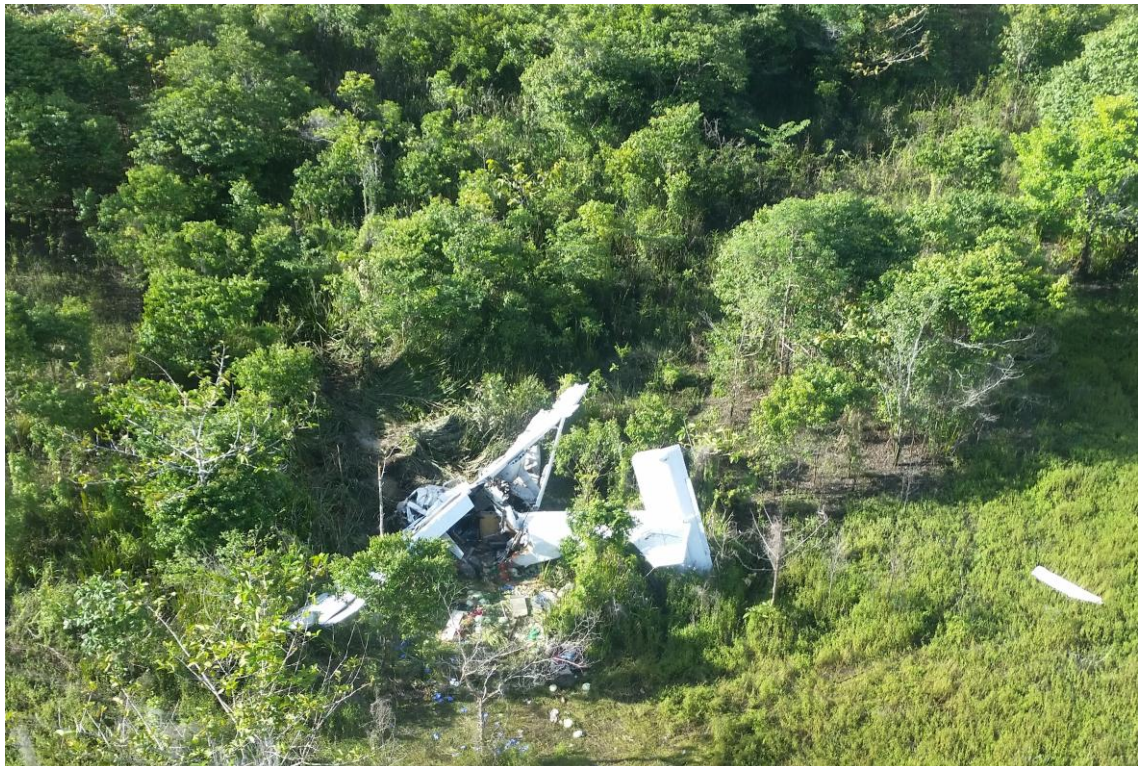
Figure 3: Wreckage of SBC

The aircraft was destroyed in the accident (Figure 3).

The wing assembly had detached from the fuselage and the fuselage had broken open behind the cockpit. The cockpit was destroyed with the left side being crushed. The right aileron came to rest a short distance from the main wreckage.

The aircraft impacted the ground almost vertically and there was consequently no wreckage trail. Bushes approximately 4 to 5 metres in front of the aircraft's nose showed evidence of disturbance during the impact sequence (Figure 3).

The flaps were in the fully-extended position (see Figure 3).

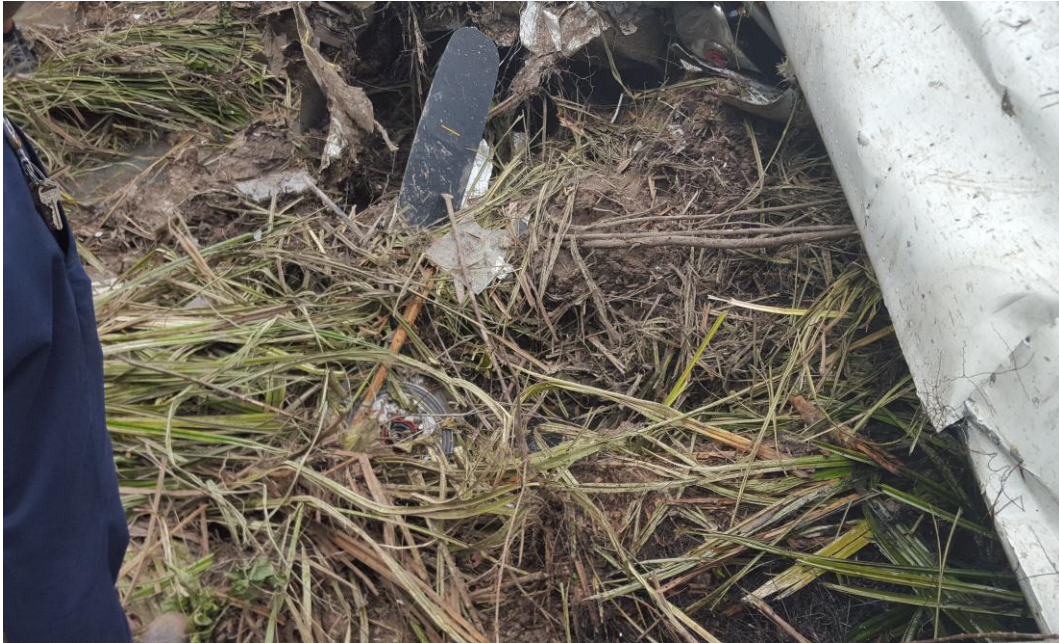
Figure 4: Left hand propeller at accident site

The left hand propeller (Figures 4 and 6) was detached from the engine due to impact forces

which broke the propeller shaft; it was not feathered. The right hand propeller (Figures 5 and 7) was still attached to the engine and was in the feathered position.

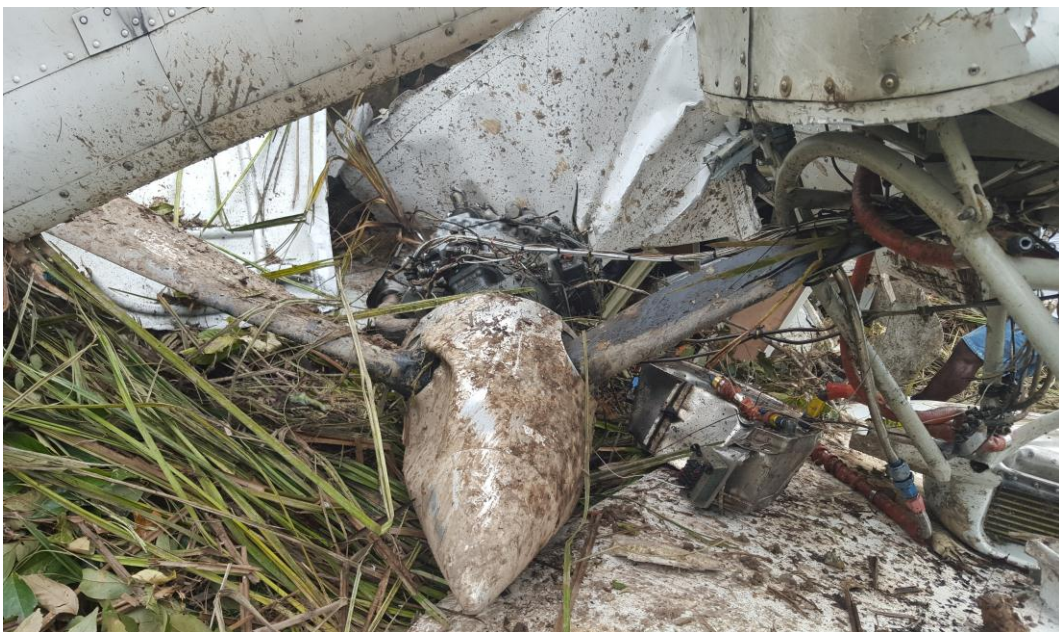
Figure 5: Right hand propeller (feathered) at accident site; note one blade buried in mud

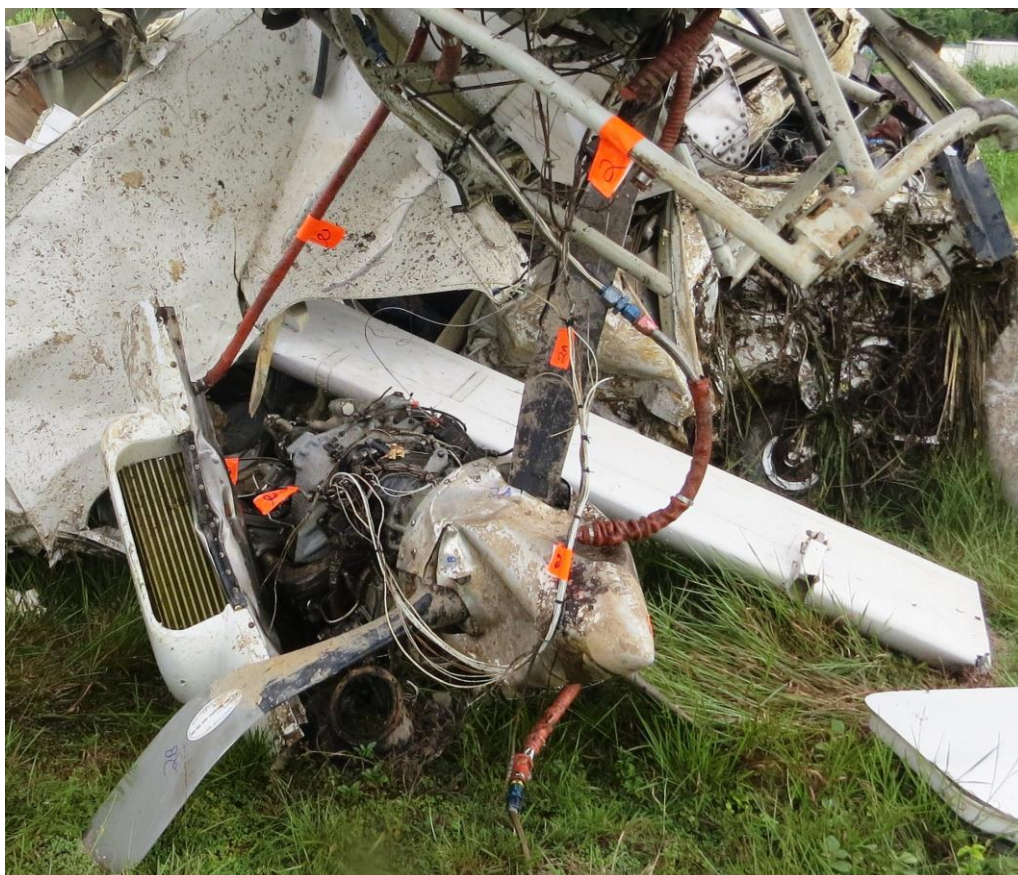
Figure 7: Right hand propeller (feathered) after removal from accident site

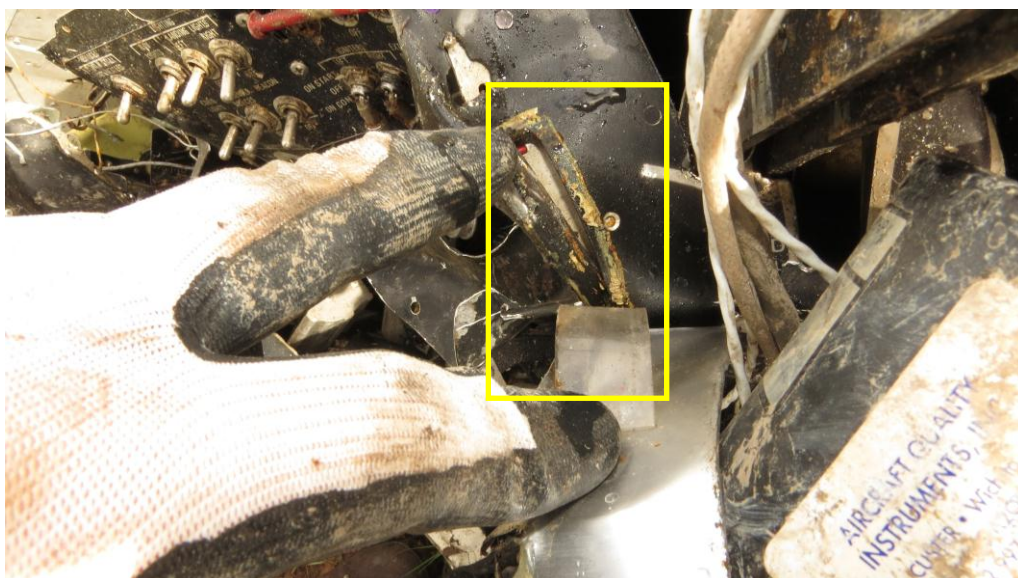
Figure 8: Elevator trim indicator (in yellow box)

The elevator trim tab was in the full nose-down position. The elevator trim indicator in the cockpit had been crushed in place; it indicated full nose-down (Figure 8).

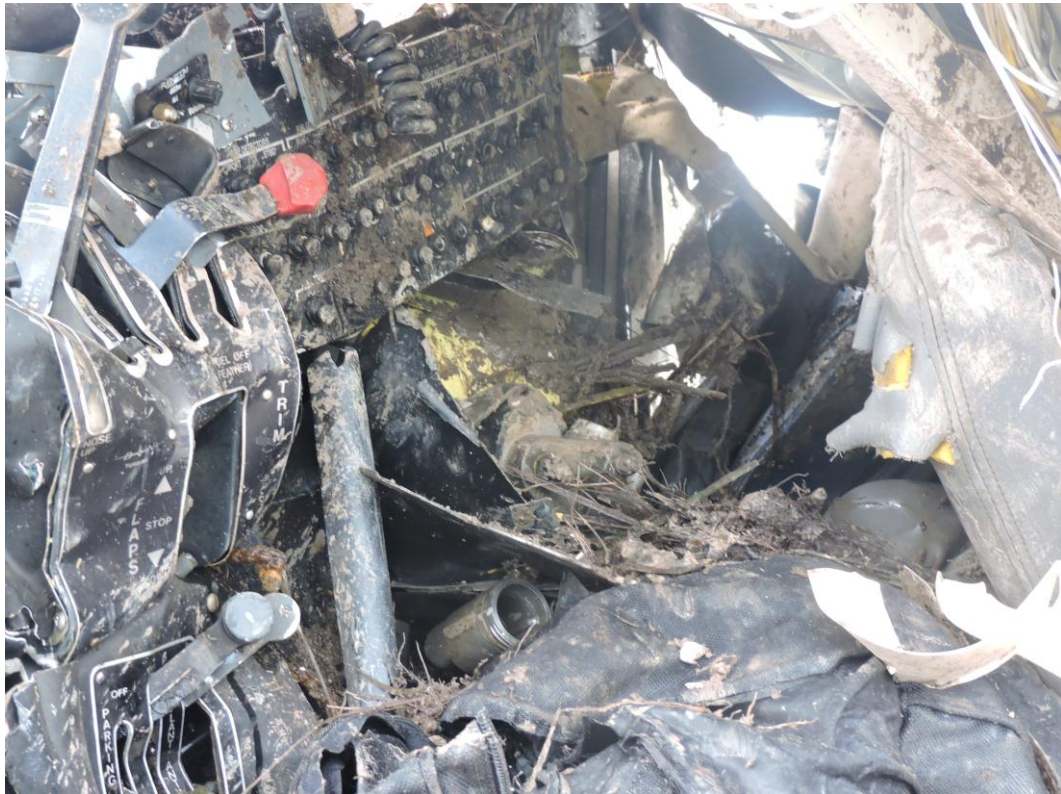
Figure 9: Power levers and condition levers

The AIC found the power levers and condition levers were positioned in the centre console as shown in Figure 9.

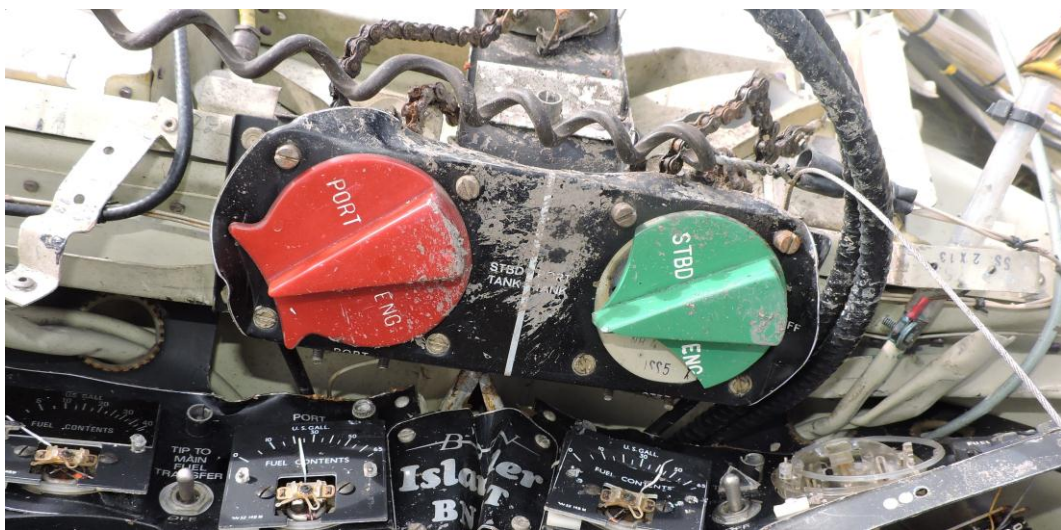
Figure 10: Fuel selectors

Both cockpit fuel selectors were found in the positions shown in Figure 10.

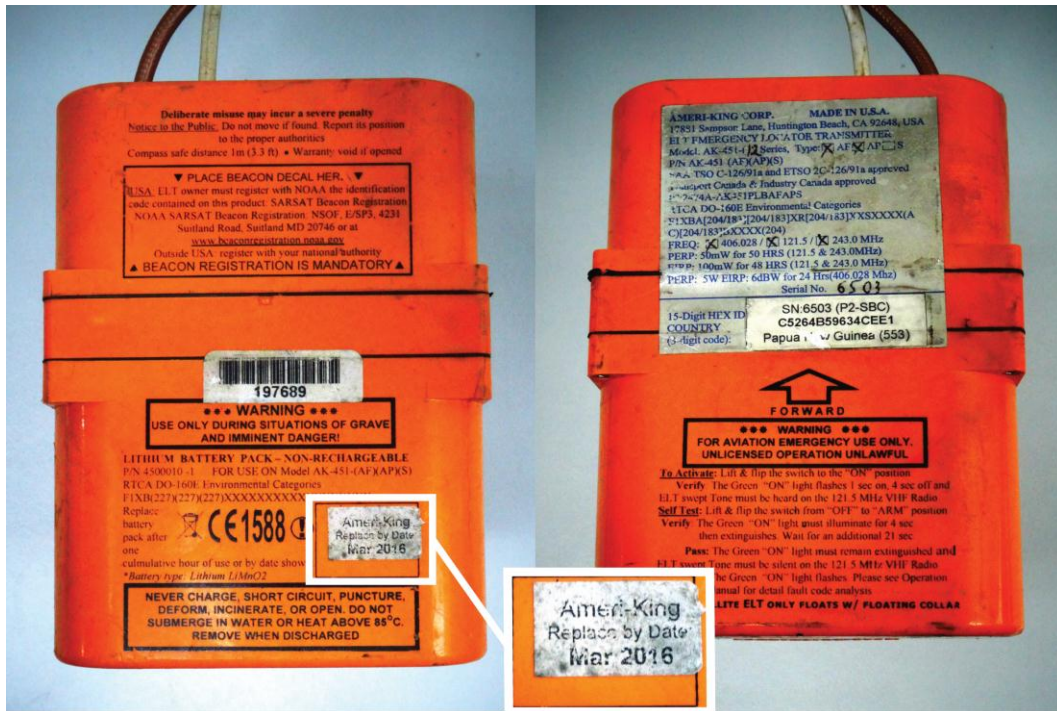
Figure 11: Emergency locator transmitter recovered from the wreckage of SBC

The aircraft was fitted with an Ameri-King AK-451-(12) series emergency locator transmitter (ELT) part number AK-451-(AF)(AP)(S), serial number 6503. The ELT (Figure 11) did not activate on impact and no emergency signal was detected after the accident. The ELT bore a label stating “AmeriKing / Replace by Date / Mar 2016”.
