FINAL REPORT

AIC 22-2001

Quest (Daher) Kodiak 100

In-flight Damage

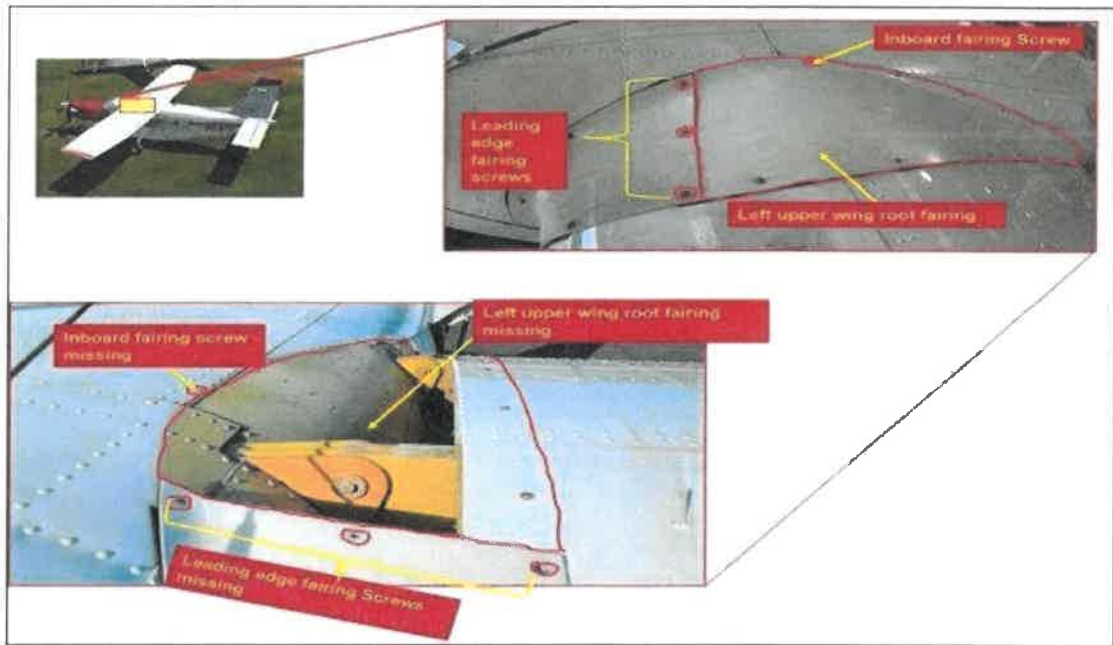
Figure 4 : Overview of damage sustained.

The aircraft sustained the loss of the left upper wing-root fairing that attaches to the leading-edge fairing but did not sustain wing, fuselage, or leading-edge fairing damage. There was significant damage to the inboard leading edge of the left horizontal stabilizer. See *Section 1.12* for detailed information.

The aircraft landed safely at Hoskins Airport. All damage to the aircraft was caused by the left upper wing-root fairing separating from the airframe and impacting the left tailplane.

The left upper wing-root fairing that detached from the aircraft in-flight is fastened to the wing and airframe fuselage using screws which thread into nutplates. During the investigation examination, it was observed that the leading-edge fairing remained intact, while the left-upper wing-root fairing detached from the aircraft. (Refer to *Figures 4 and 5*.)

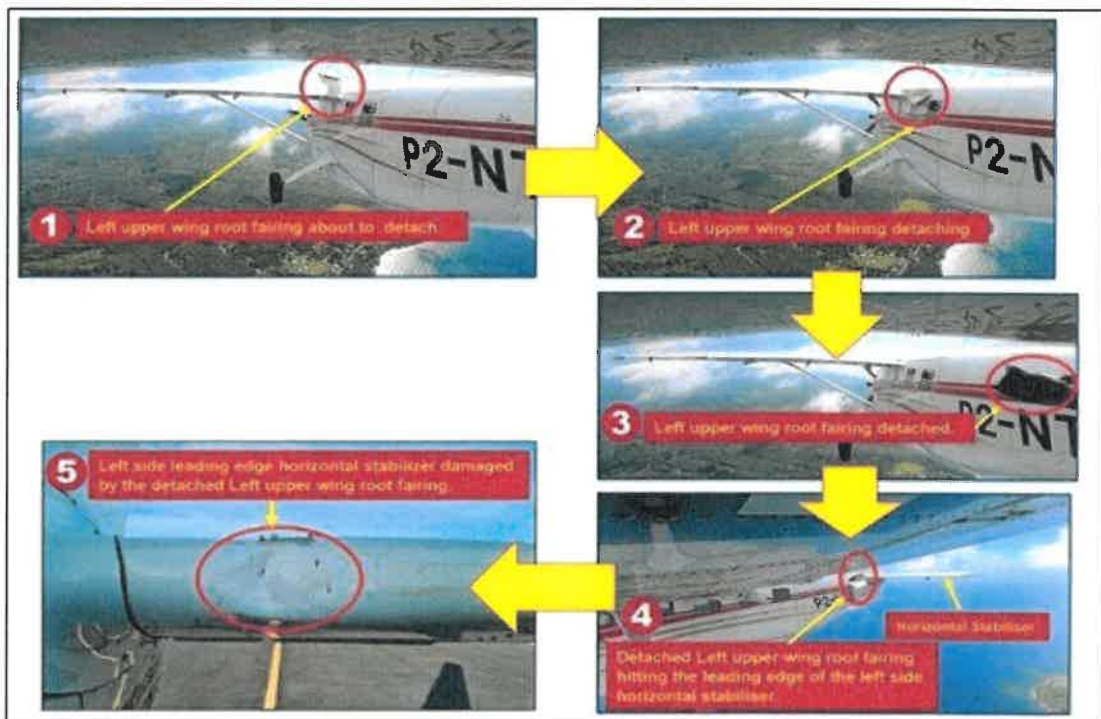
Figure 5: Screenshot of video footage (Pics 1-4) of aircraft on descent showing a detached Left Upper Wing-Root Fairing and damaged left inboard leading edge of Horizontal Stabilizer (Pic 5)

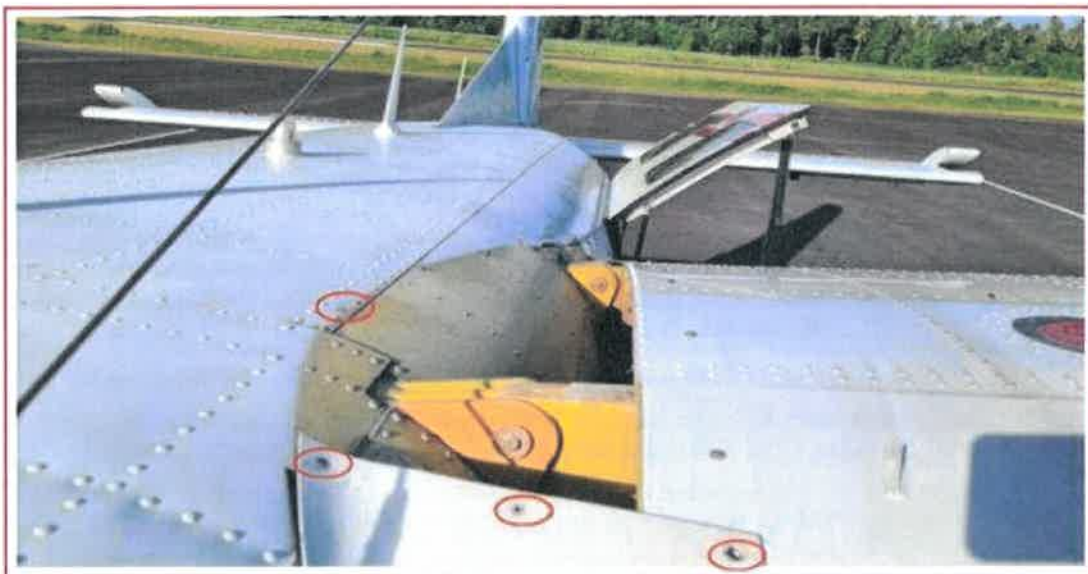
The left upper wing-root fairing separated from the wing in flight. A post-occurrence inspection found that four of the 16 attachment screws were missing. Three of the missing screws were from the aft flange of the leading-edge fairing where the leading-edge of the wing-root fairing is fastened over the aft edge of leading-edge fairing. The other missing screw was from the inboard section of the wing-root fairing which is fastened to the fuselage frame.

The remaining 12 screws found still secured to the aircraft were from the wing-root fairing's wing and fuselage attachment points.

Figure 6: Screws missing from locations circled in red.

The investigation therefore concluded that four fastening screws, three at the airflow critical front edge of the fairing may not have been installed or they may have been threaded by hand into each nutplate, but not appropriately tightened during the last maintenance and dislodged during subsequent flights. In-flight airflow and vibrations including those sustained during takeoffs and landing on unpaved rural airstrips would have been sufficient for those screws to work loose and dislodge due to vibrations.

The PNG Accident Investigation Commission (AIC) recommends that that New Tribes Mission Aviation (PNG) Limited (NTMA) should ensure that their relevant documents, manuals and operational procedures are amended to include pre-flight inspection requirements for pilots to conduct visual inspections of the exterior of the airframe to ensure security of inspection doors, panels and caps, and airframe rivets and fasteners.

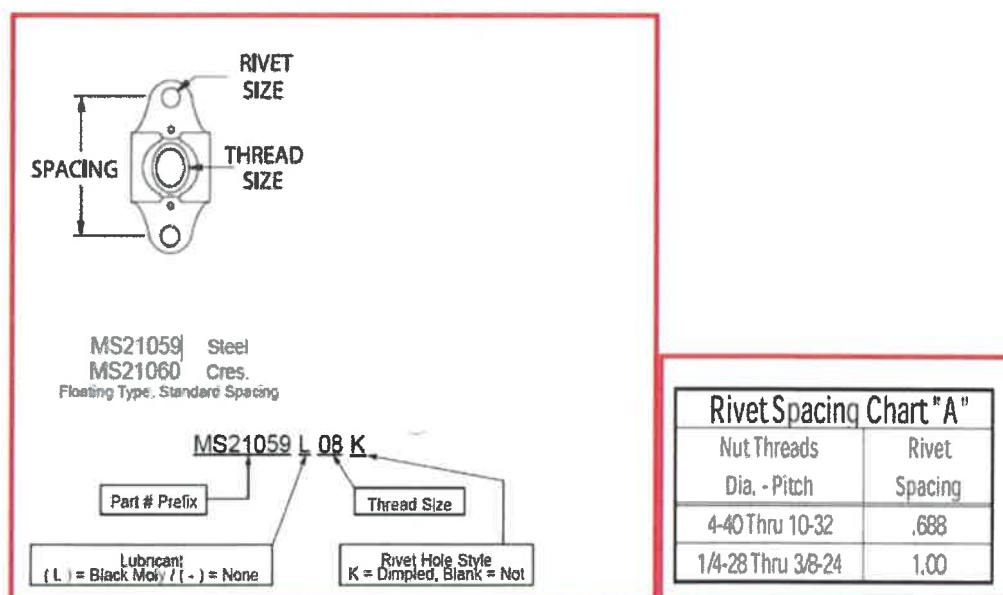
Figure 7: Nut plate specifications.

The nut plates where the screws were missing were found to be undamaged during post incident inspection of the aircraft in Hoskins. During the post-incident maintenance, the screws were installed into each nut plate and evaluated for sufficient grip. At that time no nut plates were changed.

The operator stated that the evaluation of the nut plate serviceability was not specifically recorded and that it is the general practice in accordance with *Kodiak 100 Aircraft maintenance Manual, Section 1430 (5 & 10) 'Torque Data'*.

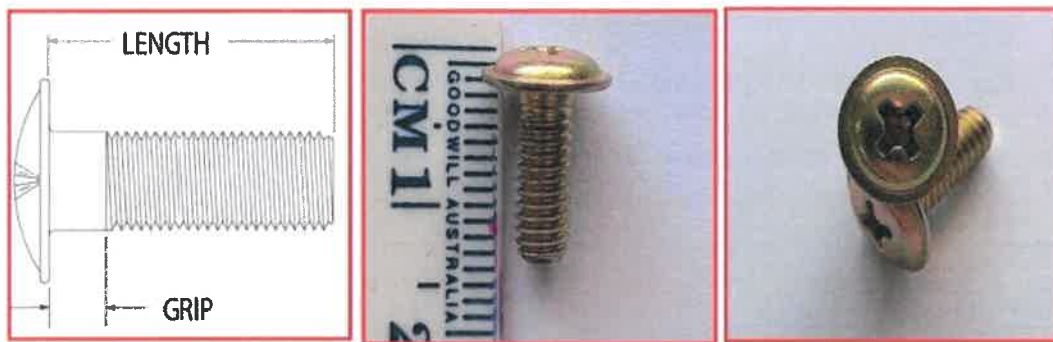
Figure 8: Sample of AN525 8-32R7 screw.

According to the *Visual Identification Chart in the Genuine Aircraft Hardware Co, Toolbox Reference Book*, referenced by the Operator, the missing screws are AN525 8-32R7 and made of Alloy Steel and 'x' on head, plated with Cadmium 11 or zinc 11 (Gold in appearance). (Refer to Section 5.3 Appendix C.)

Screws are either Fine or Coarse threaded. The AN525 832R7 screw is a course threaded screw with a greater pitch (more space between each thread). The fine threaded screw has smaller pitch (less space between each thread).

Fine threaded screws are less susceptible to working loose due to vibration than coarse threaded screws.

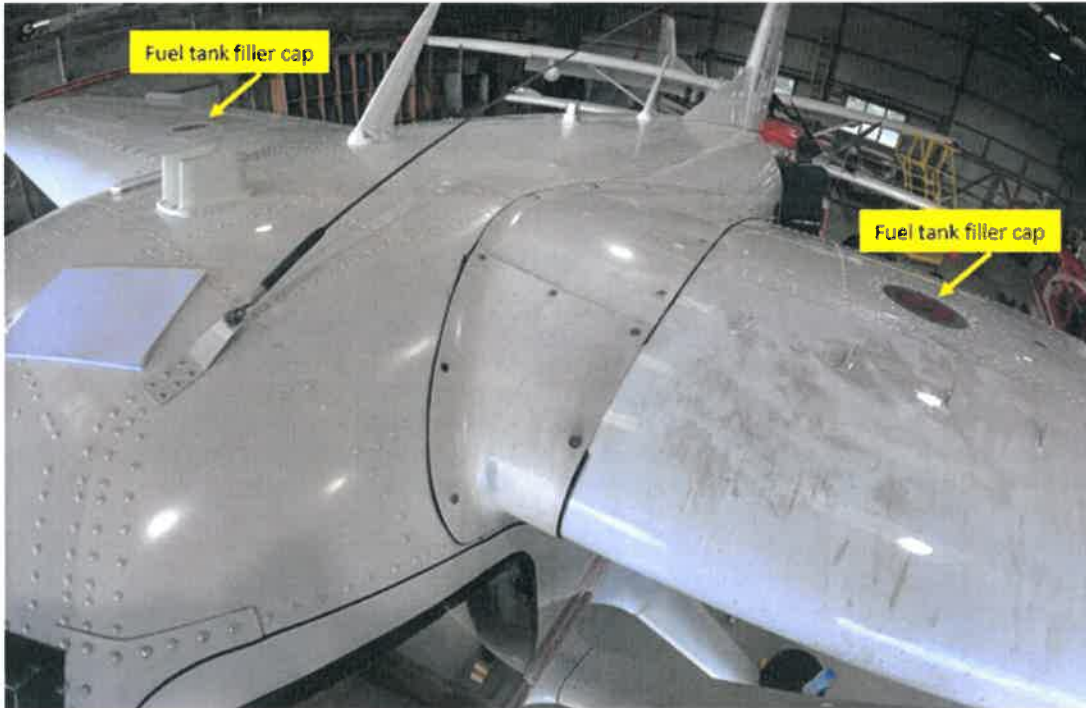
Figure 9: Over wing view showing fairings and fuel tank caps

The investigation found that the *NTMA Pre-flight Checklist* did not include a check of the exterior of the airframe to ensure security of inspection doors, panels and caps, nor does not require flight crew to check on rivets and fasteners of the airframe.

While this serious incident was not fuel or fuel system related, NTMA pilots were conducting pre-flight checks following the maintenance and subsequent pre-flight inspections between 4 and 27 April 2022 which did not detect any anomaly with the fitment and securing of the wing root panel.

A last line of defence would be the pilot or other personnel observing that screws were loose or missing from the left-wing upper wing-root fairing when refuelling the aircraft via the over-wing fuel port. Furthermore, when the pilot was conducting pre-flight checks following the maintenance, a check that the over-wing fuel tank caps were secured would have provided opportunity to scan the upper wing panels for security. The security status of the upper wing-root fairing was not observed during the post-maintenance pre-flight inspection or subsequent pre-flight inspections between 4 and 27 April 2022. The NTMA pre-flight checklist does not require flight crew to check the security of rivets, screws and fasteners of the airframe.
