PRELIMINARY REPORT

AIC 17-1003

Government Aircraft Factory (GAF) Nomad N22C

Wheels up landing due to failed undercarriage

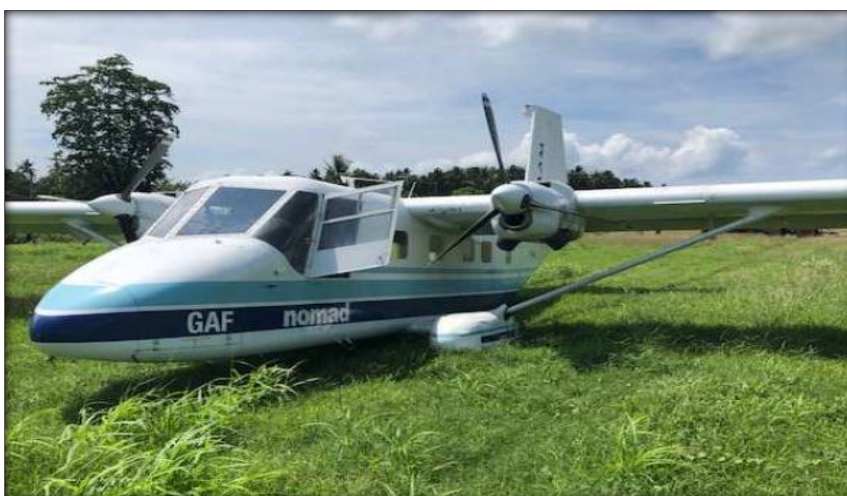
The pilot reported that when doing the pre-landing checks the landing gear failed to extend. He attempted to deploy the landing gear using the emergency system (which consists in a manual pump), but the handle of the manual pump broke after three to four pumps. The pilot decided to perform a landing in the grassy flight strip, which was about 32 metres to the right of the sealed runway centerline.

Figure 1: VH-ATO landing wheels up in the grassy flight strip

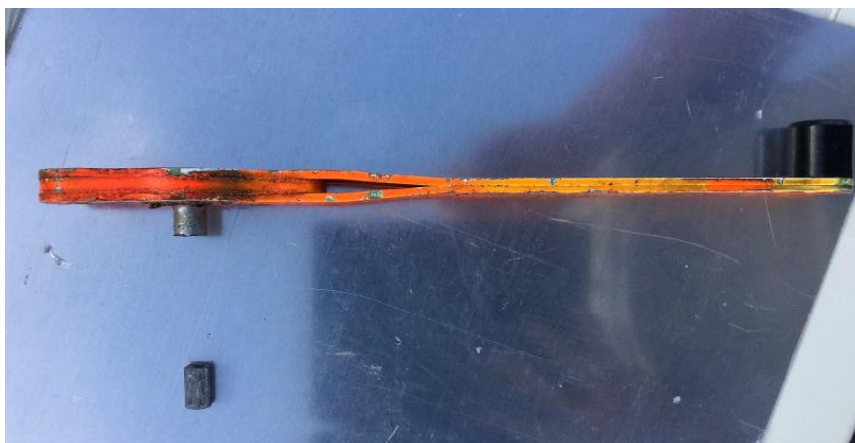
Figure 2: Broken landing gear manual extension pump handle

The investigation is continuing and will include an analysis of the reason(s) the landing gear failed to extend, and the failure mode of the manual gear extension pump handle. The operator is assisting the AIC with the investigation.

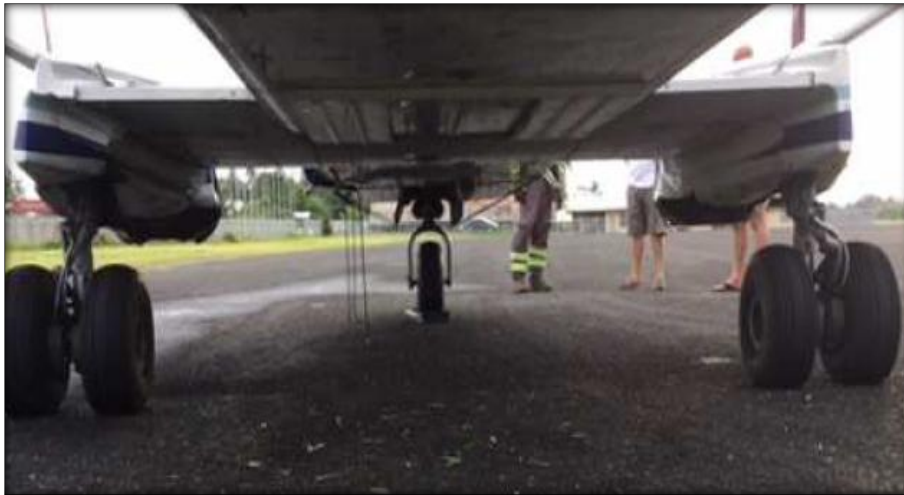
There was significant damage to both landing-gear pods and the nose forward of the nose locker. The landing gear doors had significant skin damage and were not aligned with the pods. The nose cone was punctured and torn on the underside.

Figure 3: Skin damage of the main landing gear doors

The lower attachment points of both wings' struts came into contact with the landing-gear pods and fracturing the pods side skins. The trailing skin on the left lower strut was bent.

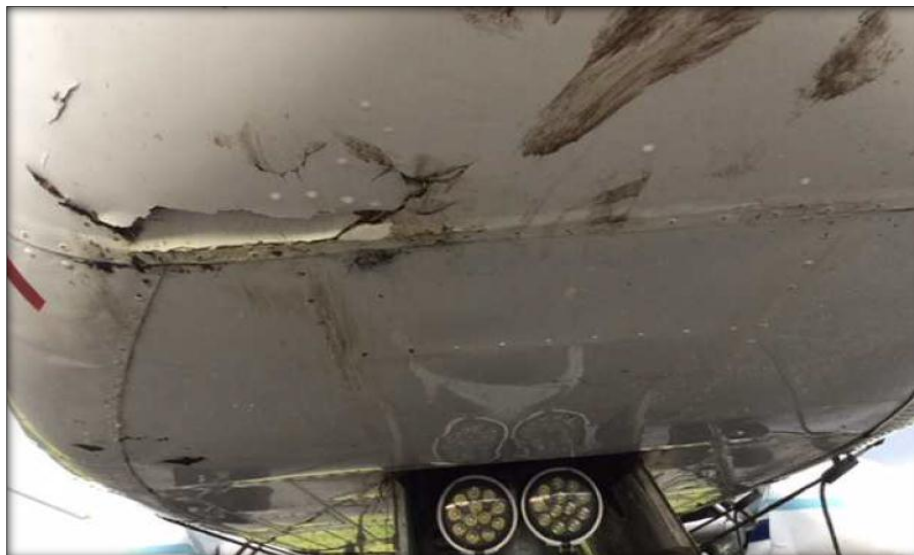
Figure 4: Puncture hole on the underside of the Nose Cone
