FINAL REPORT

AIC 23-1002

Cessna 208B Grand Caravan

Runway Excursion During Landing

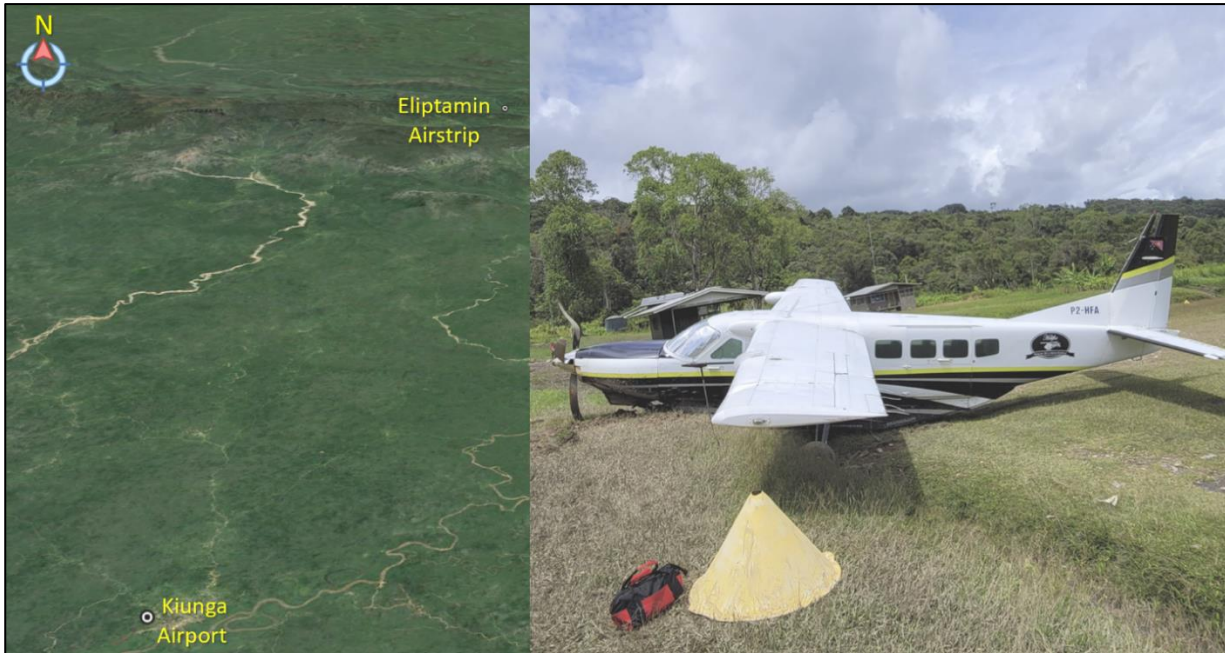
Figure 1: Overview of the accident site.

On 10 February 2023, at 13:43 local time, (03:43 UTC) a Cessna 208B Grand Caravan aircraft, registered P2-HFA, owned and operated by Helifix Operations Ltd, was conducting a VFR¹ passenger charter flight from Kiunga Airport, Western Province to Eliptamin Airstrip, Sandaun Province, Papua New Guinea, when during the landing roll, the aircraft overran the strip and impacted a drainage embankment along the edge of the strip.

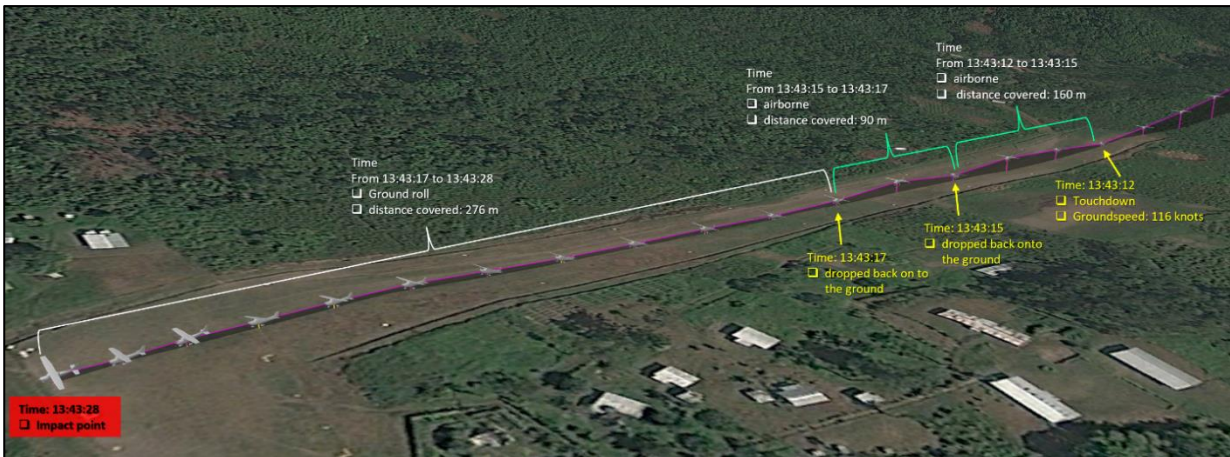
Figure 5: Initial touchdown to impact.

According to the recorded data, at 13:43:12, the aircraft touched down on the threshold with a groundspeed of 116 kts and the pilot applied reverse thrust. The aircraft immediately became airborne again and travelled forward for about 160 m in the air before dropping back on to the ground, and immediately got airborne again for the second time. The aircraft travelled forward for another 90 m, as it remained airborne and at 13:43:17, it dropped back on to the ground, rolled forward for 11 seconds, covering a distance of about 276 m before impacting the embankment.

the aircraft was pushed further forward. By the time the aircraft was back on the ground, for the third time, the pilot attempted to slow down the aircraft. However, at that point the aircraft had reached the end of the runway, where it impacted the embankment of a drain which runs along the edge of the airstrip, before coming to a complete stop.

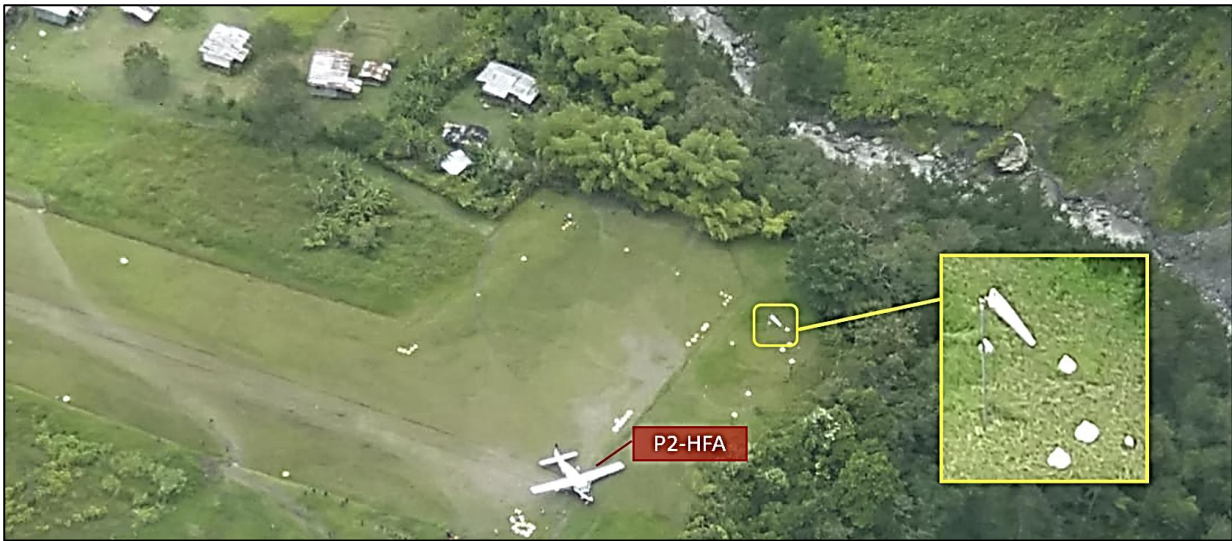
Figure 6: Picture taken by the pilot of P2-MAL overhead Eliptamin Airstrip about 5 minutes after the accident.

A Mission Aviation Fellowship (MAF) aircraft, registered P2-MAL, was also intending to operate into Eliptamin Airstrip after P2-HFA landed. About 5 minutes after the accident, P2-MAL was positioned overhead of Eliptamin Airstrip at about 6,500 ft AMSL (1,760 ft AGL) and the pilot took an aerial view picture of the airstrip with P2-HFA in its resting position.

The picture also captured the windsock located at the south-eastern (departure) end of the airstrip, in the parking bay. The windsock was indicating wind coming from a north-westerly direction with an approximate magnitude of about 10-15 knots.

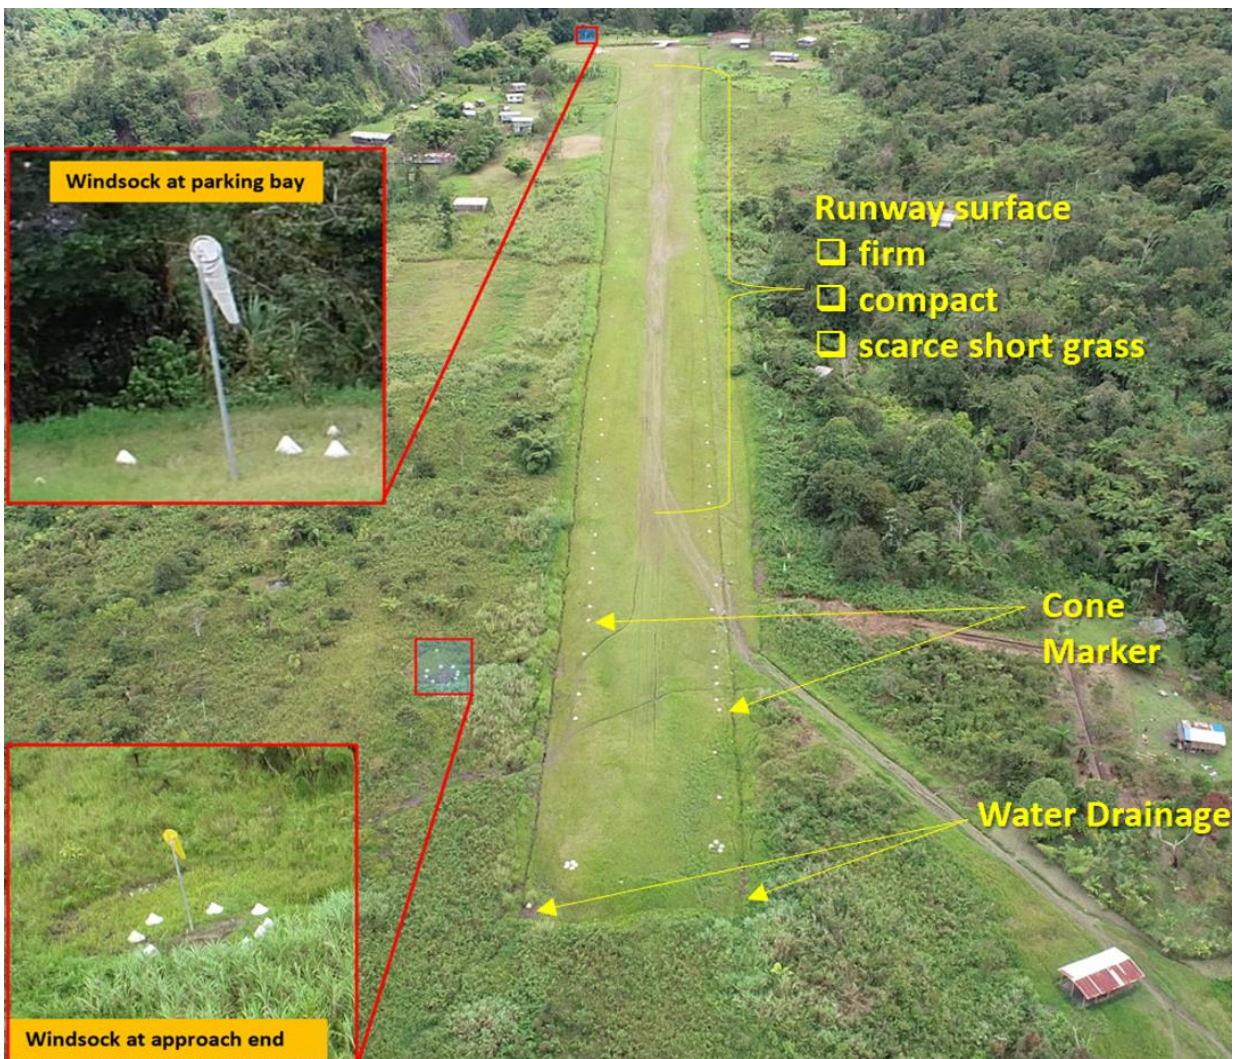
Figure 10: On-site team observation of Eliptamin Airstrip.

The on-site team observed that the windsock in the parking bay was surrounded by obstructions and the location was not suited to the prevailing wind conditions and not free from the effects of air disturbances caused by nearby objects.

According to the pilot in an interview with the AIC, he indicated that the windsock in the parking bay does not reflect the true direction of the wind most times due to the obstructions surrounding its location.

The windsock in the parking bay that the pilot had referenced when overhead the airstrip, was located at a position that did not give it optimum exposure to prevailing wind conditions in the area. There are obstacles surrounding the windsock obstructing the free flow of air. As a result, the windsock indication of wind strength is unreliable. Additionally, according to the pilot, the windsock in the parking bay provides erroneous and unreliable information during overhead inspection.

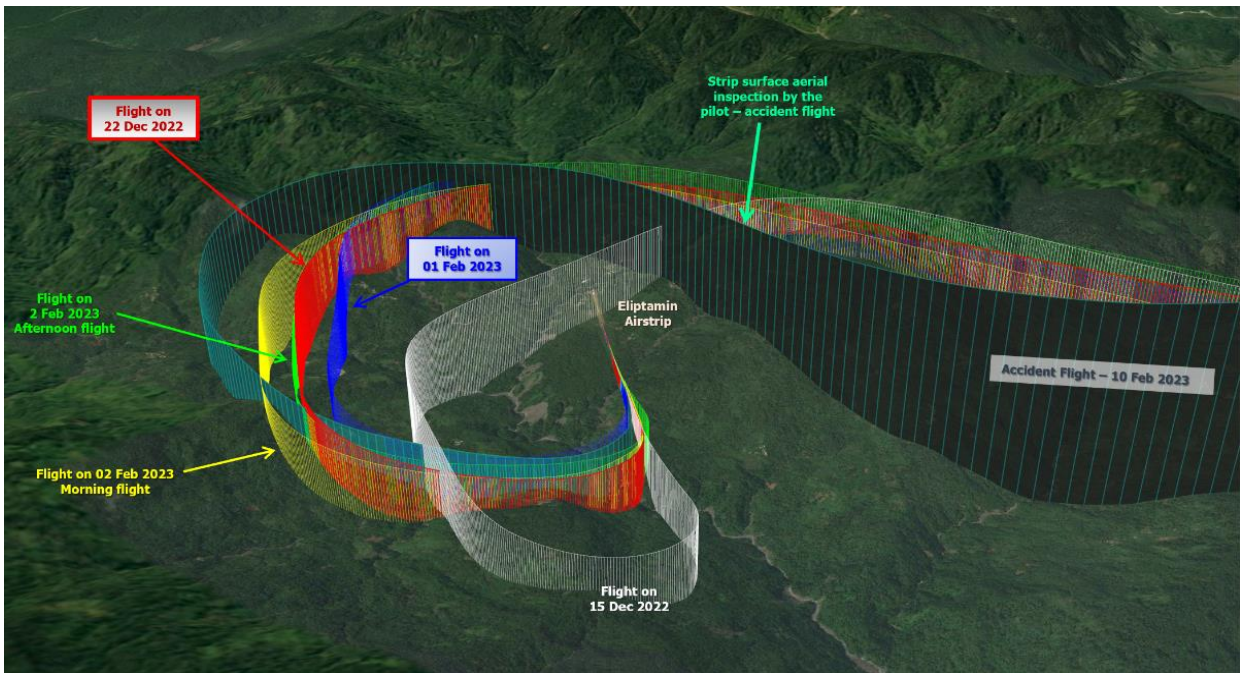
Figure 14: Circuit profiles for the accident flight and previous flights to Eliptamin Airstrip.

It is the view of the AIC that an inspection height of about 3,000 ft AGL was far too high to properly assess the surface condition of the airstrip and the wind behaviour. The AIC believes that the overhead inspection was conducted at a height significantly higher compared to his previous flights into Eliptamin where he was no higher than 1,700 ft AGL when positioned overhead the airstrip. *Refer figure 14.*

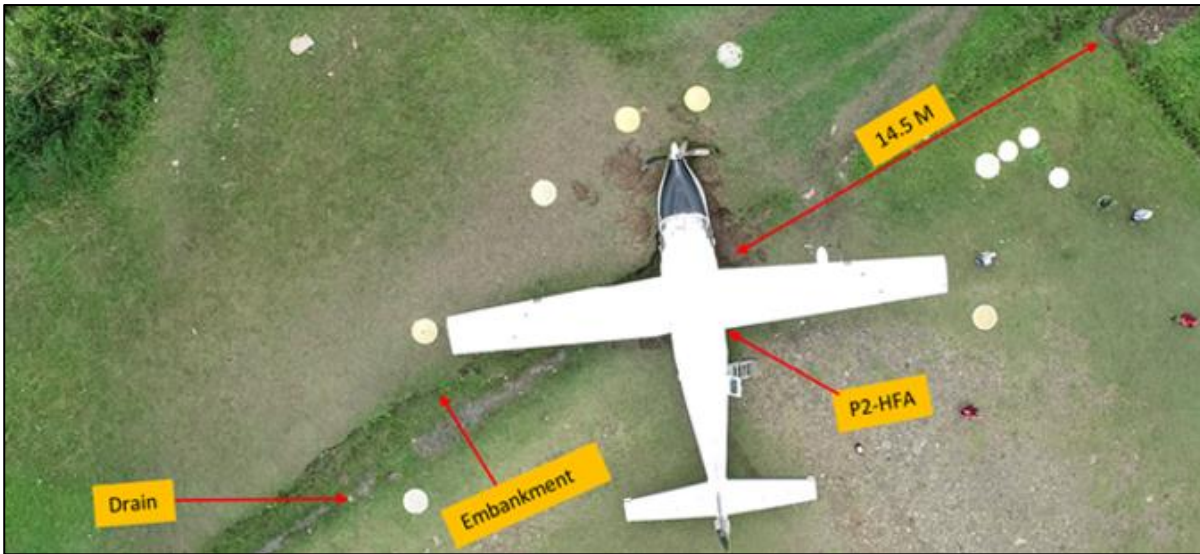
Figure 19: Wreckage following impact.

The ground markings on the drainage ditch observed by the on-site investigation team indicated that the aircraft impacted with significant force. Refer to *Figure 19*.

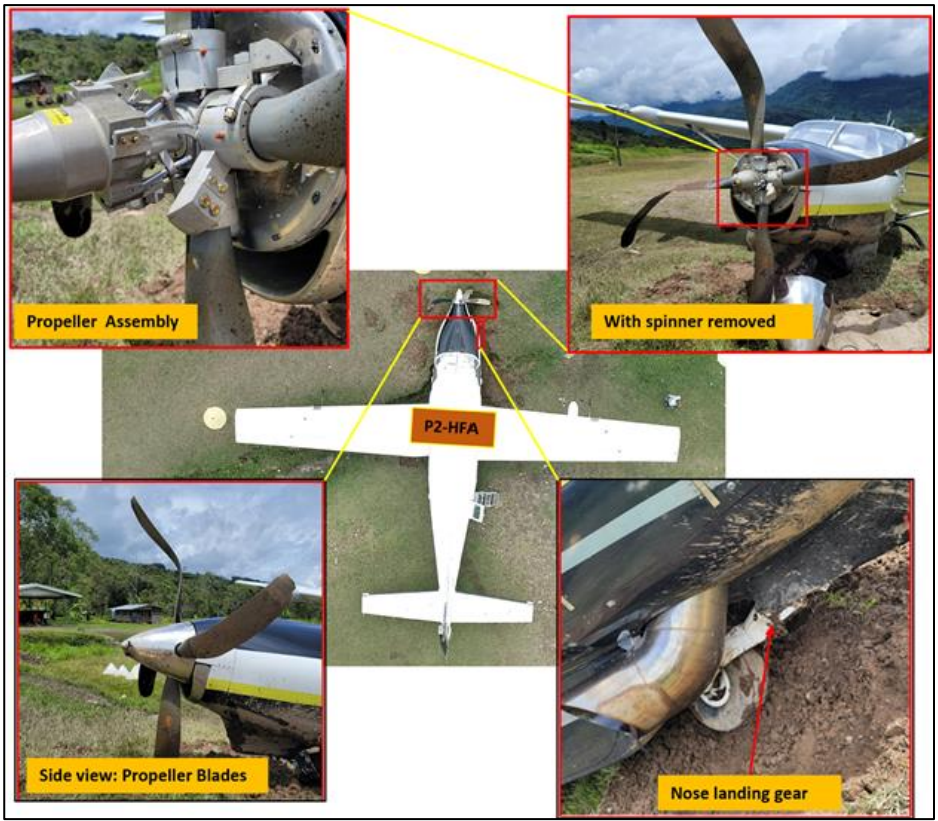
Figure 20:Damage sustained to the NLG and propeller assembly.

The on-site team inspected the aircraft and identified that the aircraft sustained substantial damage to the left wing, propellers, engine mounting, its structure, and a number of components, which included the propeller assembly, the spinner and the Nose Landing Gear (NLG). Refer to *Figure 20*.

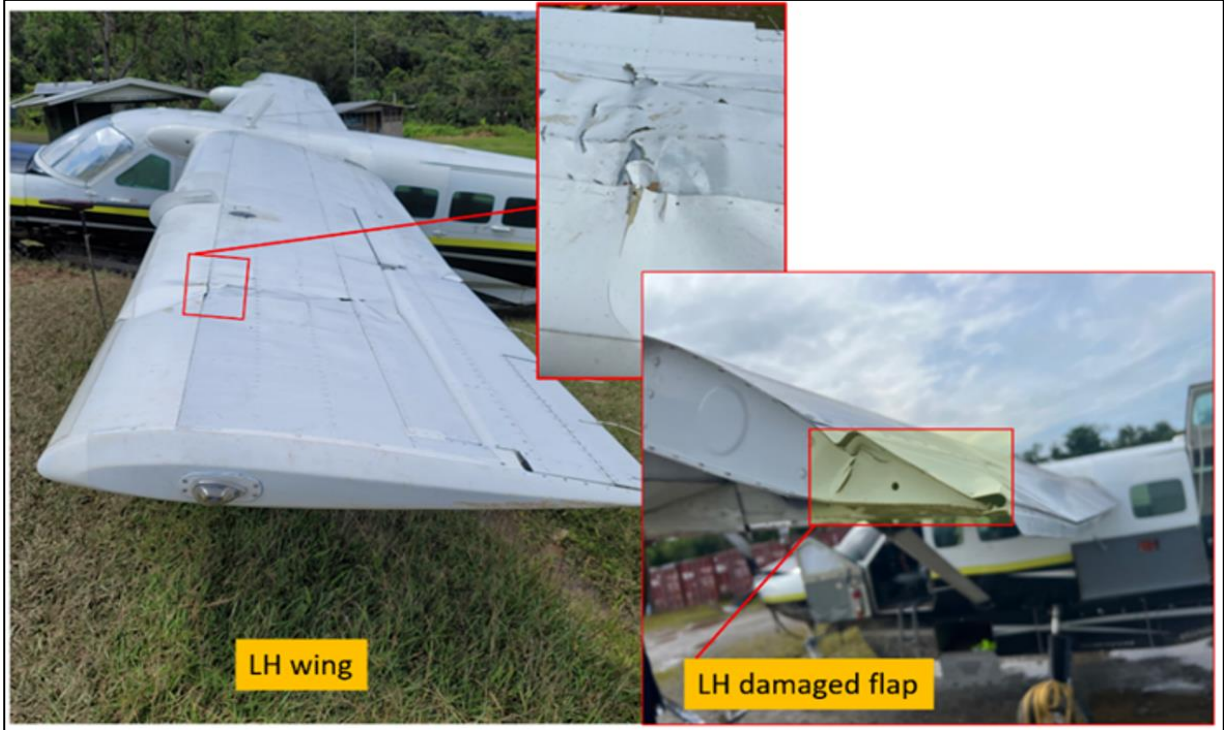
Figure 21:Damage to the LH wing and the LH wing flap.

The pilot stated during the interview that the left hand (LH) wing impacted the embankment followed by the propellers and the NLG. The investigation observed that the LH outboard wing sustained substantial damage to the leading edge. The investigation determined that the damage indicated the aircraft had experienced significant impact force due to the sudden stop following the impact. Refer to *Figure 21*.

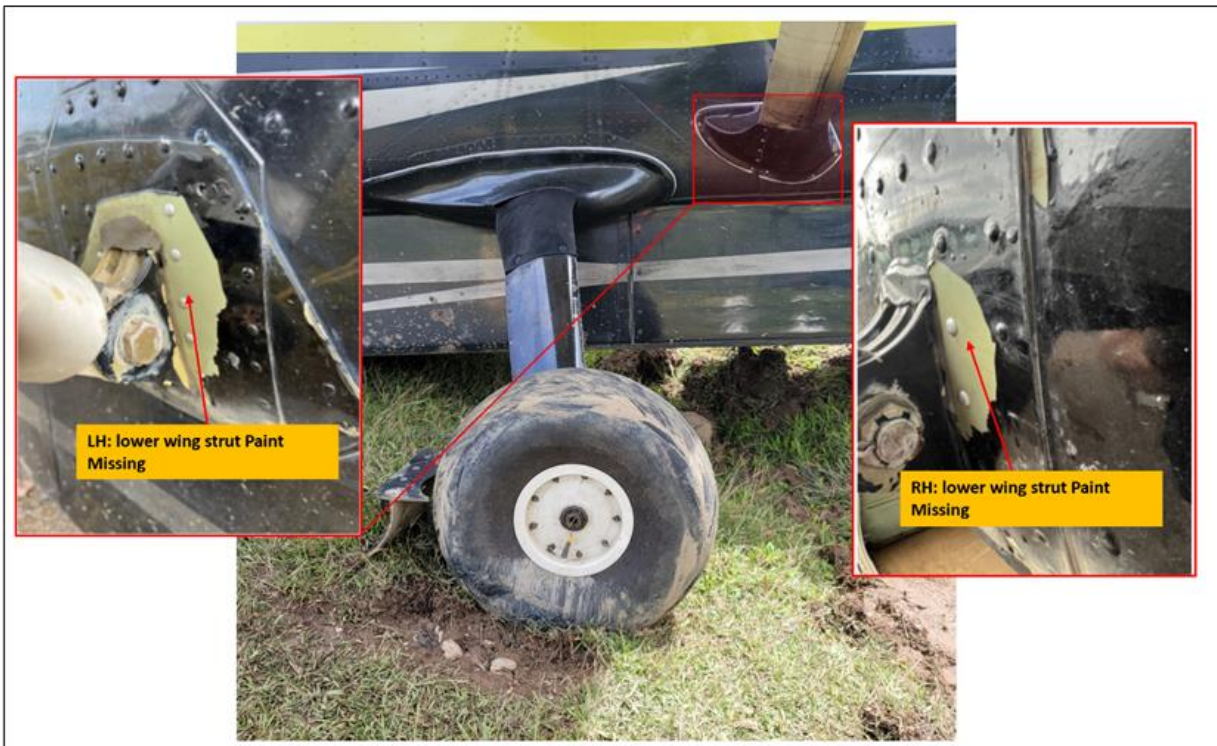
Figure 22:Left and right lower wing strut (Source : Helifix Operations Ltd).

There was fresh paint missing on both lower wing strut attachment bolts, indicating a major flex forward of both aircraft wings due to the sudden impact with the embankment. Refer to *Figure 22*.The impact

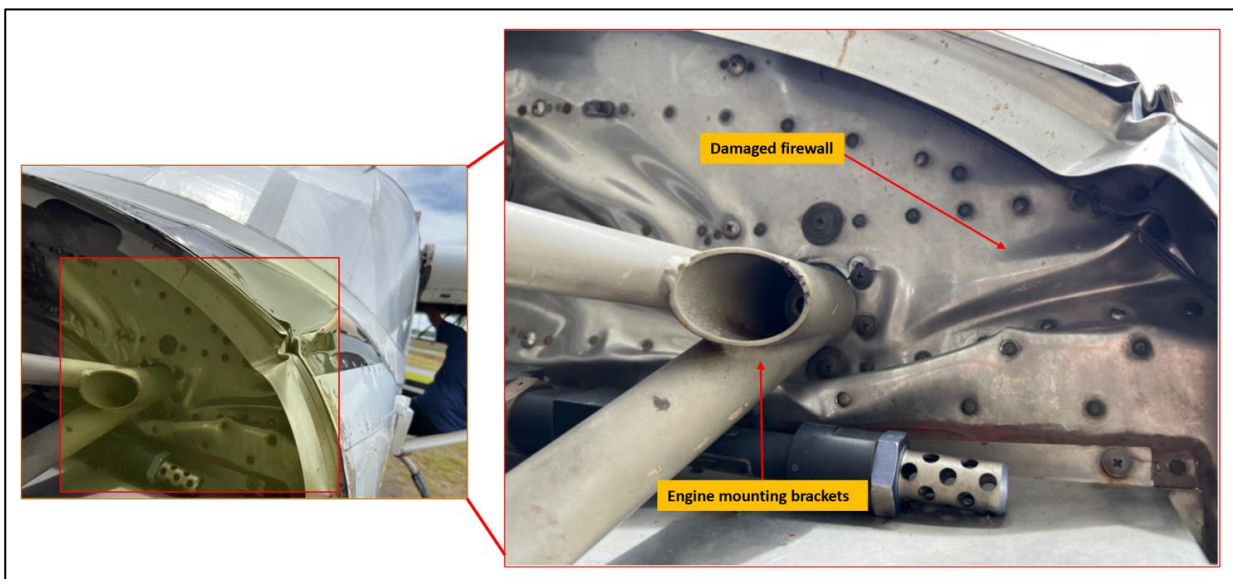
Figure 23:Damage sustained on the engine firewall (Source :Helifix operations Ltd).

force on the propeller blades and engine mount, resulted in the engine mounting brackets causing severe damage to the engine firewall. Refer to *Figure 23*.
