FINAL REPORT

AIC 22-1005

Airbus MBB-BK117 D-2 helicopter

Fenestron sustained substantial damage during landing

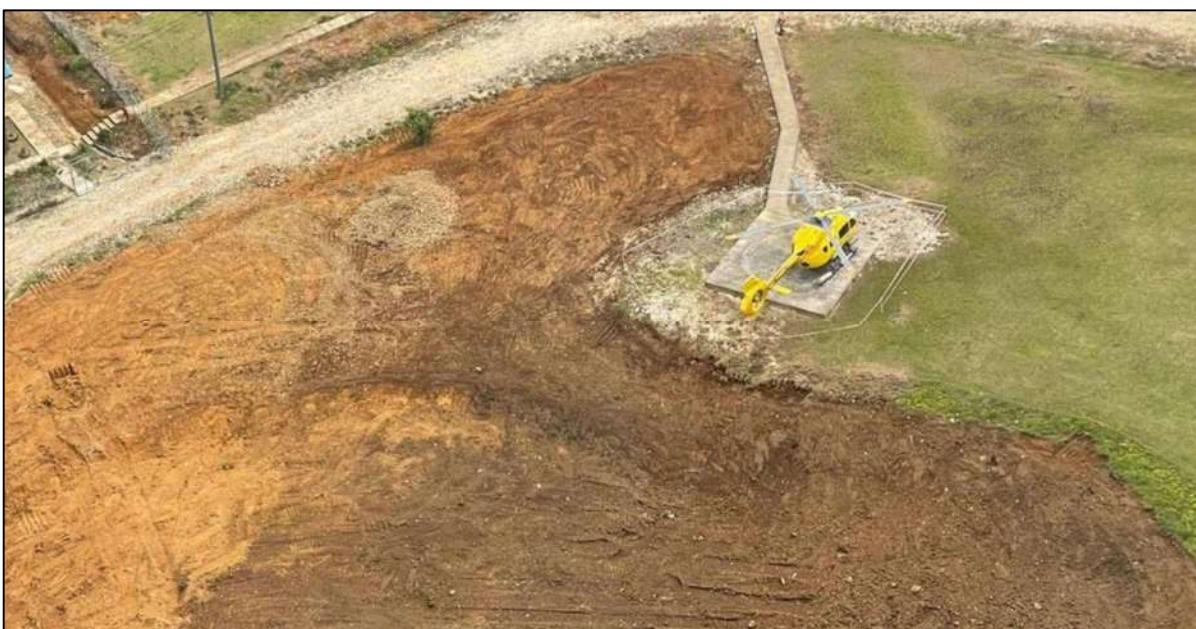
Figure 4: P2-PHA at the helipad

The PIC then exited the helicopter to assess the situation. He observed damage to the fenestron caused by a FOD; pieces of the denim material ingested into the fenestron from the ground during landing.

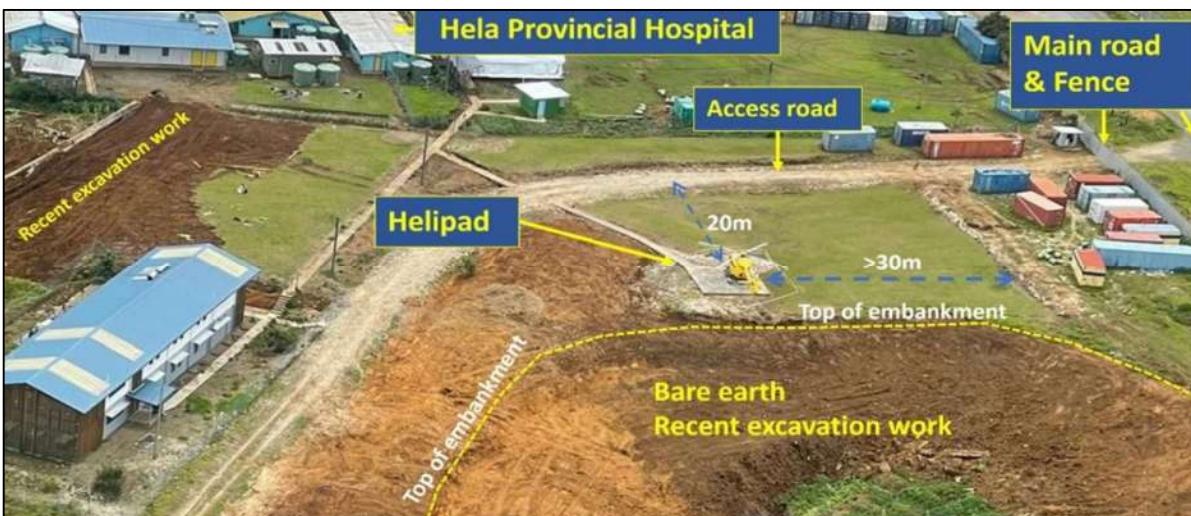
Figure 6: Aerial view of the helipad and its vicinity at Tari Hospital

The crew stated during an interview with the AIC that during the approach, they noticed that the area around the helipad had recently been excavated. They also noticed that it was cleaner and tidier than the last time they landed on the helipad, therefore, they decided to continue with the approach.

The Tari Hospital Helicopter Landing Site (HLS) did not meet the Standards set for consideration as a Class 2 HLS. The investigation found that the managing authority, Santos Ltd, had not completed a 12 monthly HLS assessment for the Tari Hospital HLS since the last assessment in November of 2019. This assessment would have involved the inspection of the physical condition and layout, vegetation growth that may impinge on the Clear and Obstacle free areas, as well as the departure/approach paths.

The AIC found that there was no risk assessment carried out at the HLS. There was also no evidence to show that an identification of non-conformances. It is the view of the AIC that any activities around the helipad were not coordinated, and Santos was not aware of the excavation activities being carried out by the hospital. The fact that the HLS authority was not aware of activities around the HLS and the general condition of the HLS was itself considered a non-conformance.

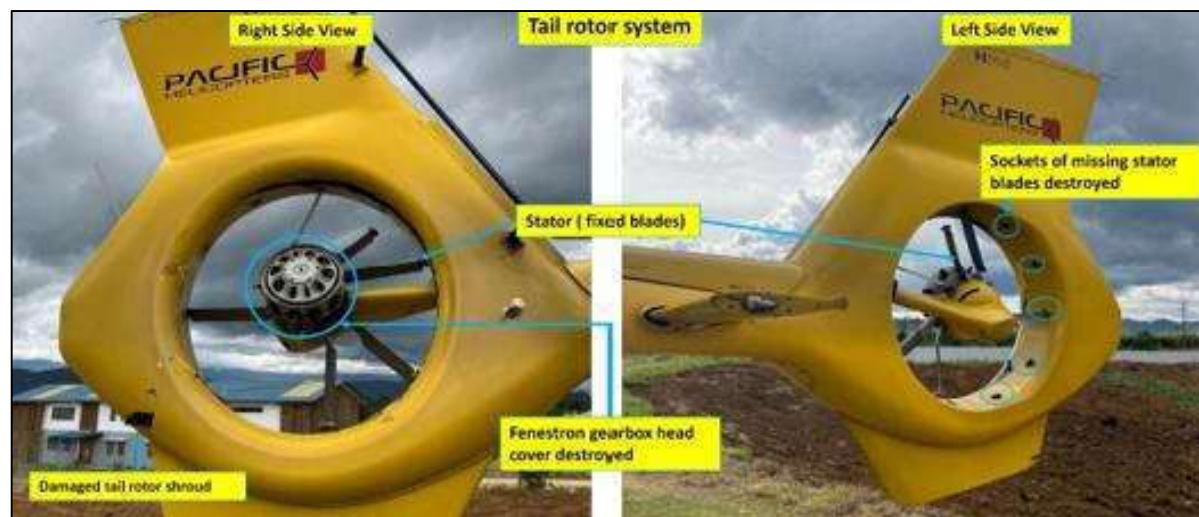
Figure 7: Damage sustained to the fenestron and its components

During the investigation, the Operator provided AIC with images of the landing site, helipad, and damage sustained by the helicopter's tail rotor. AIC observed from the images that the helicopter's fenestron tail rotor system sustained significant damage and multiple components of the system were destroyed and snapped off. Provided below in the table, the list of components was destroyed.

Component	Description of the damage
Rotor Blades	All ten rotor blades of the fenestron tail rotor were shredded. The damage was consistent with external impact, suggesting a foreign object had entered the rotor area.
Stator Vanes	Six of the stator blades were affixed to the central hub (head), but they exhibited noticeable dents and bends. The extent of damage indicated a forceful impact.
Central Hub	The central hub sustained fractures and deformations on the hub structure. The head's covering was shattered with the rotating blades.
Tail rotor structure	The inner housing of the tail rotor exhibited widened fractures, which were likely caused by the stress impact force. This damage compromised the structural integrity of the shroud.

The AIC also did not observe any evidence to indicate that the helicopter had a landing or ground contact damage. The damage to the aircraft was limited to the fenestron from the FOD contact.

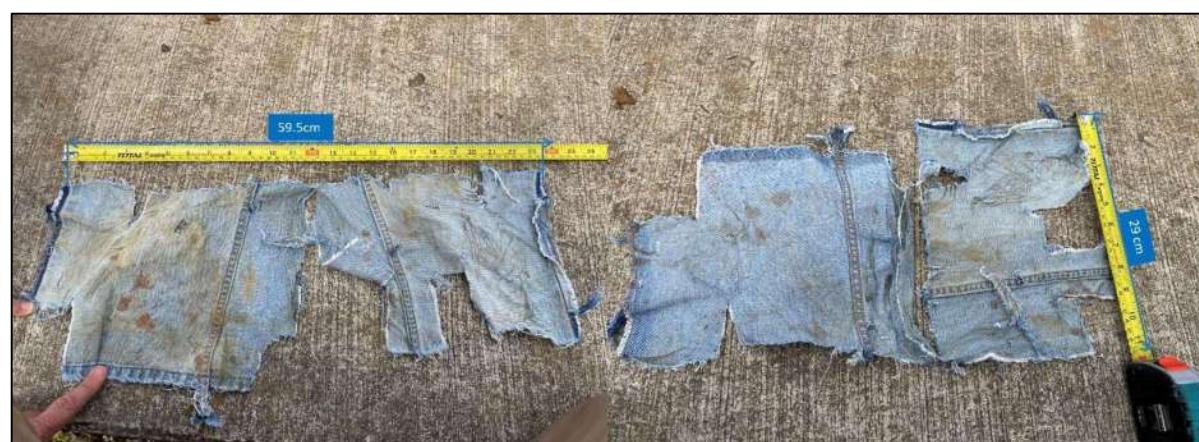
Figure 8: FOD - Pieces of the denim material

During the investigation, it was established that about 10-15 ft above the helipad, the helicopter's rotor downwash blew up the piece of denim material into the air and into the fenestron jamming the blades and subsequently the blades snapped off as a result. The recent excavation work around the helipad uncovered FOD's that remained free on the ground adjacent to the helipad and the dirt laden denim material could not be detected from the air by the crew as it blended into the ground and due to its size.

The Operator's on-site team also identified that a FOD had been caught in the helicopter's fenestron. The FOD was a piece of denim material that was blown up in the air by the helicopter's rotor downwash and ingested into the fenestron causing substantial damage to the fenestron and damaging its components.
