FINAL REPORT

AIC 23-1003

Bell - 407

Tail Rotor Component Failure - Inflight

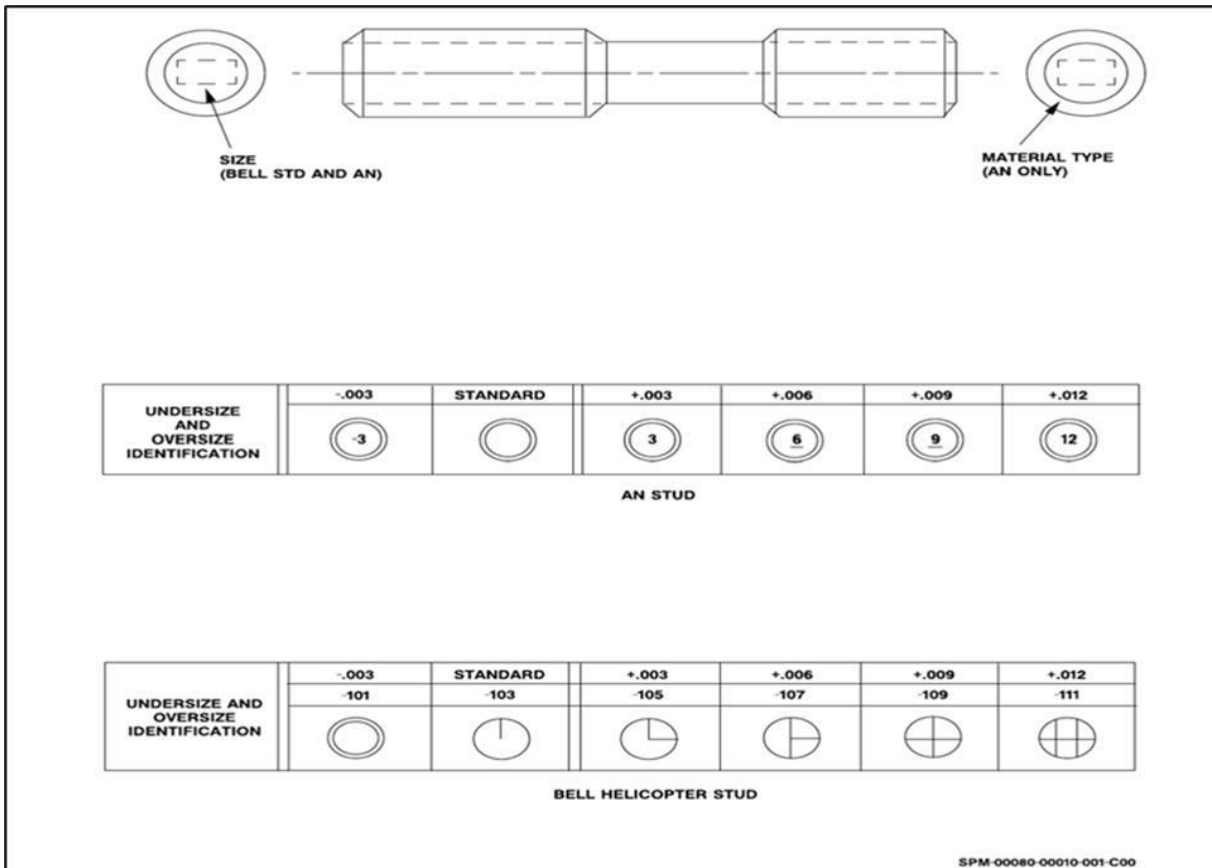
Figure 5: Studs and Inserts-Standard Stud Identification

During the on-site investigation, it was found that the four studs inserted into the TRGB had snapped off from its attachment point, refer to Figure 5. During the onsite investigation, the AIC retrieved three of the four snapped studs with nuts securely attached. The investigation did not locate the other missing stud and nut at the accident site. The nuts were found to be MS21042L4 which were superseded by NAS9962-4L or could remain in service and be replaced by attrition if they are serviceable and meet the minimum torque requirement or until depletion. The four Studs part number was AN126 324 ,0.003, standard size.

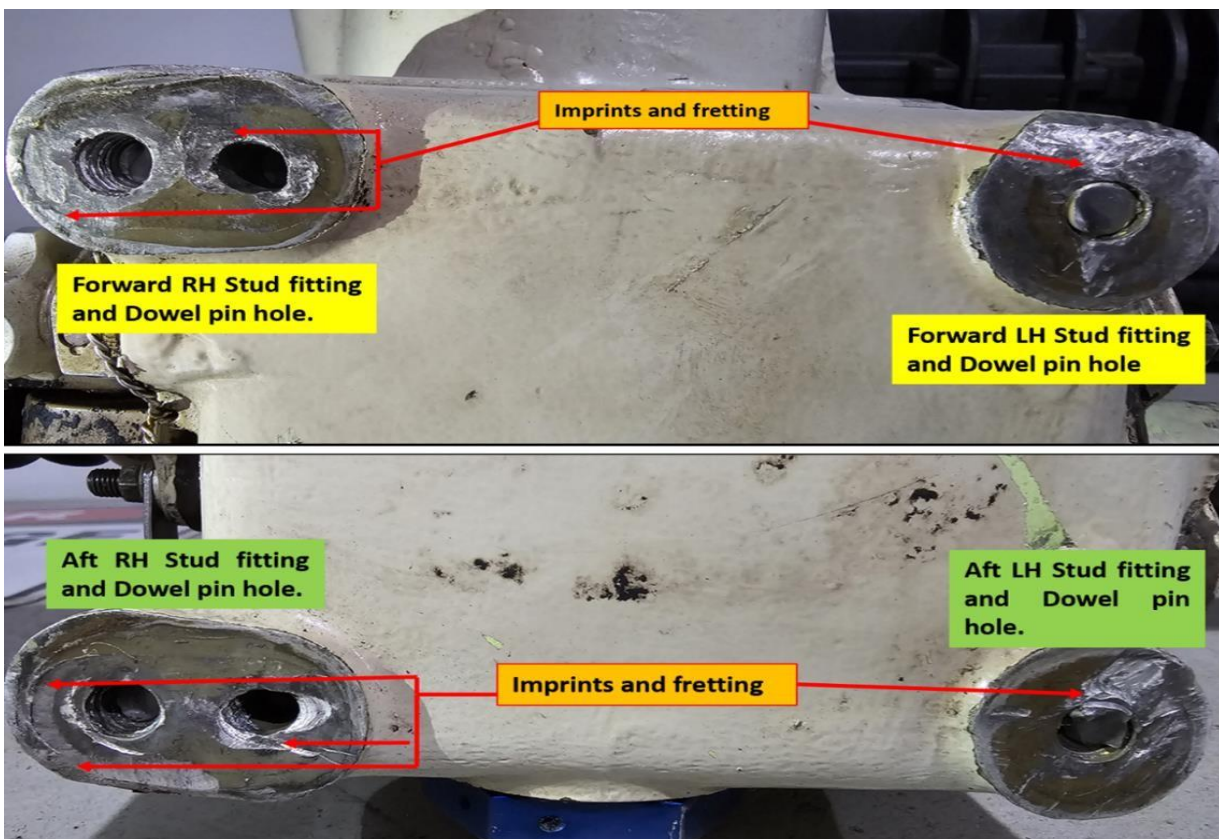
Figure 6: TRGB mating surface

The TRGB mating surface was inspected and the following were observed.

- TRGB is found to be made of magnesium alloy.
- Dent sustained on the RH mating surfaces.
- Fretting (both new and old) on the mating surface.
- Dowel pin holes were expanded in the direction of applied force.
- The studs on the RH forward and aft were snapped from the inside.
- Studs on the LH forward and aft were snapped from the mating surface.
- There was no dowel pin on the TRGB.

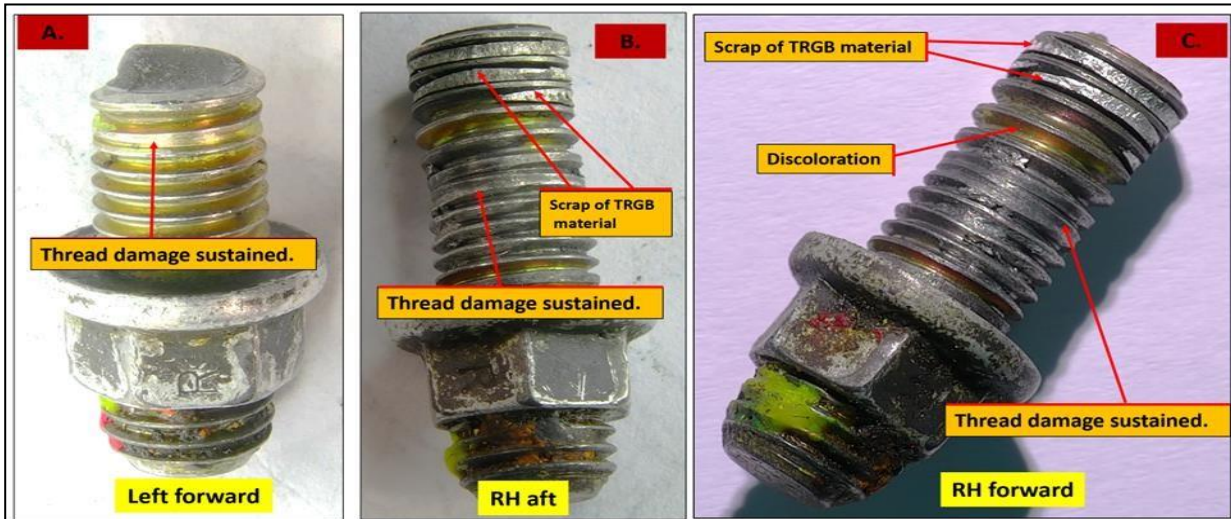
Figure 7: Studs retrieved from the accident site

According to the maintenance documents provided, the studs, as part of the TRGB assembly had been in operation on P2-HSM for 4,982 hours since manufacture. The AIC further examined the studs and the following were observed:

- ⊕ The nuts were attached to the studs.
- ⊕ LH forward stud snapped from the mating surface.
- ⊕ RH aft and forward stud snapped off from the inner side.
- ⊕ The stud thread was damaged from the TRGB bore and discoloured.
- ⊕ Both studs' thread were damaged and believed to be just above the mating surface.

Upon review, several factors were identified as contributing to the premature rupturing of the TRGB studs. Significant wear was observed in the TRGB inner bores, suggesting excessive exposure to vibrations above normal. The inner studs exhibited fatigue cracks along the thread grooves, indicates repeated stress cycles and vibration, leading to material fatigue and cumulative weakening over time.

The flattened stud threads along the length of the mounting points suggest predominant lateral vibrations prior to the studs rupturing. The elongation observed on the inner stud bores and the dowel pin bores also supports this observation. Sustained vibrations weakened the studs, and additional fatigue cracks were observed along the length of the inner studs. The continued weakening of the studs through these vibrations reduced their structural integrity below that of the nuts. Evidence of fretting in the stud bores further indicates that as fretting continued to create clearance between the stud and bore making the stud movement more pronounced, promoting further weakening and cracking.

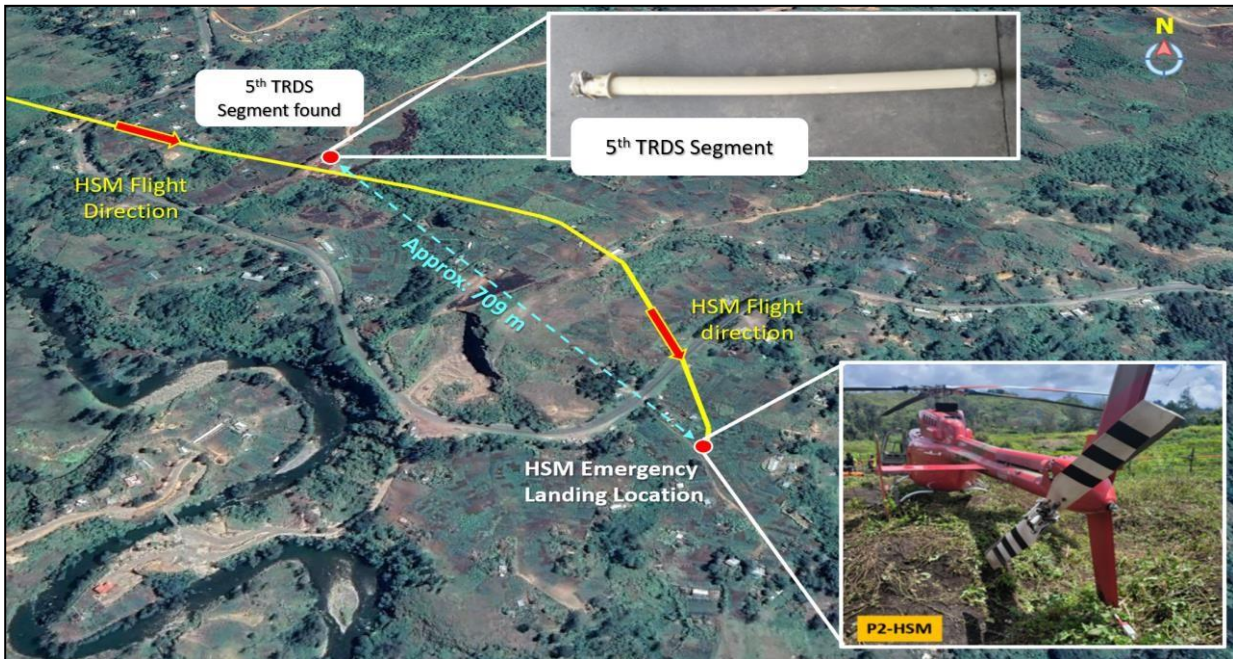
Figure 9: Overview of the Accident Site

A total loss of tail rotor thrust occurred about 9 NM Northwest of Wapenamanda Airport, prompting the helicopter to perform an emergency landing approximately 3.5 NM Northwest of the airport.

The fifth segment of the tail rotor drive shaft was detached in-flight and was later recovered about 700 metres Northwest of HSM's resting position (Refer to Figure 7).

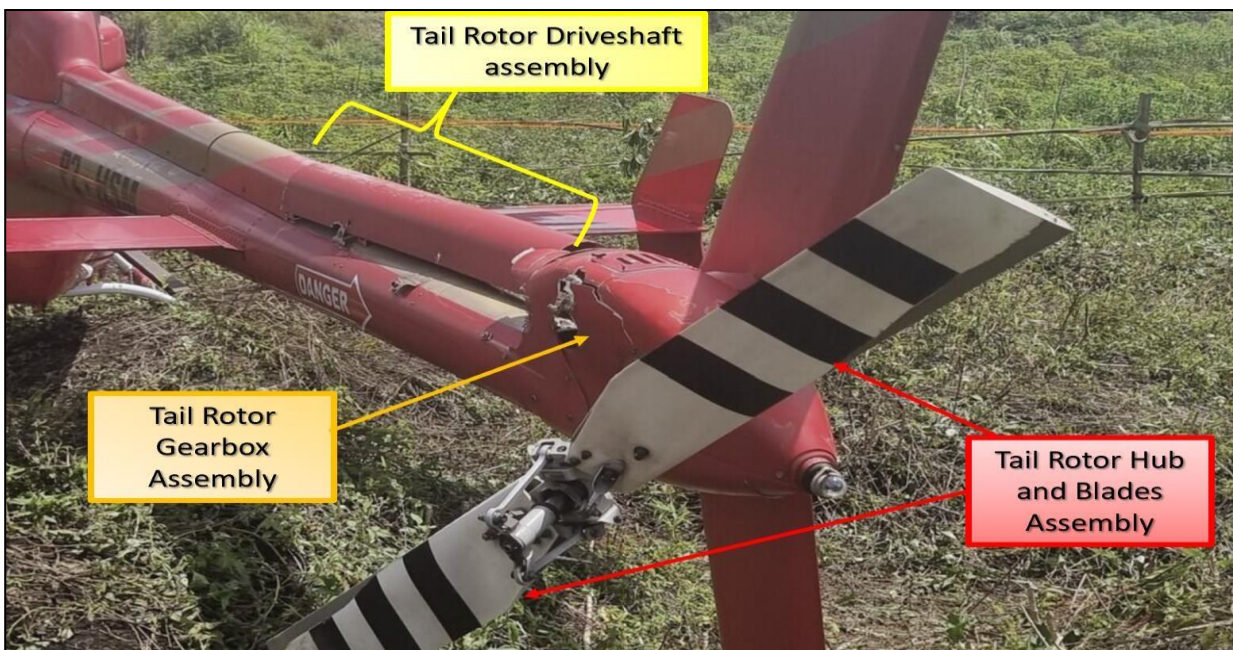
Figure 10: Damage Sustained

The helicopter suffered notable structural damage to several components, including the tail boom, tail rotor gearbox, tail rotor hub and blades, and tail rotor driveshaft (Refer to Figure 8). Additionally, minor damage was observed on the skid rear cross tube, and there was a crack in the chin bubble on the left side.

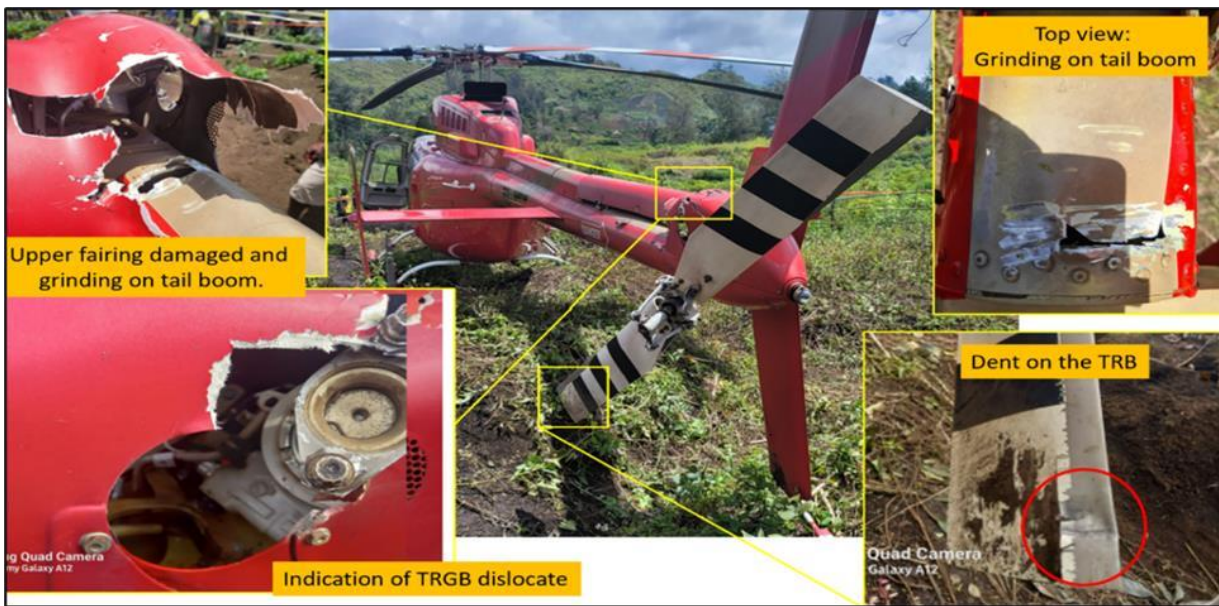
Figure 11: Damage sustained to the TRGB and Tail Boom

The TRGB became detached from its mount, with only the tail rotor blade control link preventing complete separation. Upon site inspection, damage was visible on both the TRGB and the top fairing of the tail rotor shaft. Furthermore, the aft tail rotor driveshaft assembly had completely fractured, causing the gearbox to shift from its original position and move leftward from its designated mount. This displacement resulted in the tail rotor blades hanging over. Subsequent examination revealed that the four fastening hardware securing the gearbox had failed. As a result, the TRGB was left suspended on the tail boom solely by the control mechanism.

Moreover, the rivets connecting the forward and aft TRDSAs at the bearing hanger were absent, and noticeable abrasion was observed on the tail boom structure where the aft TRDSA connects to the input pinion of the TRGB. A notable dent on the leading edge of the TRB's tip was attributed to impact with a soft foreign object.

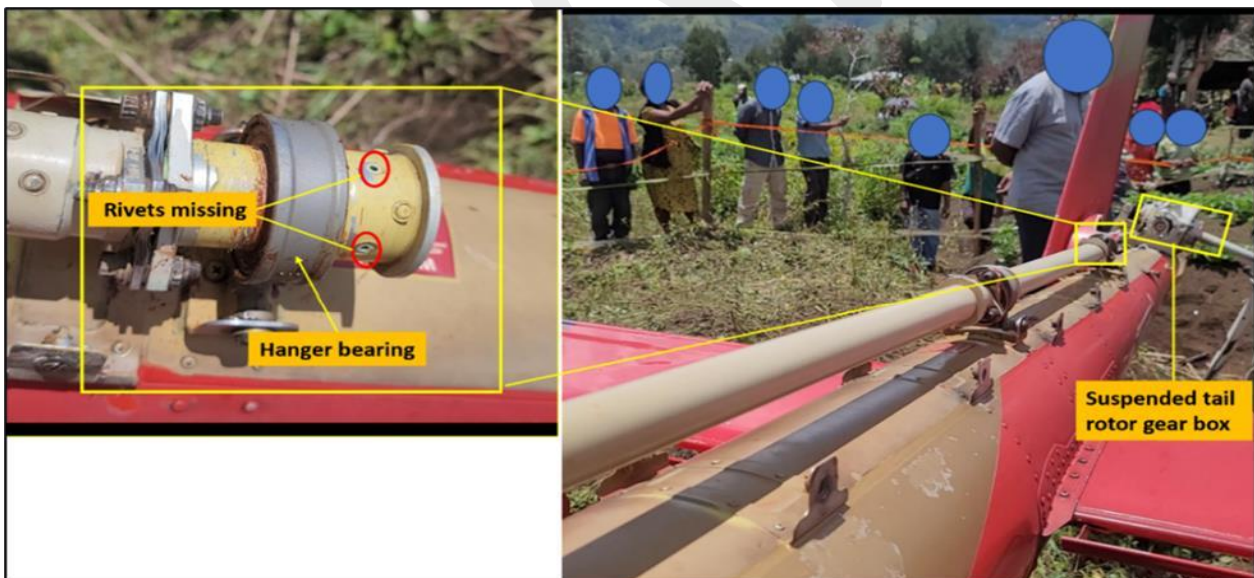
Figure 12: Drive shaft and TRGB

The TRGB mounting studs fractured, causing the gearbox to detach from the tail boom support. Of the four studs that failed, two were positioned within the stud bores of the gearbox, while one was situated on the surface of the TRGB mounting, as illustrated in *Figure 11*. The location of the remaining stud was undetermined. Refer to *Section Figure 7* for details regarding the attachment positions of the studs with secured nuts and to view a microscopic picture.

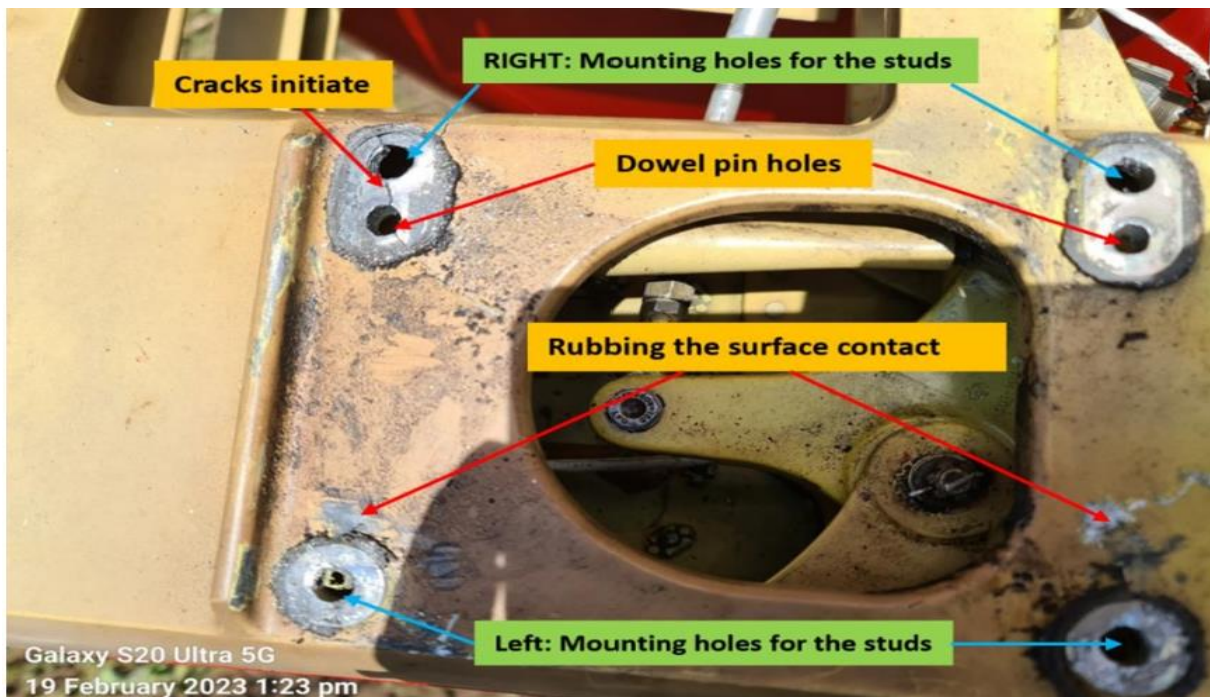
Figure 13: Tail Boom mating surface.

During inspection of the tail boom support (TRGB mounting surface), cracks were observed extending from the forward right stud hole to the dowel pin hole position (Refer to *Figure 11*)
