FINAL REPORT

AIC 23-1005

Beechcraft Super King Air B200C

Nose Landing Gear Collapse During Landing Roll

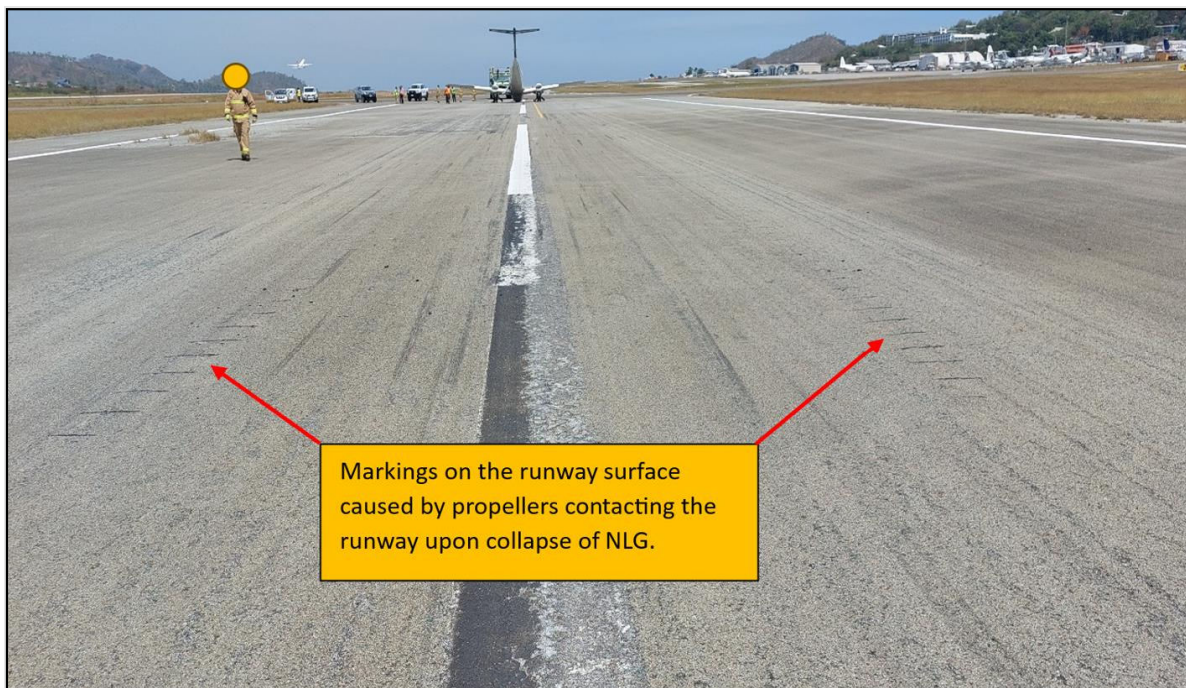
Figure 4:Runway Surface Markings-14R.

Limited to markings on the runway surface caused by the left-hand and right-hand propellers contacting the runway surface.

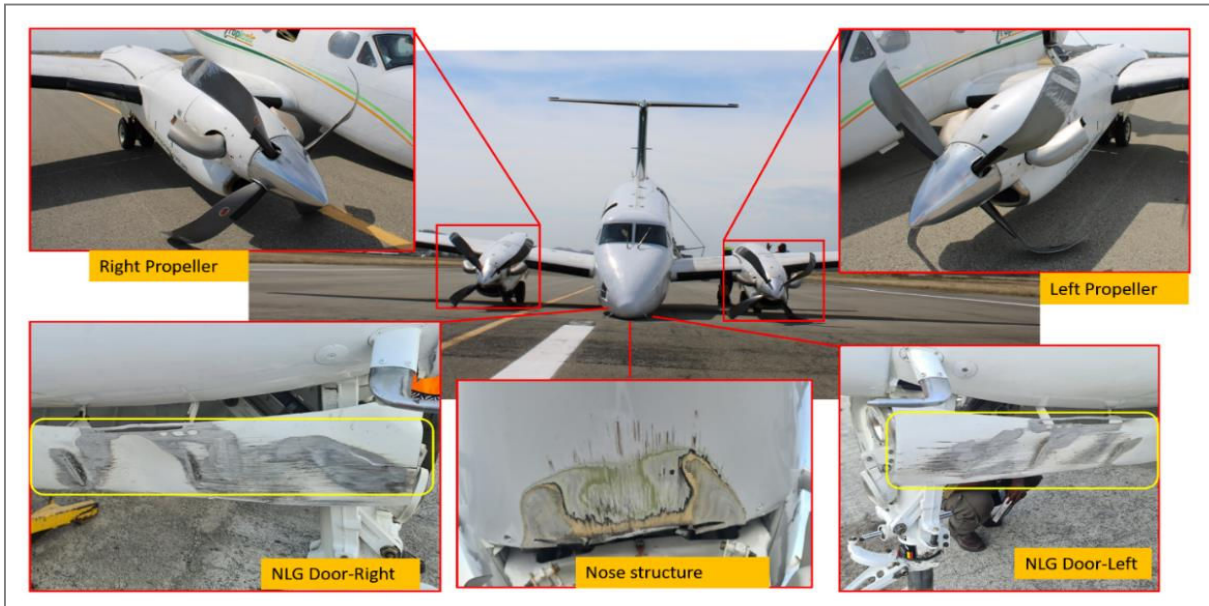
Figure 15:P2-JAU Overview of Damage Sustained.

When the aircraft's nose dropped to the ground, the left and right propeller blades struck the runway surface, causing damage to the left and right propeller assemblies. The nose structure and left and right nose landing gear (NLG) doors also sustained damage upon contact with the runway surface.

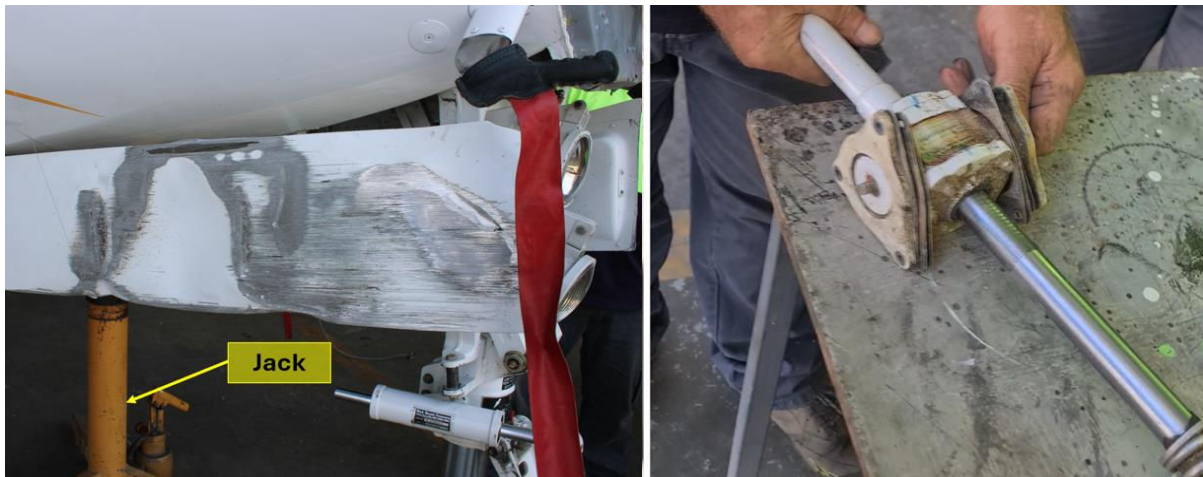
Figure 16:Retraction Test of the NLG and Inspection of the Faulty Actuator at Tropicair Hangar.

The aircraft was towed to the operator’s maintenance hangar where retraction tests were done by Tropicair maintenance team in the presence of AIC onsite team to check the operation of the Nose Landing Gear system by placing the aircraft on a jack prior to the inspection. It was determined that the nose landing gear actuator had failed internally. No anomalies were noted with the landing gear system other than the failed nose landing gear actuator.

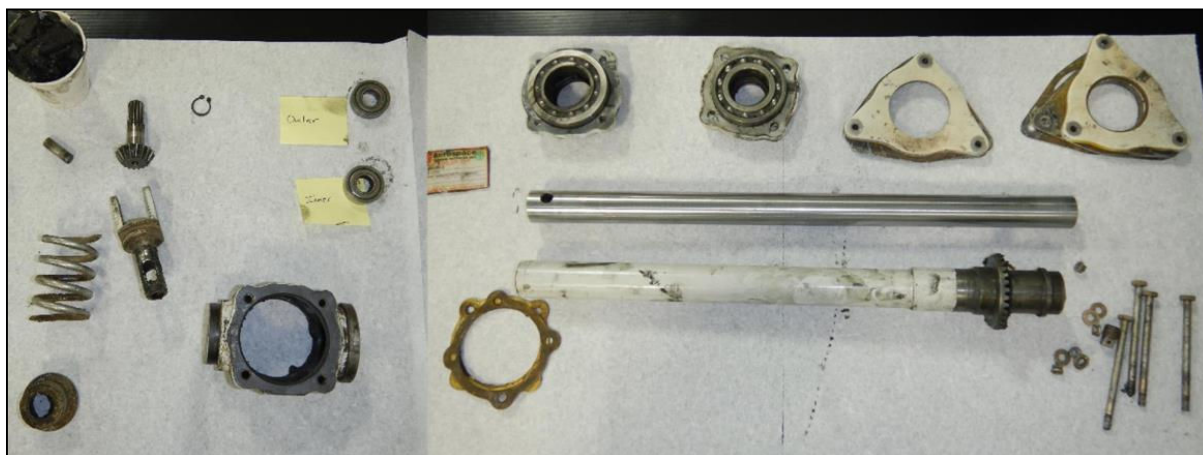
Figure 20: Components cleaned with solvent for further examination.

The detailed inspection identified that all the components examined had minor wear and corrosion, whereas the Nut Assembly had excessively worn threads.

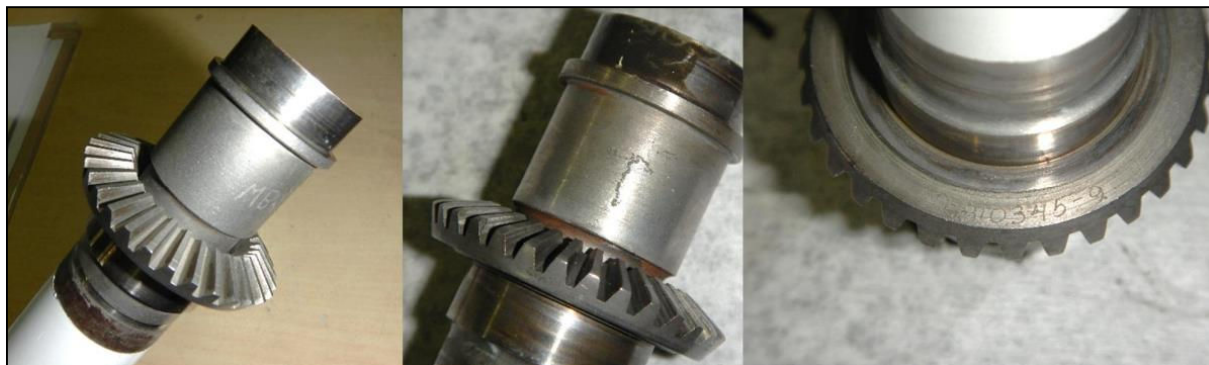
Figure 21: Bevel Gear Teeth.

All the Bevel Gear teeth were present, and there was no noticeable wear. There was some corrosion present on the inside diameter surface of the screw housing, possibly due to inadequate grease before cleaning.

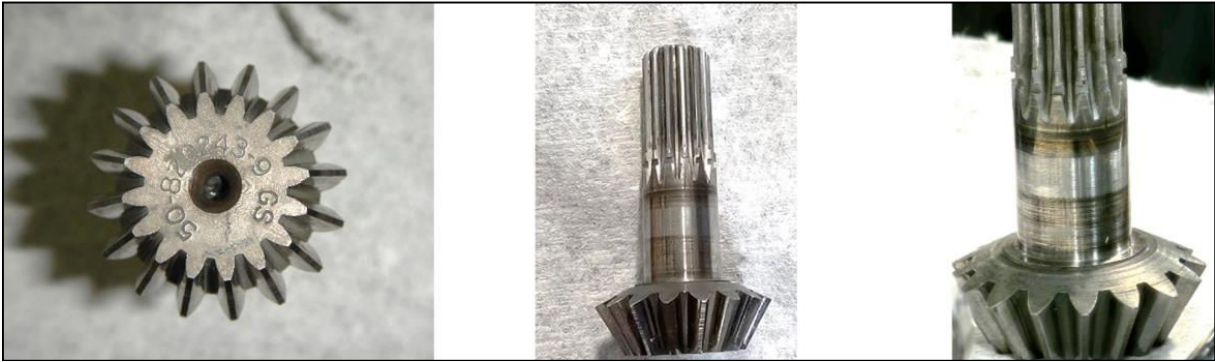
Figure 22: Pinion Gear

The Spline Gear portion of the Pinion Gear was inspected, there was no damage found. All the Pinion Gear teeth were present, with minimal wear. The Pinion Gear Snap Ring was examined, with no damage noted. There appeared to be some light wear on the Pinion Gear shaft.

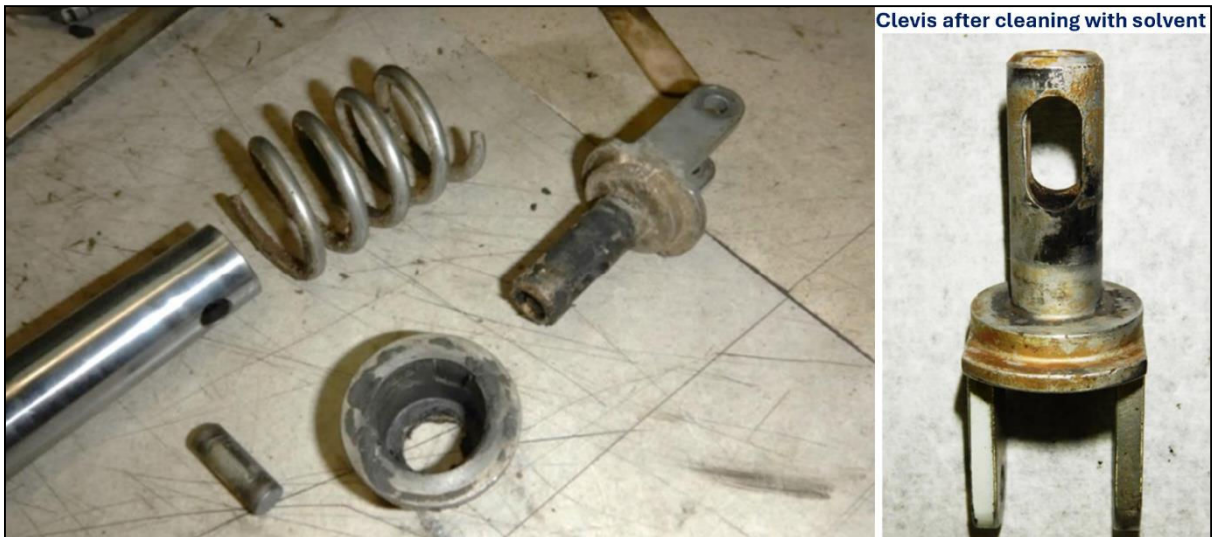
Figure 23: Clevis Pin, Clevis Spring and Retainer.

The Clevis Pin, Clevis Spring and Retainer were examined. Before cleaning, there was grease on the Clevis shaft, but it was dry and tacky. The bottom side (Spring side) of the Clevis flange showed considerable debris and corrosion. The Retainer had a layer of dry, tacky grease on its interior.

The Clevis was cleaned with solvent and inspected. There is a light layer of corrosion over the center portion of the Clevis, which is relatively uncommon.

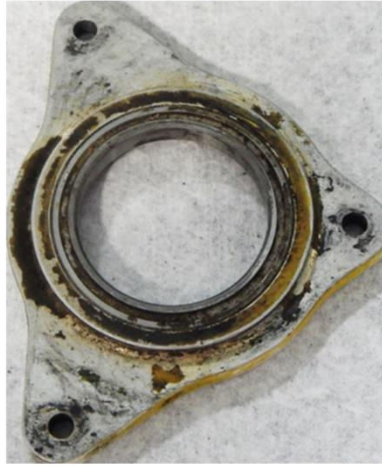
Figure 24: Landing Gear Actuator Support.

The Plug-side Bearing, when rotated, felt very rough, and would only rotate approximately 180° before binding and rotating no further.

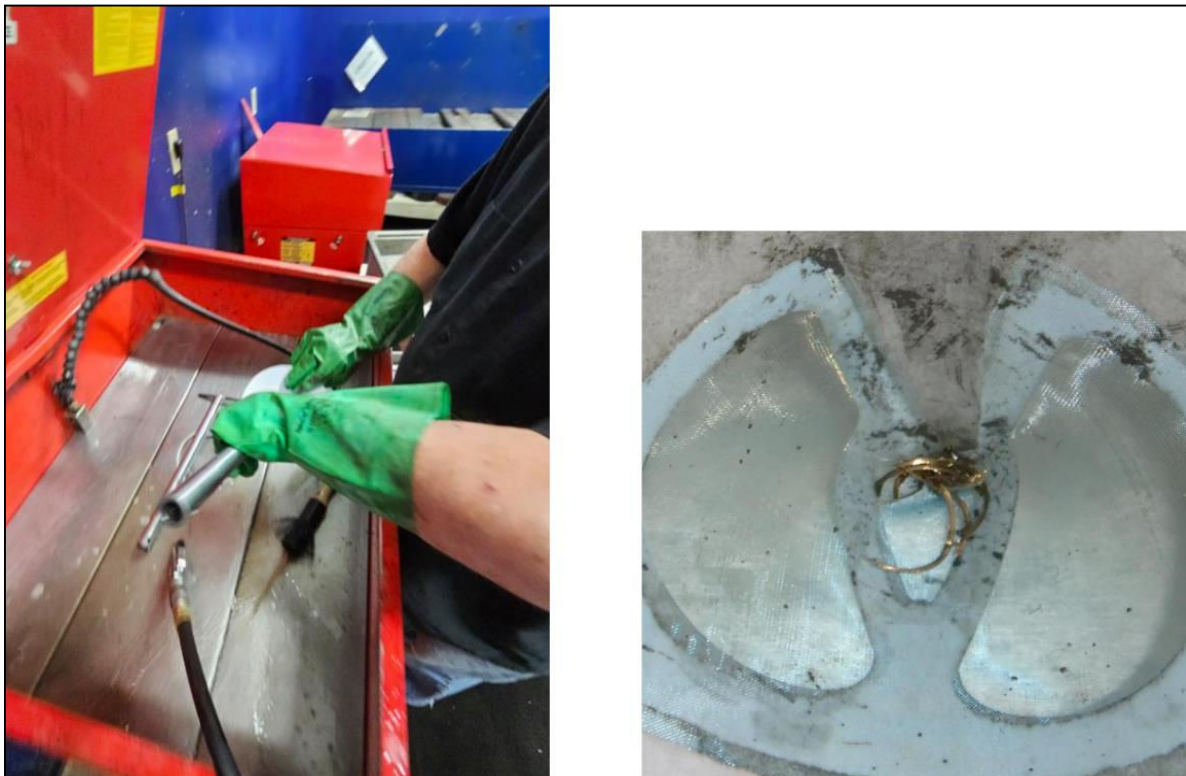
Figure 25: Nut Assembly Rinsed with Solvent.

The grease was cleaned from the clevis-end of the Nut Assembly. The interior of the Nut Assembly was then rinsed with solvent and drained through a filter, in order to collect any debris such as metal shavings. The process was repeated approximately 10 times. The debris that was collected was less than the total loss of threads observed on the Nut Assembly. This indicates that either the debris had migrated somewhere else prior to the analysis, or the debris migrated out of the threads through extend and retract operations.

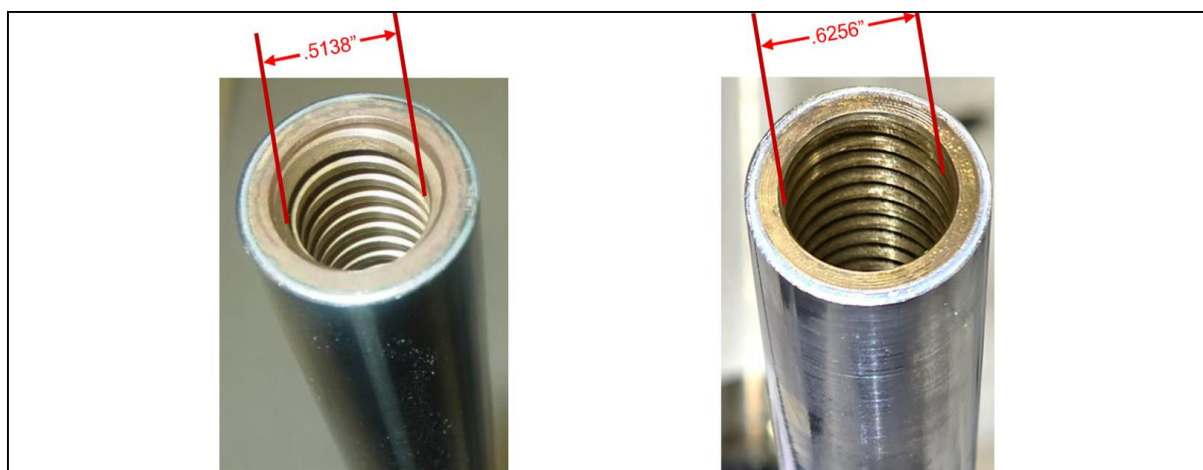
Figure 26 L to R: Threaded portion of the New Nut Assembly Compared to the Subject Nut Assembly.

The threaded portion of the Actuator Nut Assembly was compared to that of a new Nut Assembly. The Minor Diameter of the subject Nut Assembly was measured and compared to that of a New Nut Assembly. The diametric difference was .6256”-.5138”³².

A teardown and internal inspection of the faulty NLG Actuator by the Manufacturer showed that the Nut Assembly was found with excessively worn threads on the nut assembly preventing it from engaging with the screw housing. All other components had minor wear and corrosion. The grease present in the Nut Assembly appeared somewhat thick and dry. The grease present in all other parts of the Nose Landing Gear Actuator also appeared dry and stiff.

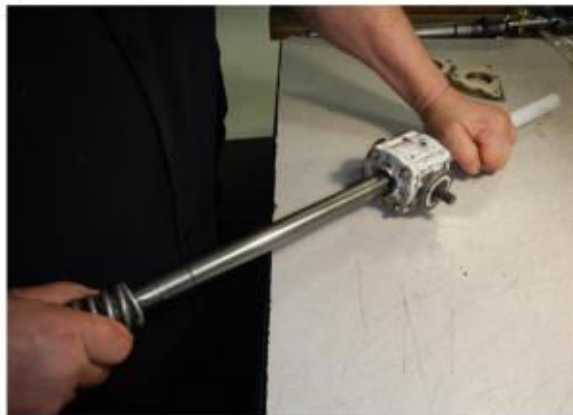
Initial inspection of the Nut Assembly revealed that the Nut Assembly could be pulled completely out of the Screw Assembly without rotating its threads (Figure 6). It did not have adequate thread contact to inhibit it from pulling straight out of the screw housing without rotation. Inspection of the exterior of the nut assembly and clevis indicated that there were no dents, scratches, bends or any other damage on the exterior of the nut assembly or clevis. Grease was present on the Nut Assembly, but it was thick and dry (Figure 7).

Figure 6 – Nut Assembly Removal Without Rotation

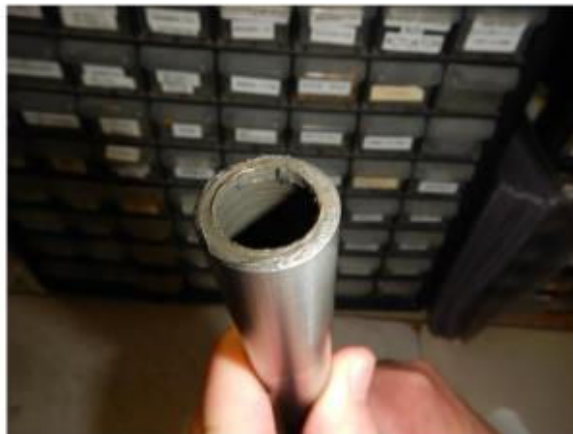
Figure 7 – Nut Assembly Threads with Grease

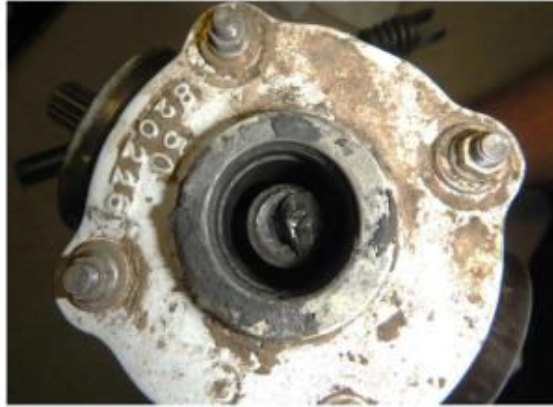
No damage was found on the interior of the Screw Assembly, although an insufficient amount of grease was observed (Figure 8).

Figure 8 – Screw with Grease

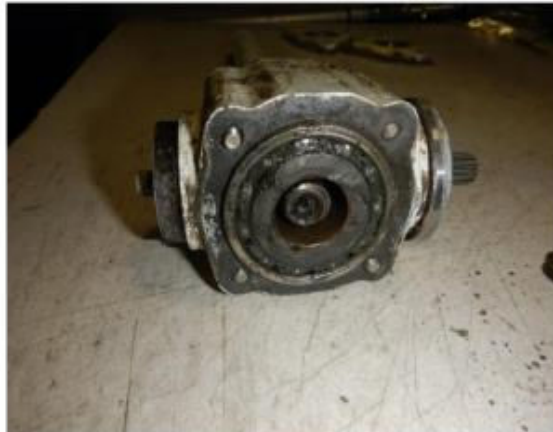
The actuator Lower Cover was removed in order to inspect the Gearbox Lower Bearing. Grease was present but it was thick and pasty, as it would if it were old (Figure 9).

Figure 9 – Gearbox Lower Bearing with Grease

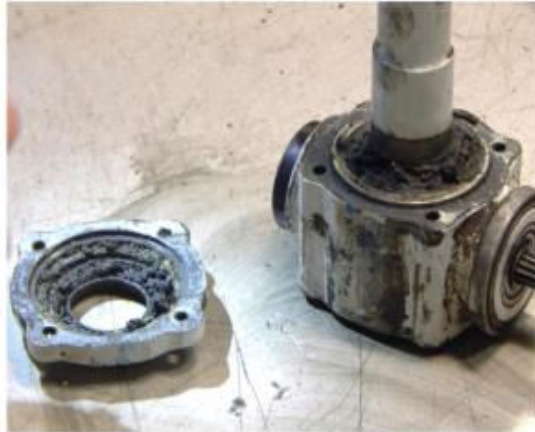
The actuator Top Cover was removed and examined. The grease appeared very dry and crumbly as it would if it were old. The grease in the Gearbox Upper Thrust Bearing had the same appearance (Figure 10).

Figure 10 – Top Cover and Gearbox Upper Thrust Bearing with Grease

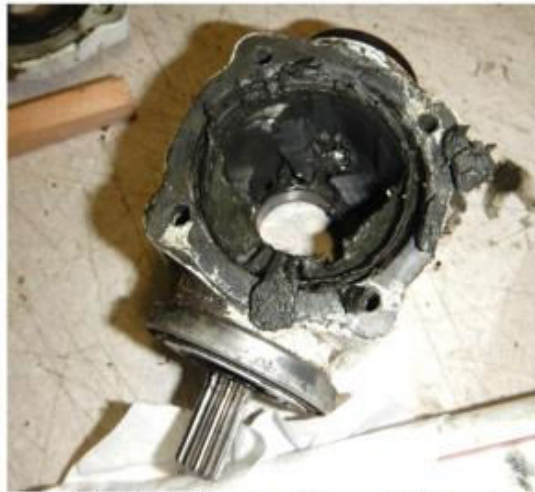
Grease was present on the inside of the housing, but it appeared dry and stiff as if it were old (Figure 11).

Figure 11 – Actuator Housing with Grease but Dry and Stiff

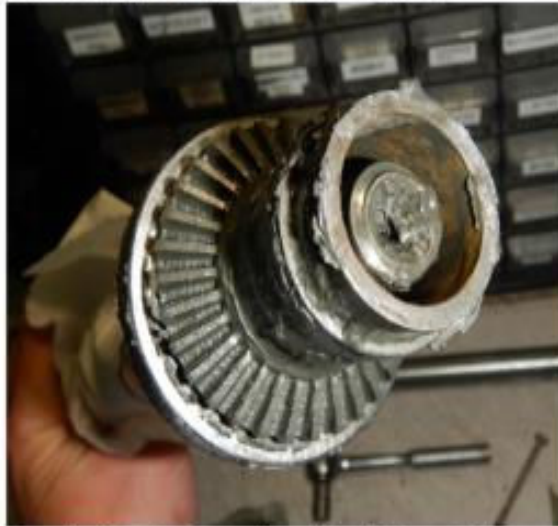
The Screw Assembly was examined (Figure 12). The grease was slightly dry and stiff. There was no noticeable wear on any of the gear teeth. There is some corrosion present on the inside diameter surface of the Screw Assembly, possibly due to inadequate grease.

Figure 12 – Actuator Screw Assembly with Grease but Dry and Stiff

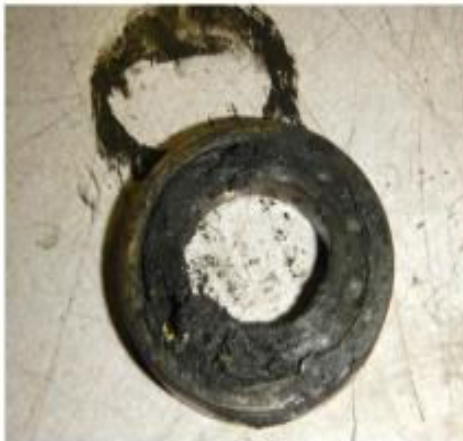
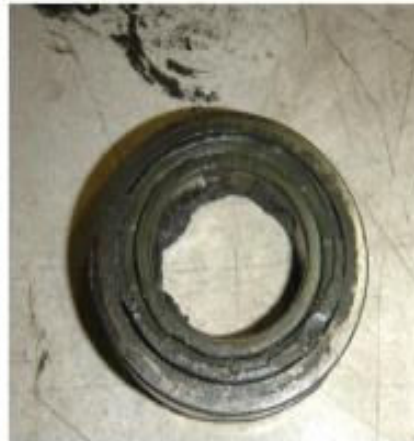
The Gearbox Lower Bearing was examined (Figures 13 and 14). Grease was present, but it appeared old, as evidenced by being dry and stiff. The bearing was stiff to rotate by hand.

Figure 13 – Gearbox Lower Bearing with Grease, but Dry and Stiff

Figure 14 – Gearbox Lower Bearing with Grease, but Dry and Stiff, Other Side

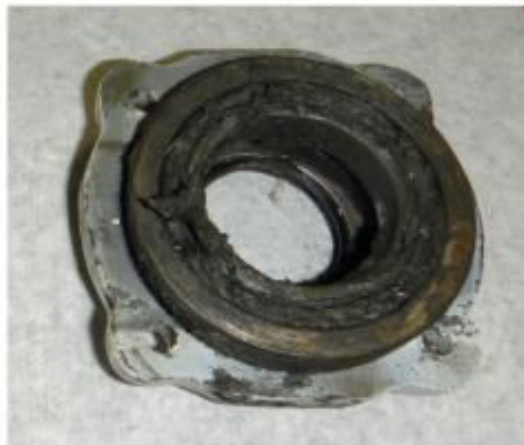
The Gearbox Upper Thrust Bearing was examined. Grease was present, but it was very dry and stiff, as if it were old (Figure 15). The bearing was stiff to rotate by hand.

Figure 15 – Gearbox Upper Thrust Bearing with Grease, but Dry and Stiff

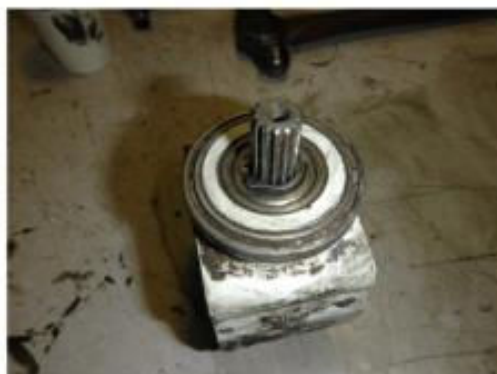
The Pinion Gear was inspected, with no damage found. All of the teeth were present, and they showed only minimal wear (Figure 16). The Pinion Gear Snap Ring was examined, with no damage noted.

Figure 16 –The External Spline Gear Portion of the Pinion Gear Prior to Removal

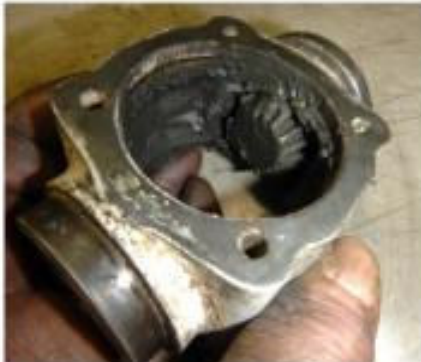
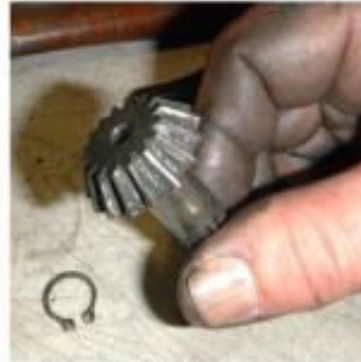
The Snap Ring was then removed from the Pinion Gear, and the Pinion Gear was removed from the Housing. The Pinion was inspected. No damage was observed. Grease was present on the inside Pinion Gear, but it was dry and stiff as if it were old. No excessive wear was found on the teeth or shaft (Figures 17 and 18).

Figure 17 – Pinion Gear with Grease, but Dry and Stiff

Figure 18 – Pinion Gear with Grease, but Dry and Stiff

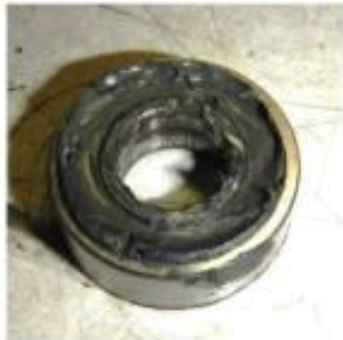
Figure 19 – Inner Pinion Thrust Bearing with Grease, but Thick and Gummy

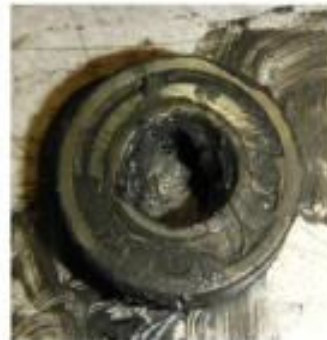
The Outer Pinion Bearing was removed and inspected (Figure 20). Grease was present, but it was thick and gummy. When rotated by hand, the bearing rotation was very stiff.

Figure 20 – Outer Pinion Bearing with Grease, but Thick and Gummy
