FINAL REPORT

AIC 23 - 2001

Fokker 70

Cabin Pressurisation Event In Flight

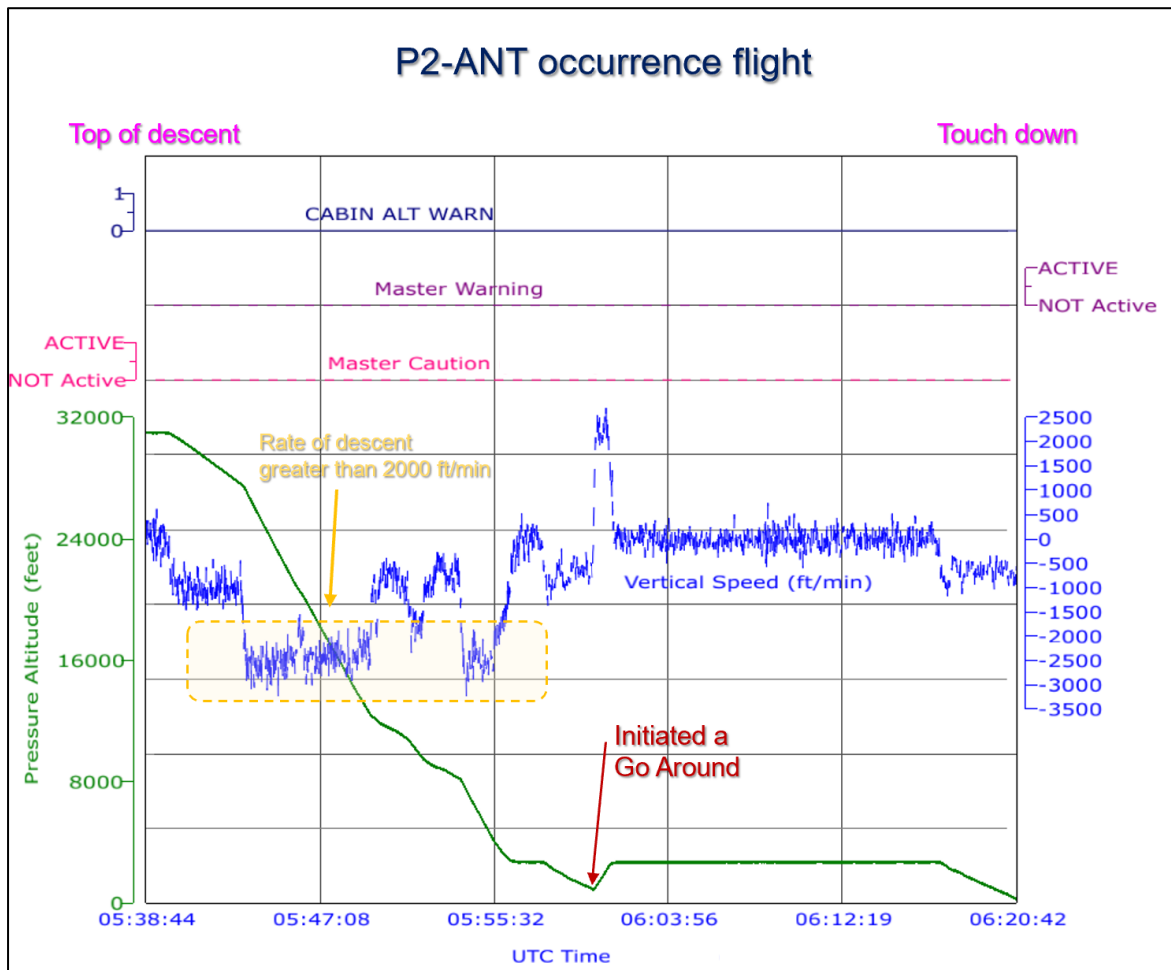
Figure 7. SSFDR recorded data plot of the serious incident flight.

The investigation also used recorded data to generate a graphical plot of the serious incident flight from top of descent to touchdown, at Jacksons Airport, to show the aircraft's rate of descent.
