PRELIMINARY REPORT

AIC 16-1003

Hard landing

N8841X

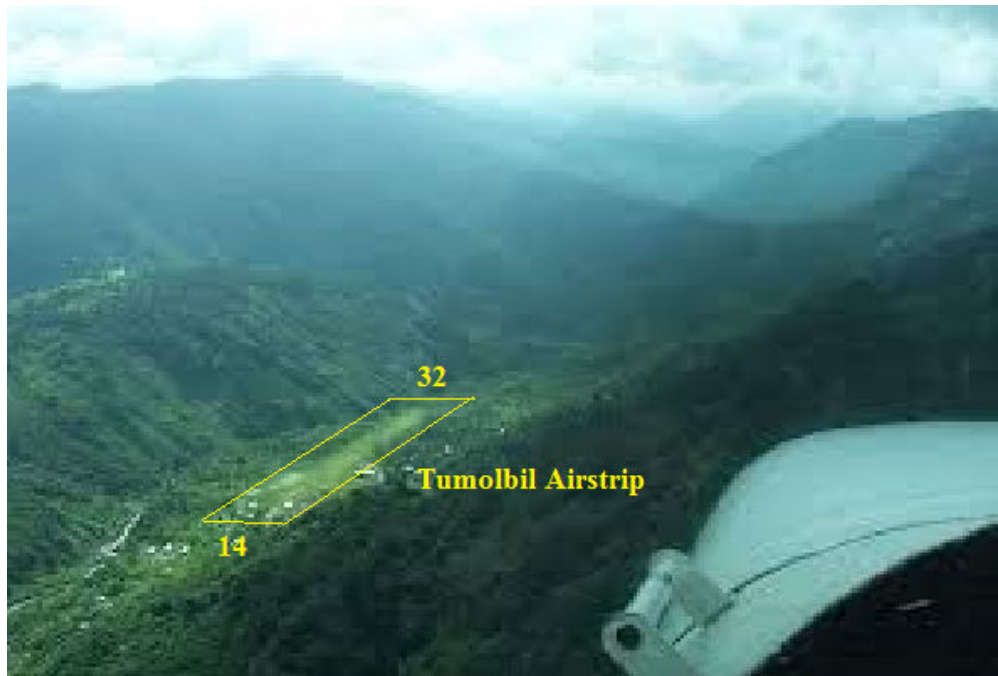
Figure 2: Aerial view of the Tumolbil Airstrip

The Tumolbil airstrip, oriented 14/32 (140°M/320°M), is a one-way grass strip 3,367 feet AMSL³ and surrounded by high mountainous, densely vegetated terrain. The airstrip slope is 12% down to the north-west. As published in the PNG AIP⁴, the Tumolbil airstrip is administered by the Sepik Baptiste Inc.

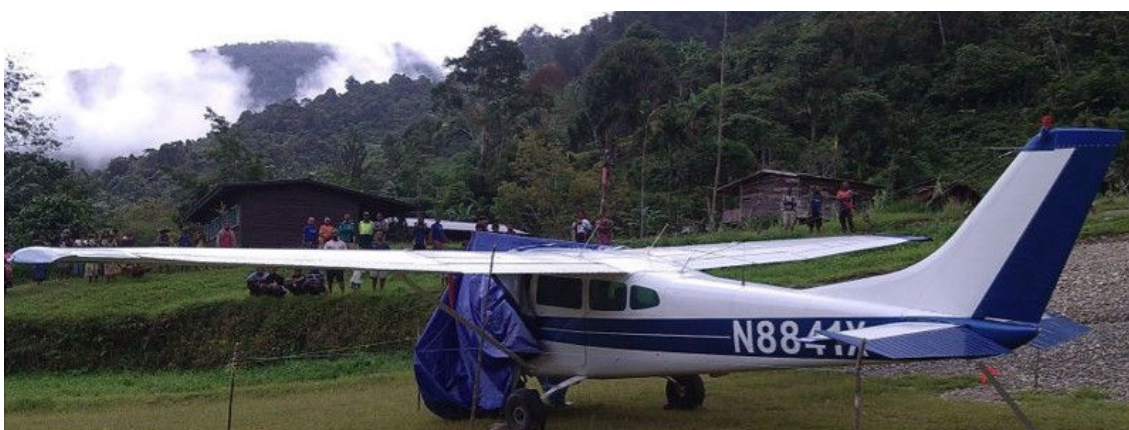
Figure 3: Aircraft at Tumolbil after accident

On 24 June 2016 the pilot of a Cessna 182 aircraft, registered N8841X, was conducting a ‘private flight’ delivering medical supplies to Yapsie and Tumolbil, in the West Sepik Province of Papua New Guinea. After unloading supplies at Yapsie the aircraft departed for Tumolbil carrying medical supplies and a bottle of compressed propane gas. The air traffic services (ATS) flight strip showed that the pilot advised ATS that he was in the circuit area at 01:05 UTC¹ and he cancelled SAR² on the ground at 01:06. During the touchdown the nose-wheel heavily impacted the strip surface. The aircraft bounced causing it to pivot about its lateral axis, and strike the rear fuselage on the ground. The pilot, the sole occupant was uninjured.

The investigation is continuing and includes analysis of the weather, airstrip condition, aircraft systems and flight controls, and operational aspects including the pilots training and experience in PNG and operations into Tumolbil.
