**AIC 14-2518**

**PAPUA NEW GUINEA  
ACCIDENT INVESTIGATION COMMISSION  
SHORT SUMMARY REPORT**

**P2-NHW**

**Engine failure**

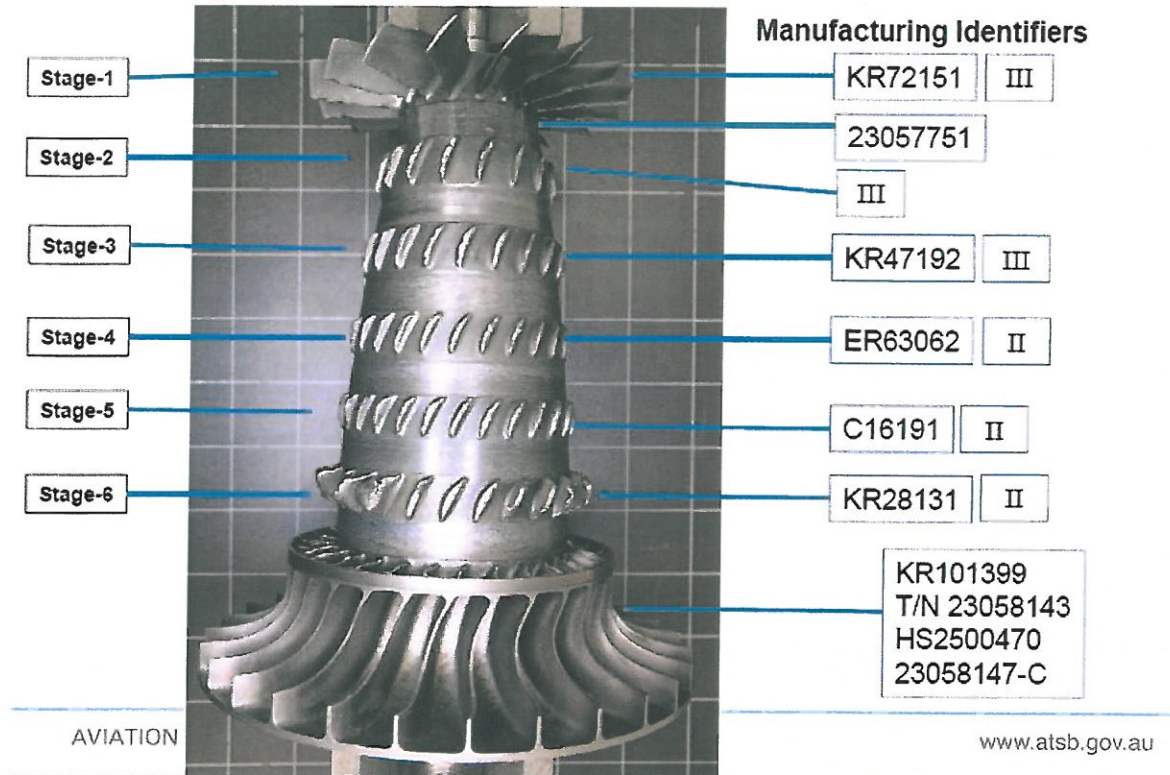
Figure 11: Compressor turbine stages (photo ATSB)

The blades on all stages of the compressor had failed with stage one showing evidence of trailing edge damage and erosion damage on the tips. The blade bending was found to be consistent with failure under engine power loads.
