**FINAL REPORT**

**AIC 13-1002**

**Cessna Aircraft Company 172SP**

**Loss of directional control – overturned on soft flight strip**

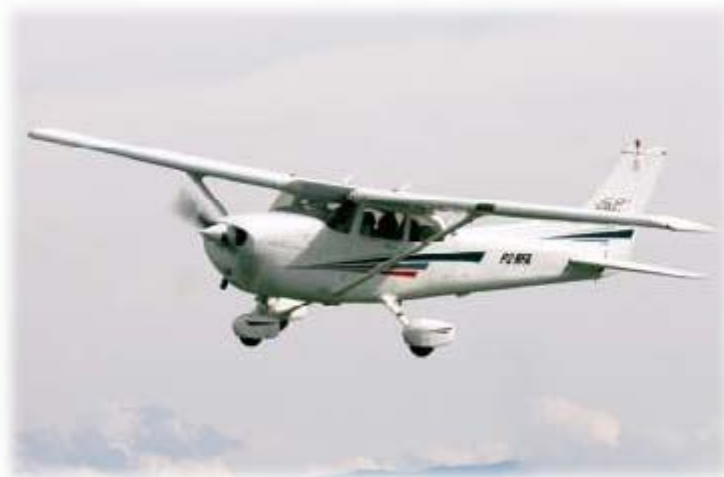
C172  
P2-MFA

The aircraft left wheel tracks in the grass to the side of the runway, which indicated that for a short period it was nearly airborne again and skidding in a slight left turn. After this the wheel tracks showed that the nose wheel had dug into the soft grass, the skidding left turn caused the right wing to impact the ground and the aircraft tipped onto its back.

The aircraft was damaged substantially, beyond economical repair.
