**PRELIMINARY REPORT**

**AIC 22-1005**

**Airbus Helicopters MBB-BK117 D-2**

**Fenestron sustained substantial damage during landing**

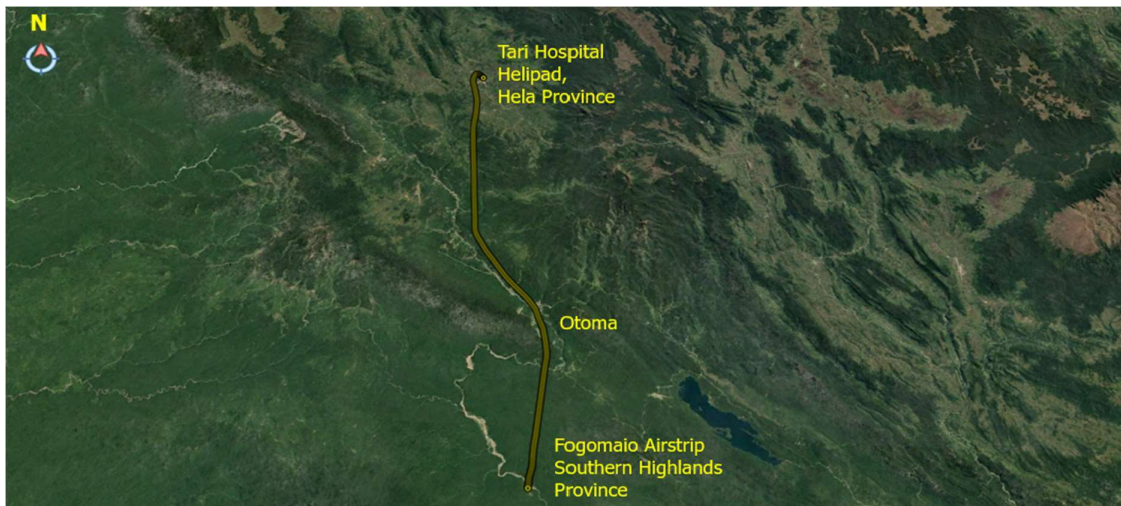
**Figure 2: P2-PHA occurrence flight path**

The recorded data showed that at about 15:14, the helicopter arrived in the Tari Circuit at 600 ft AGL<sup>4</sup> joining the circuit on a wide right base. The helicopter then proceeded with a normal approach to land at Tari Hospital's helipad, 0.23 NM southeast of Tari Airport.

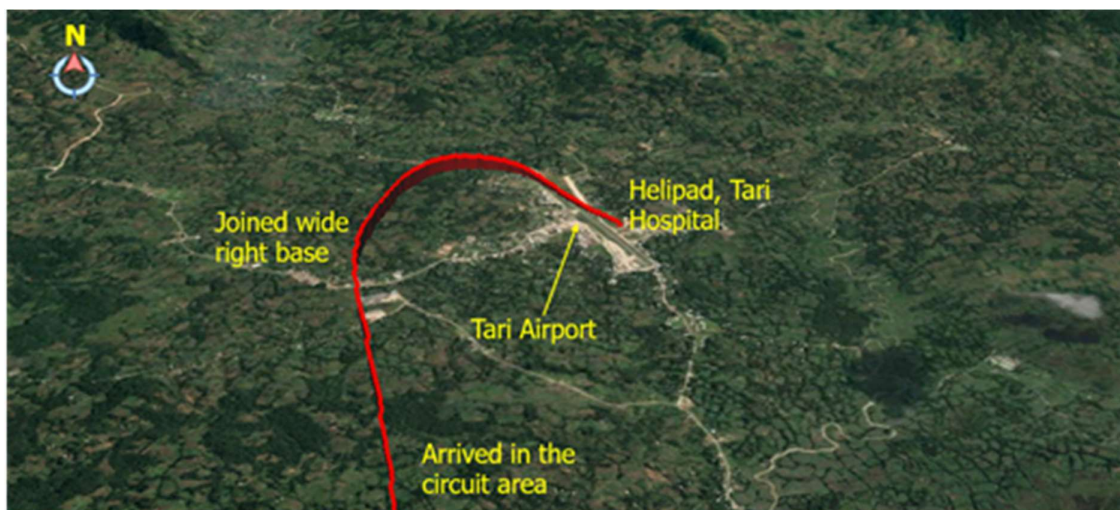
**Figure 3: Tari Circuit Area**

According to the PIC, approximately 10-15 feet above the helipad they heard an unusual loud noise from the rear of the helicopter and followed immediately by strong airframe vibrations. The PIC stated that he continued flying the VTOL profile to the ground and was able to land before any yaw motion developed.
