FINAL REPORT

AIC 22-2001

Quest (Daher) Kodiak 100

In-flight Damage

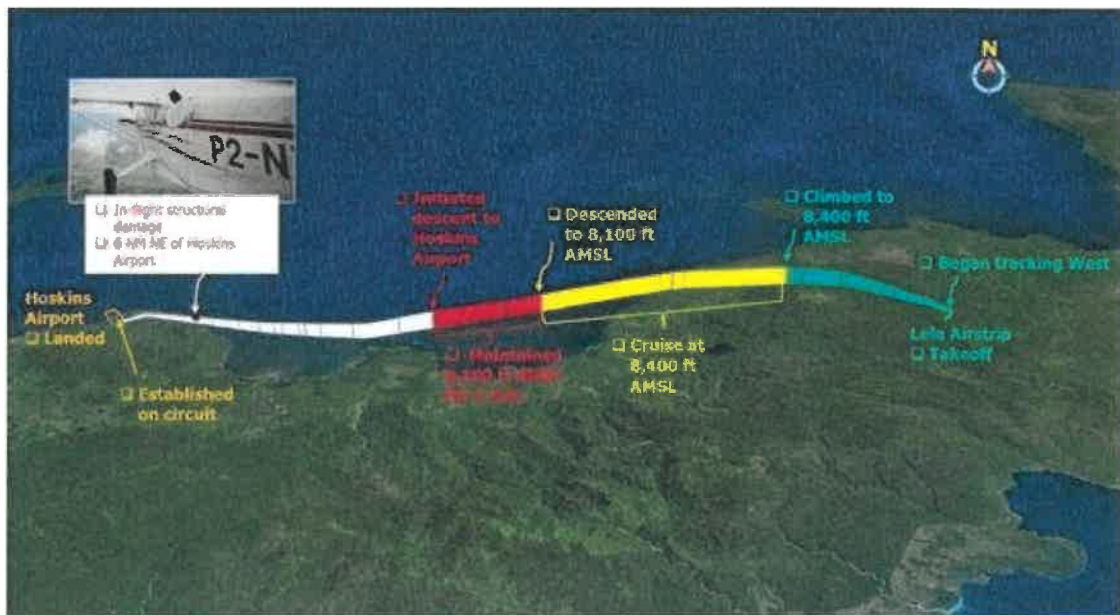
Figure 2: Occurrence flight path with events

The pilots stated during interview with the AIC that they heard a thump sound and felt it through their feet, but while it didn't sound like it was in the cabin, they assumed that it was a life vest containing a small scuba air tank located behind the crew seats. It had fallen over on the floor and they thought that was where the thump came from. The aircraft continued to fly normally.

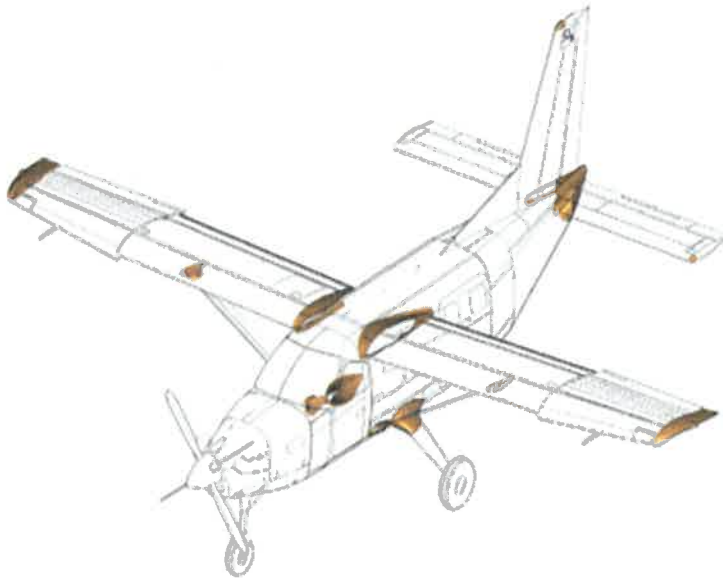
Figure 53-14: Fairing Location Diagram

- B. All composite external aerodynamic fairings are non-structural items and are fabricated from woven fiberglass cloth type "E" style 7781 conforming to MIL-C-9084, Type VIII A with proper finishes for resin systems used. Refer to the materials table in this section for compatible resins. Standard wet layup repair techniques as described in Chapter 51 Standard Practices and AC 43-13-1B Ch 3 are approved for use. If repair of the damaged part is extensive, the part should be replaced. Vacuum bagging is recommended, but is not required. Regardless of the layup and cure method used, voids and entrapped air must be avoided.

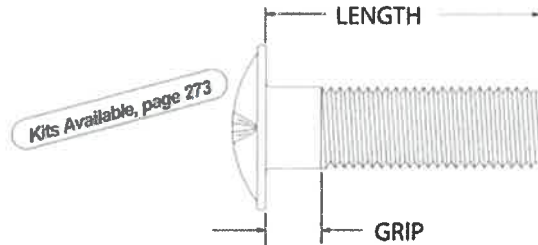
AN525-832R9 = 8-32 threads 9/16 Overall Length under the head, 5/32" grip
