FINAL REPORT

AIC 23-1002

Cessna 208B Grand Caravan

Runway Excursion During Landing

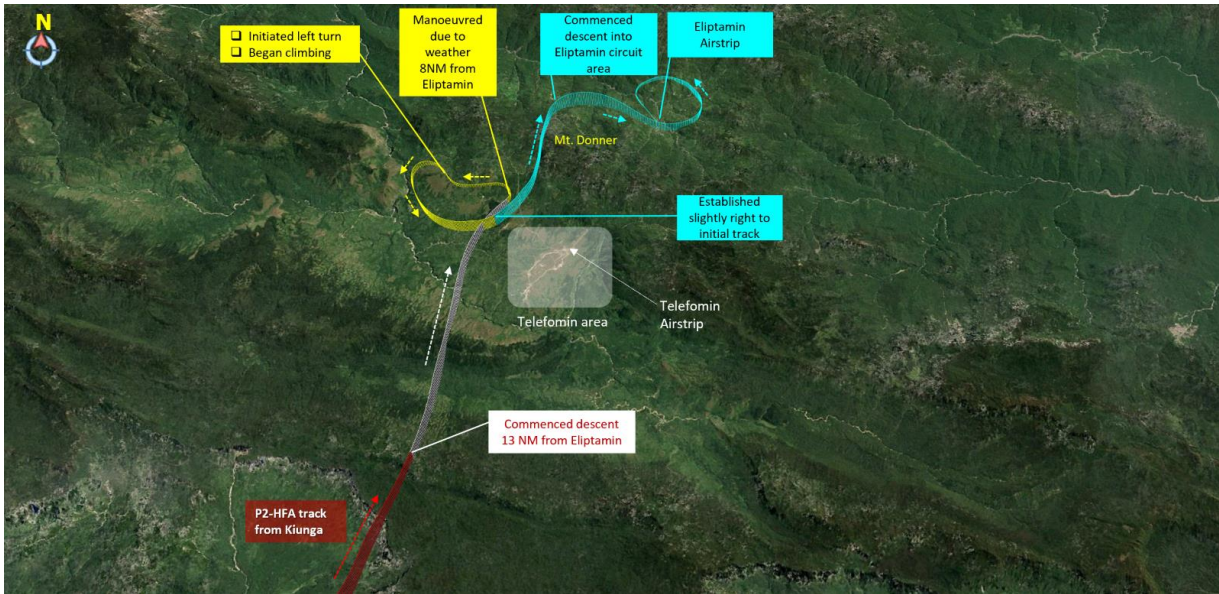
Figure 2:P2-HFA Flight Path from top of descent to Eliptamin Airstrip.

The aircraft arrived in the circuit area at 13:39 and the pilot subsequently cancelled SARWATCH⁶

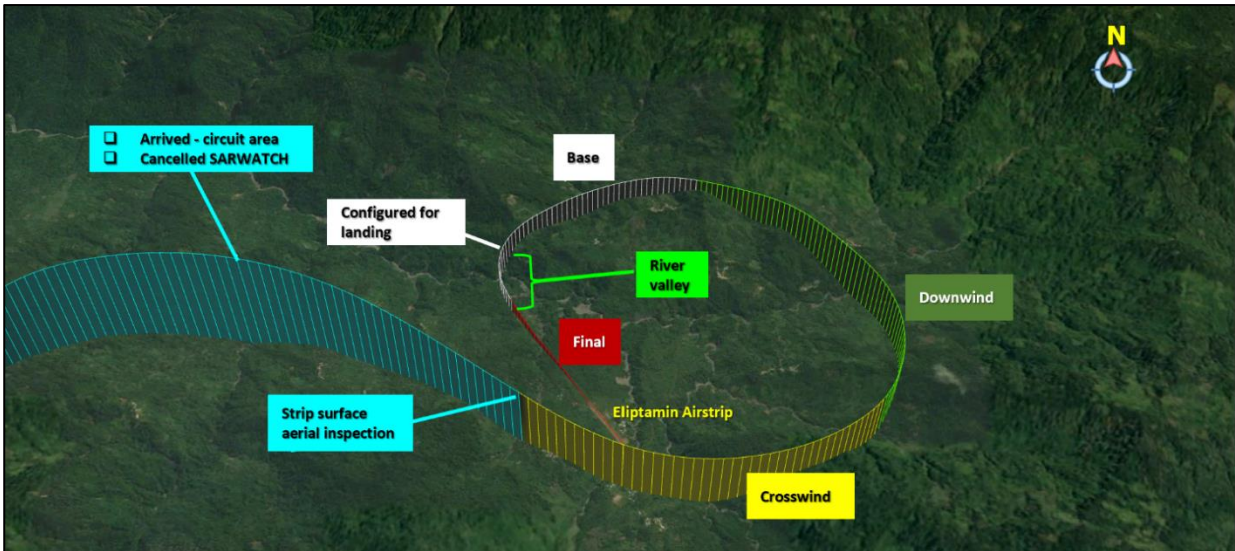
Figure 3: Eliptamin Circuit Area.

According to the pilot, as he turned on to final, he encountered very strong winds in the valley on the approach path. Since he was already past the committal point⁸, he continued the approach. The pilot recalled that on final approach, the airspeed was fluctuating between 85 to 90 kts with prevailing gusts⁹ of wind.

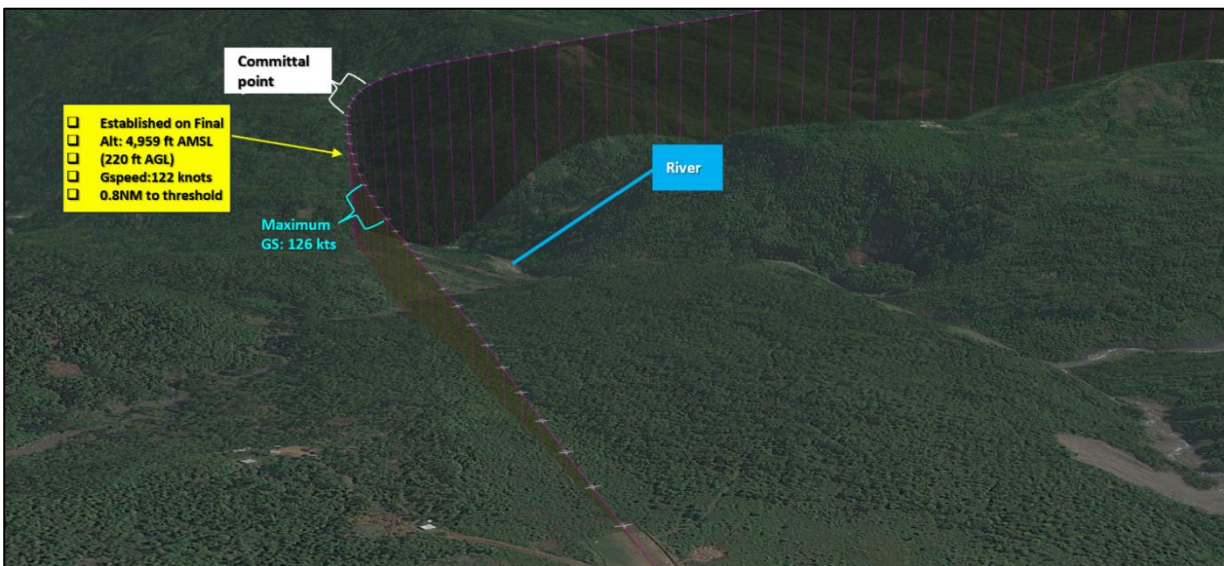
Figure 4: Final Approach.

According to the recorded data, at 13:43:12, the aircraft touched down on the threshold with a groundspeed of 116 kts and the pilot applied reverse thrust. The aircraft immediately became airborne again and travelled forward for about 160 m in the air before dropping back on to the ground, and immediately got airborne again for the second time. The aircraft travelled forward for another 90 m, as it remained airborne and at 13:43:17, it dropped back on to the ground, rolled forward for 11 seconds, covering a distance of about 276 m before impacting the embankment.

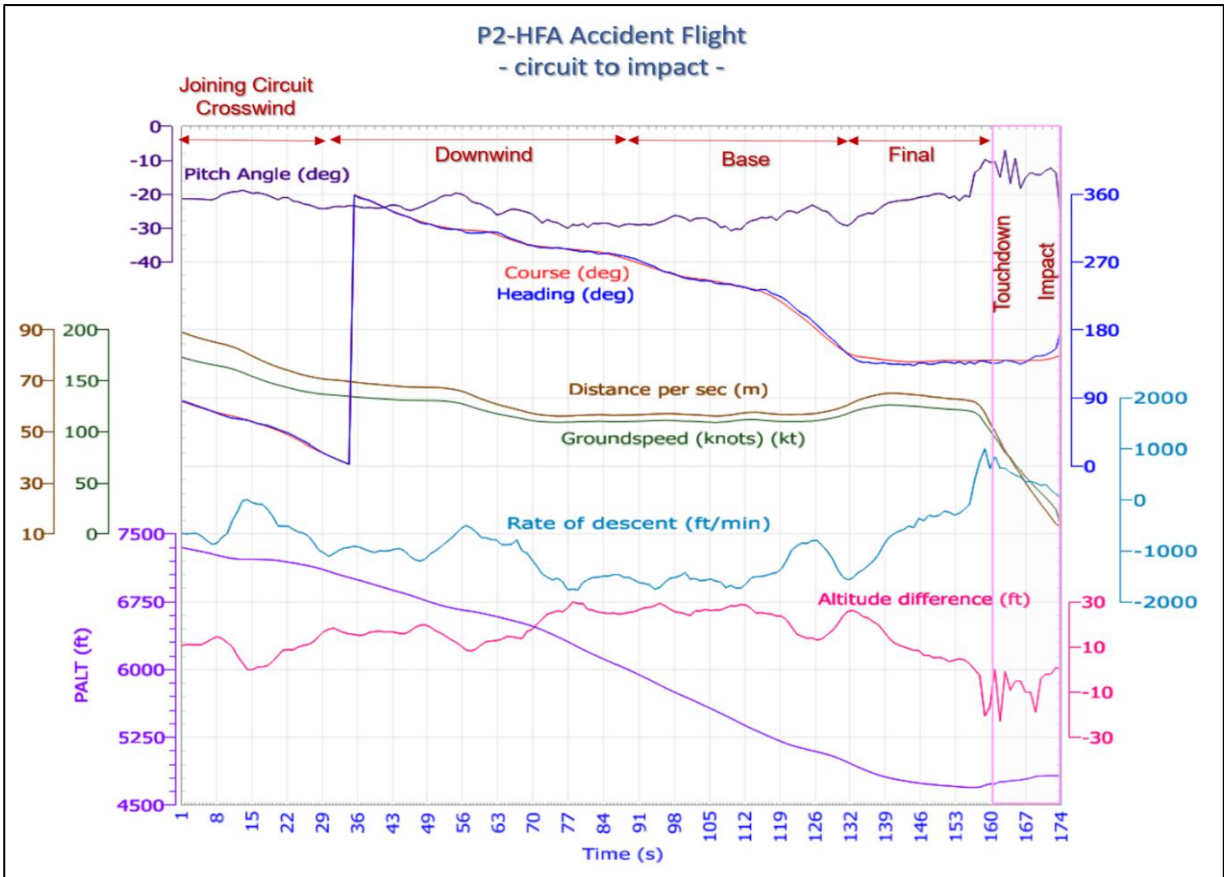
Figure 11: P2-HFA from joining circuit to impact.

The plot also showed that the aircraft had a constant rate of descent of 1,750 fpm when the aircraft was on base. When the aircraft was turning from base to final, the rate of descent reduced significantly from 1,750 fpm to about 500 fpm. Refer to *Figure 11, 12 and 13*.

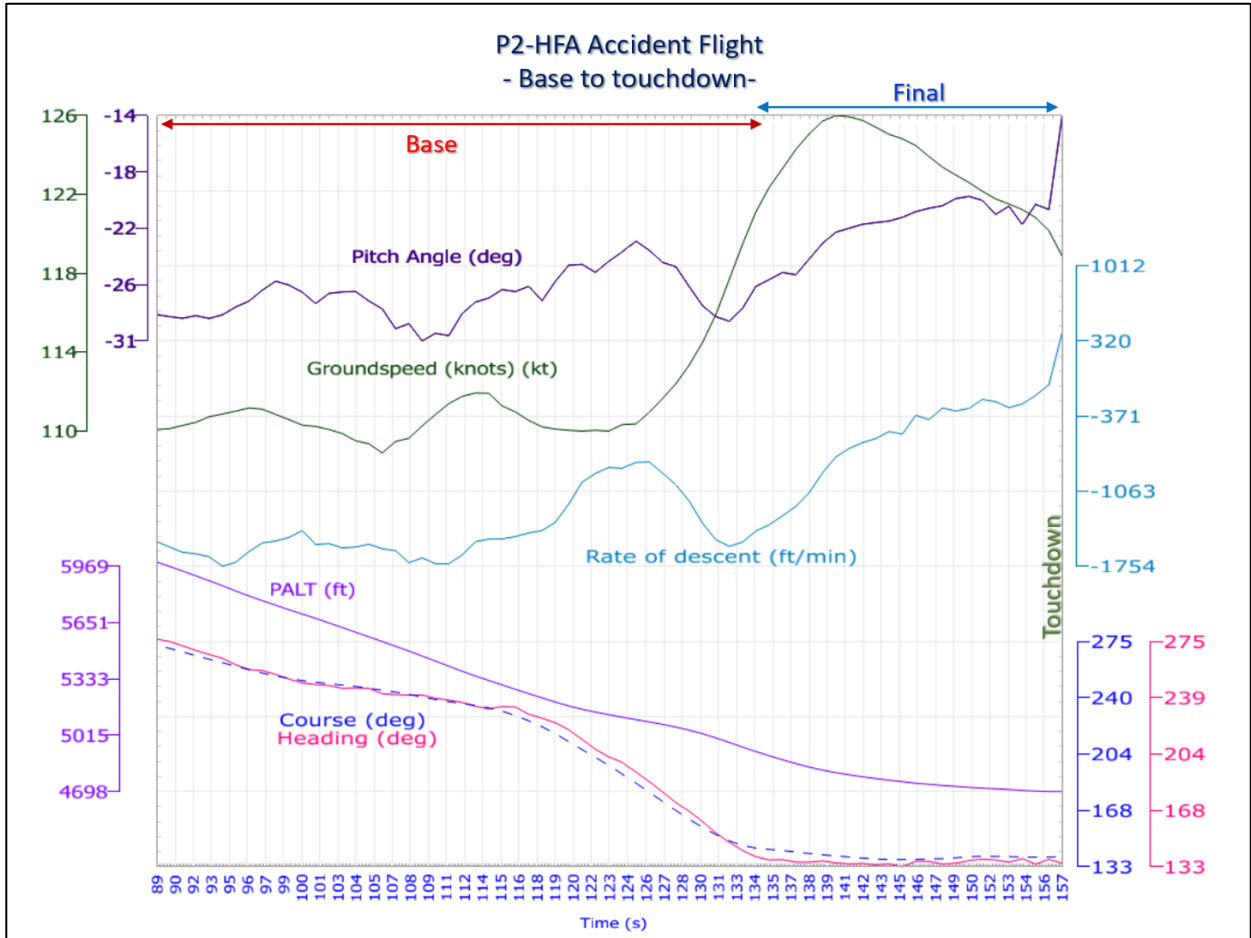
Figure 13: P2-HFA from Base to touchdown.

The recorded data showed that at 13:41, the aircraft turned left on to downwind while passing 2,400 ft AGL and continued tracking in the Northwest direction. The aircraft then turned left onto base while passing 1,400 ft AGL at a steep decent rate of 1,750 fpm, tracking in a Southwest direction. As the aircraft commenced a left turn from base to final while passing through 700 ft AGL and still maintaining a Southwest direction, there was a significant reduction in the rate of descent from 1750 fpm to about 500fpm, and a gradual increase in groundspeed. Just before establishing on to final in a Southeast direction, with the aircraft fully configured for landing, the rate of descent increased again from 500 fpm to 1500 fpm with the groundspeed continuing to increase. *Refer figure 13.*

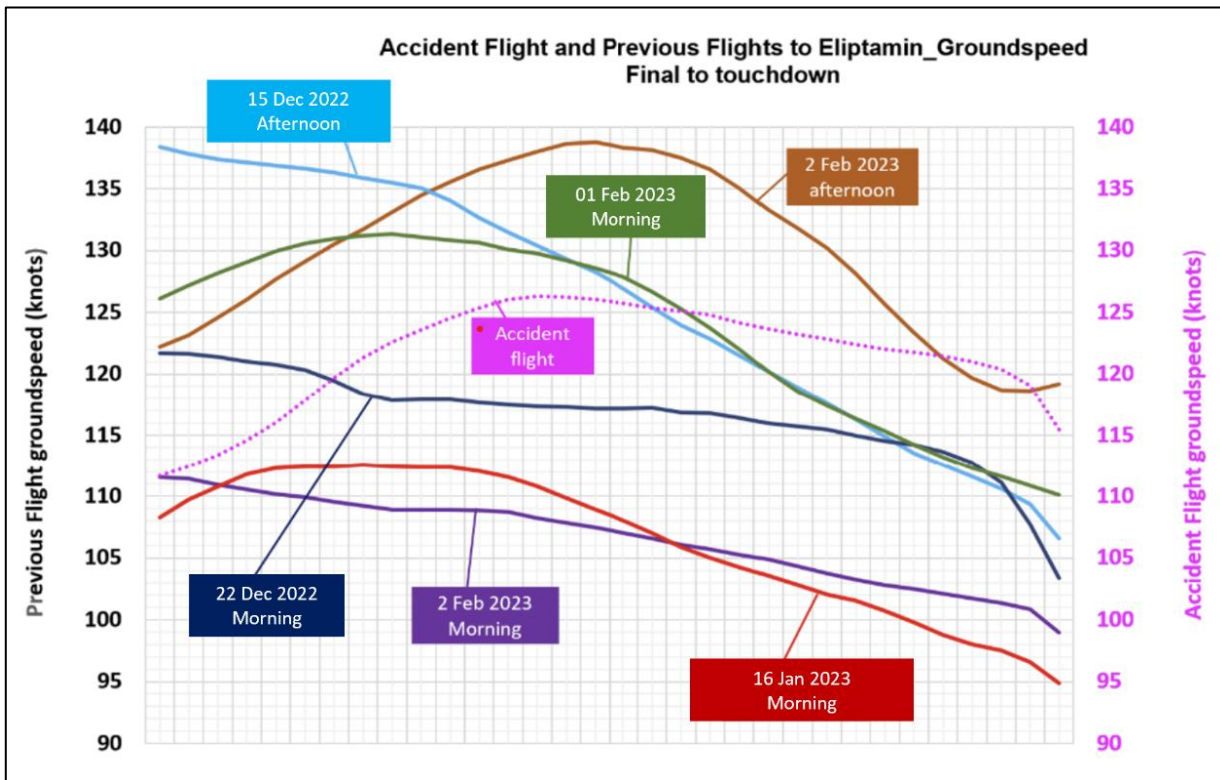
Figure 15: The groundspeed of the accident flight and previous flights to Eliptamin Airstrip.

The AIC also used the Appareo's recorded data to generate a graphical plot to compare the groundspeed of the accident flight against the previous flights into Eliptamin. Refer to *Figure 15*.

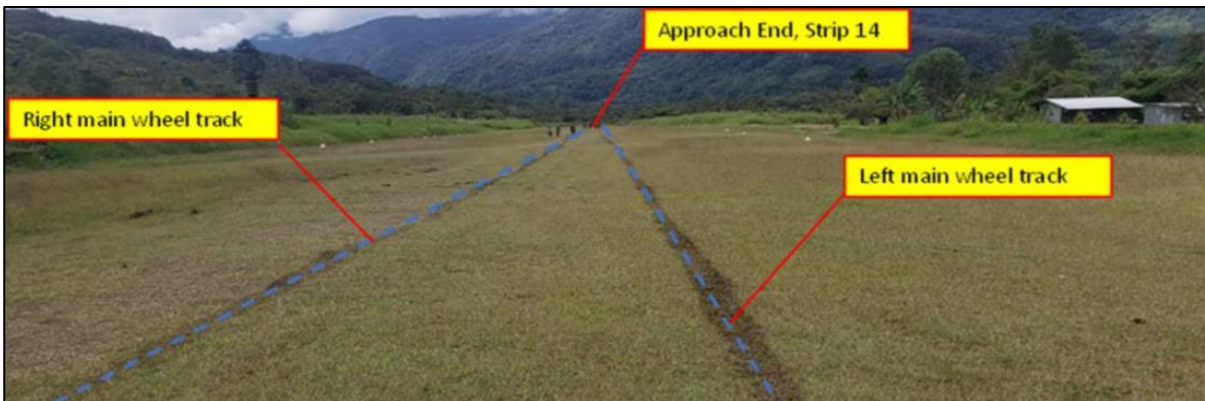
Figure 17: P2-HFA tyre tracks form the main wheels.

The evidence of tyre markings on the surface indicated that the main wheels were in contact with the ground all the way to impact, however, there was no evidence of the tyre markings from the nose wheel on the runway surface. The investigation, therefore, determined that the nose wheel was not lowered and did not contact the strip during the ground roll until impact. Refer to *Figure 17*.

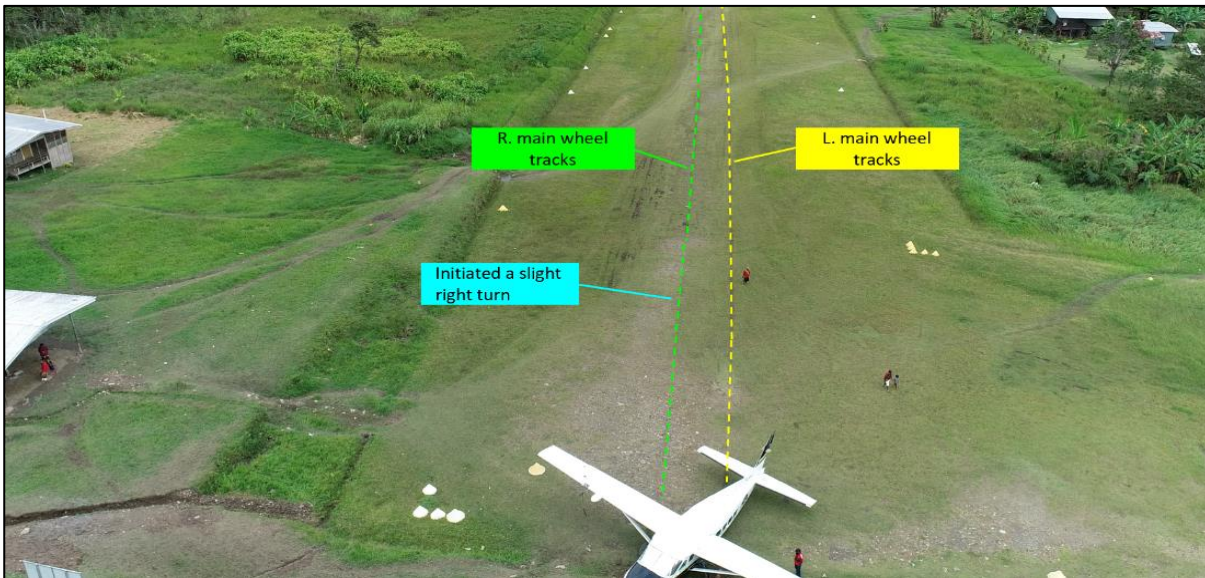
Figure 18: Tyre marks of hte main wheels showing the aircraft's heading

The tyre markings from the main wheels indicated that the aircraft was rolling on the centre hard surface of the runway strip and maintaining the runway heading of 140°. The markings also indicated that the aircraft's main wheels turned slightly to the right when the aircraft was about 44m to its resting position. The aircraft impacted the drainage ditch and came to rest at a heading of about 180°, facing South. Refer to *Figure 18*.
