FINAL REPORT

AIC 22-1005

Airbus MBB-BK117 D-2 helicopter

Fenestron sustained substantial damage during landing

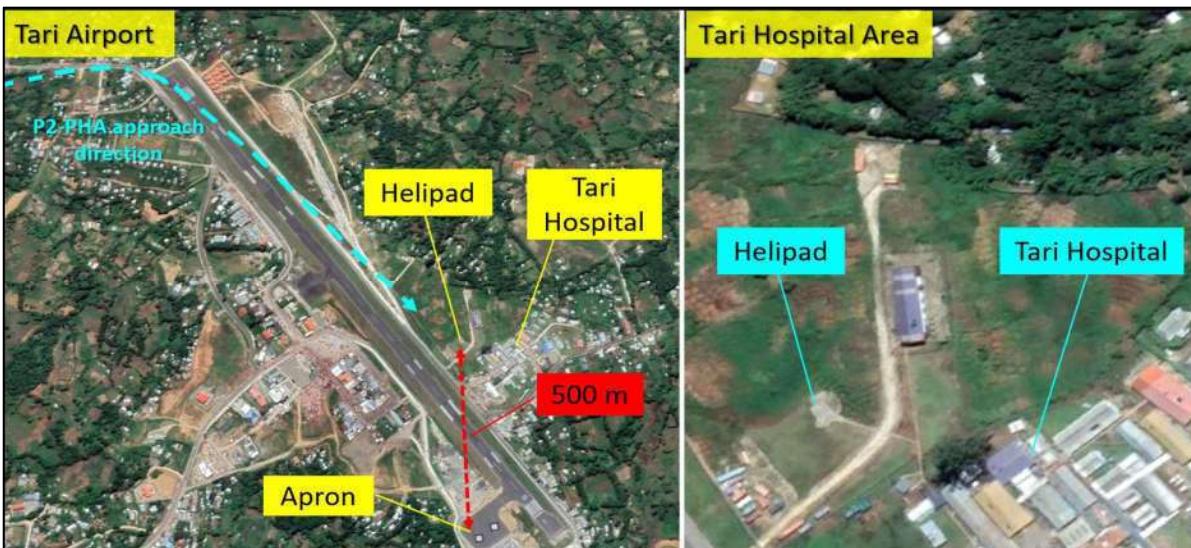
Figure 5: Helipad in reference to Tari Airport Apron

The helipad was located within the Tari Hospital's perimeter fencing and was about 500m Northwest of Tari Airport apron. The helipad is owned by Hela Provincial Health Authority and managed by Santos Aviation Ltd. It is used by the helicopter operators for medivac operations.
