FINAL REPORT

AIC 23-1003

Bell - 407

Tail Rotor Component Failure - Inflight

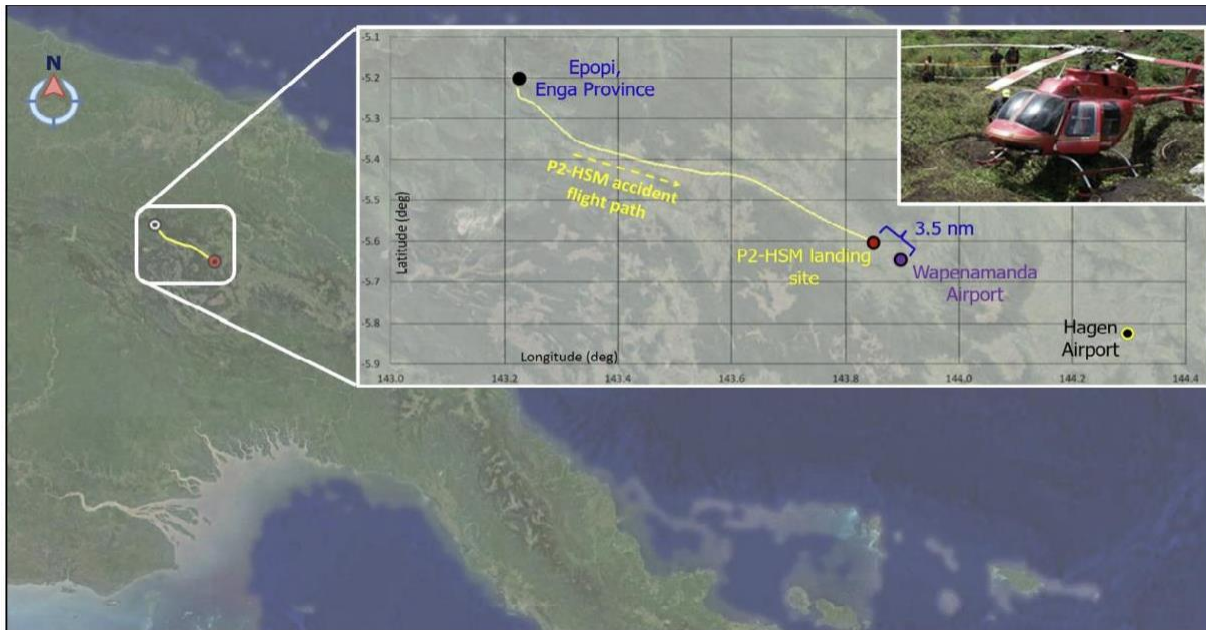
Figure 1: Overview of the HSM accident flight and landing site.

On 18 February 2023, at about 11:40 local time 01:40 Coordinated Universal Time (UTC), a Bell 407 helicopter, registered P2-HSM (HSM), owned and operated by Heli Solutions Limited (Ltd), was conducting a single pilot VFR passenger charter flight from Epopi village to Wapenamanda Airport in Enga Province, when it sustained a complete loss of tail rotor thrust, resulting in an emergency landing on a garden patch, approximately 3.5 nautical miles (NM) Northwest of Wapenamanda Airport.

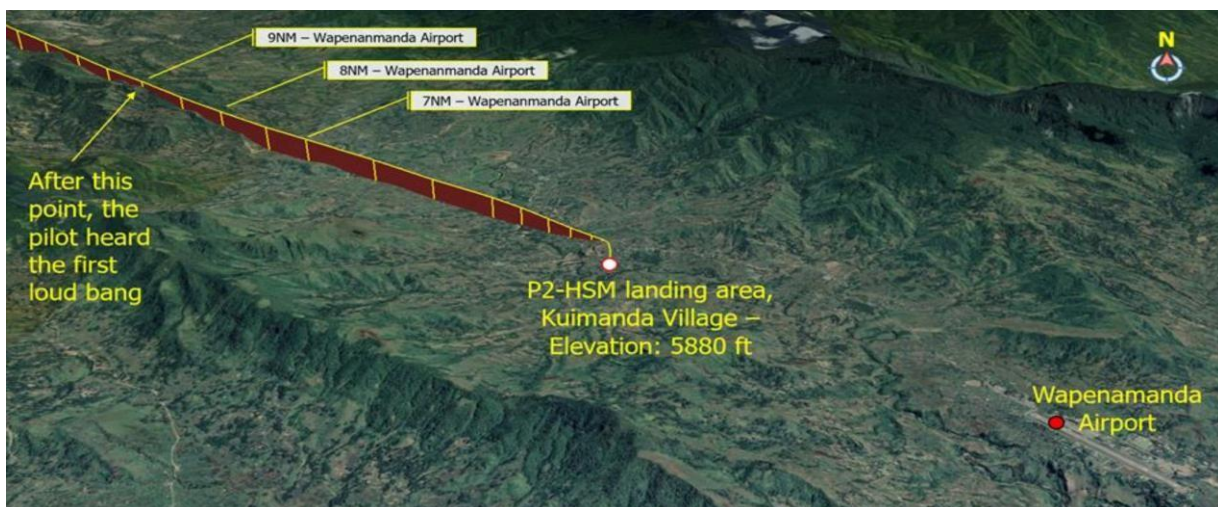
Figure 2: HSM position, 9NM from Wapenamanda Airport (5.5 NM from emergency landing position)

The pilot stated during interview that when they were about 9 NM from Wapenamanda, during the descent phase, he heard a loud bang from the back of the helicopter. He recalled suspecting that noise had emanated from the tail rotor section. He subsequently checked the foot pedals but felt no resistance. The pedals were moving loosely, which he said indicated that the helicopter had lost tail rotor thrust. He recalled feeling vibrations as the helicopter yawed toward the right with its nose pitching dipping which characterized the helicopter entering a spin.

Shortly after, the pilot heard another loud bang from the back of the helicopter, followed by vigorous airframe vibration while the helicopter continued to spin. He immediately alerted the Loadmaster of the situation and announced that an emergency landing was imminent. The Loadmaster subsequently instructed the passengers over the intercom to brace for an emergency landing.

The recorded data indicated that the descent was a steeper descent profile from that point, coupled with a fluctuating rate of descent, peaking at 800 feet per minute.

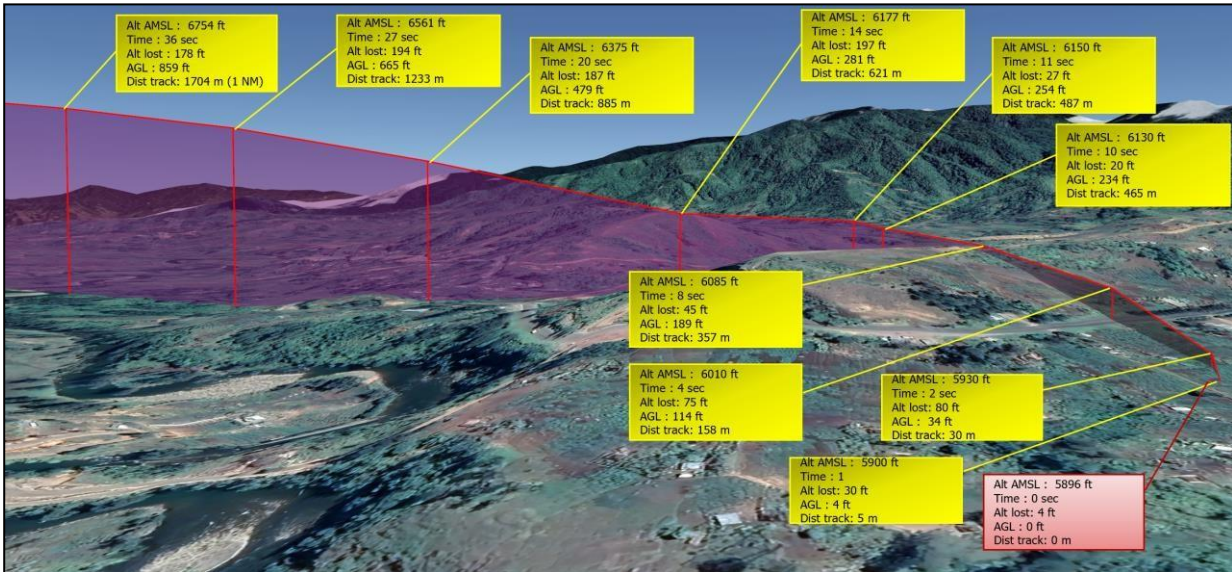
Figure 3: HSM altitude (6750 ft AMSL) and position (about 1NM from emergency landing position).

As he got close to the ground, prior to touchdown, he reduced power further and flared the helicopter. He explained that this was in order to arrest the descent as well as to sink the skids first as an attempt to prevent a rollover on impact. He further added that upon doing so, the helicopter began to spin. He recalled experiencing two full spins before the helicopter skids contacted the ground.

The pilot stated that once the tail skid contacted the ground, he pushed the collective forward and made a hard landing on the skids.

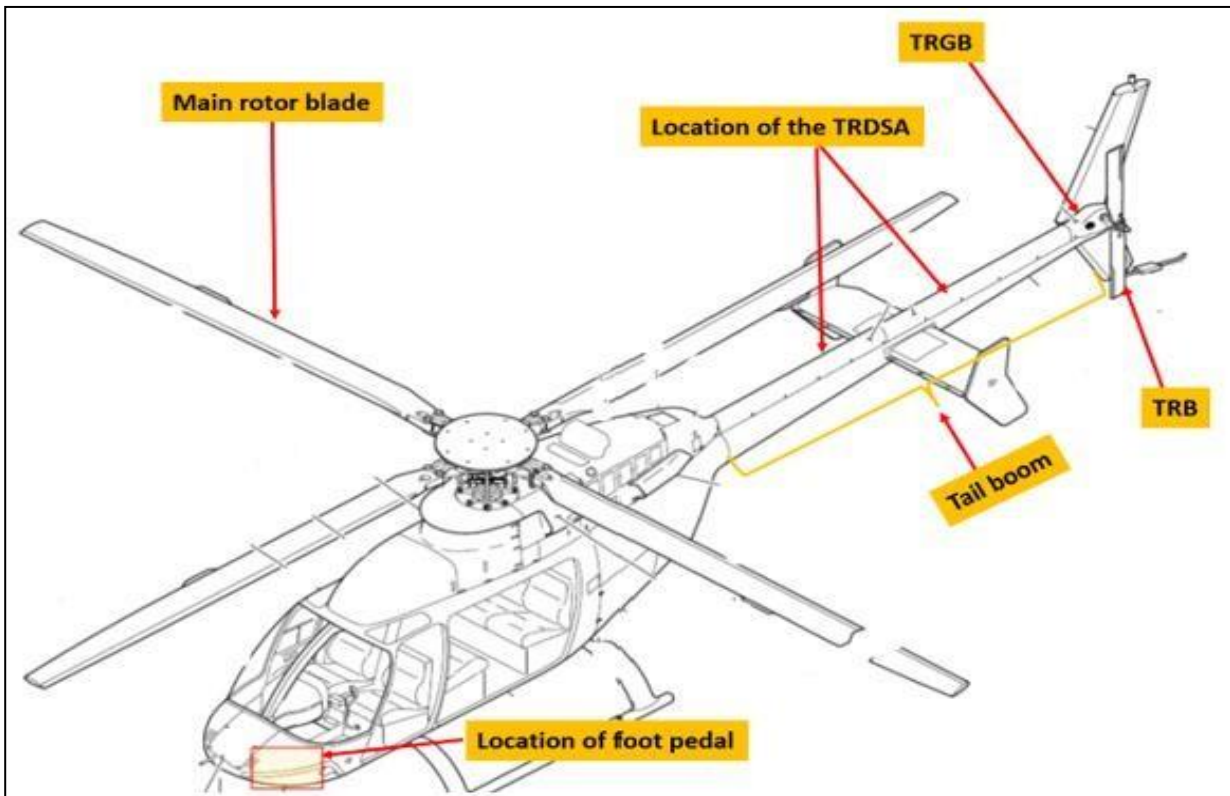
Figure 4: Bell 407 Helicopter Technical Diagram, illustrating the Tail Rotor Drive System

The tail rotor gearbox (TRGB) is mounted on the aft end of the tail boom by a washer and a self-locking nut on each of the four studs and has two dowel pins for alignment. On the output shaft of the TRGB, the tail rotor blades (TRB) are fitted with the pitch control mechanism.

The TRGB is driven by the engine through a segmented tail rotor drive shaft connected aft freewheel section by a segmented tail rotor drive shaft.

During engine operation, the power from the engine freewheel unit turns the forward short shaft and supplies power to an oil cooler blower assembly. The power then goes through the five tail rotor drive shaft assembly (TRDSA) to the input pinion of the tail rotor gearbox. The tail rotor gearbox then changes direction through the gears inside of the power and reduces the speed. The TR blades rotate at this reduced speed and the pilot controls the aircraft's direction by changing the pitch angle of the tail rotor blades using the foot pedals in the cockpit.

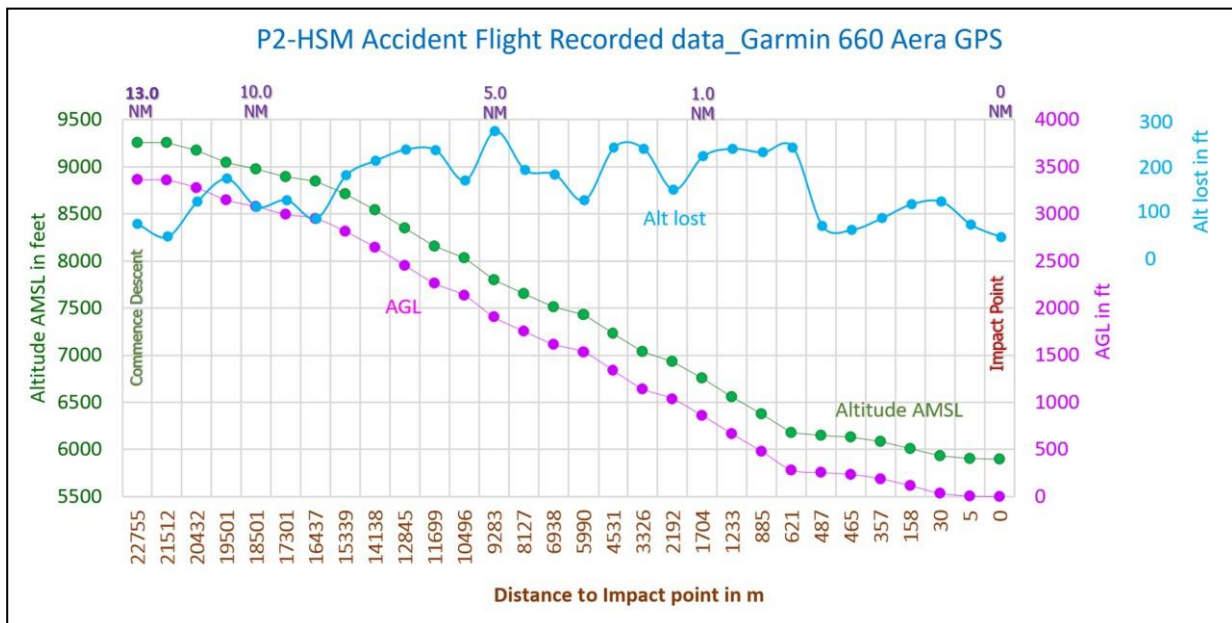
Figure 8: Garmin Aera 660 GPS recorded data and computed data plot.

The data captured by the Garmin Aera 660 GPS was utilized in creating the graph below to complement the investigation. The graph displays recorded and computed data, detailing altitude loss, distance travelled, elapsed time, and above ground level (AGL) in feet. It correlates with the elevation of the emergency landing site, approximately 5,800 feet AGL.
