FINAL REPORT

AIC 23-1005

Beechcraft Super King Air B200C

Nose Landing Gear Collapse During Landing Roll

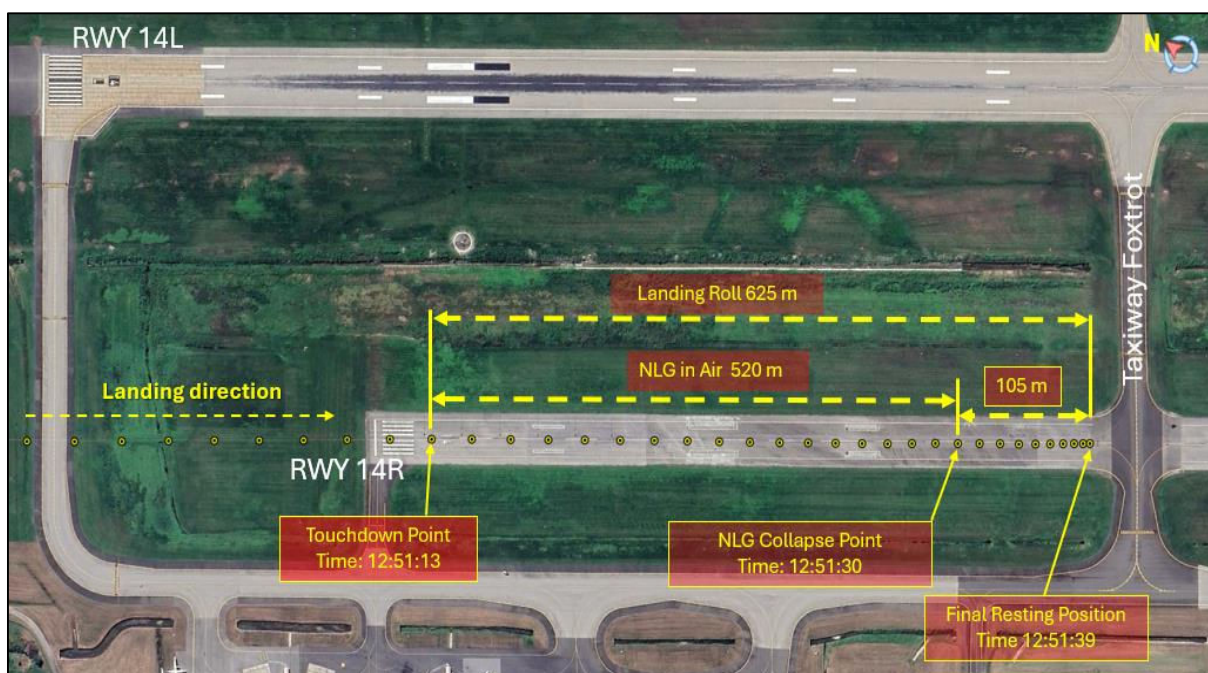
Figure 14:P2-JAU Landing Roll on Runway 14R to Final Resting Position.

The aircraft then continued forward with momentum for 105 m before coming to rest adjacent taxiway Foxtrot (Refer to Figure 14). Total distance covered from touchdown to final resting position was 625 m.

When the aircraft's nose dropped to the ground, the left and right propeller blades struck the runway surface, causing damage to the left and right propeller assemblies. The nose structure and left and right nose landing gear (NLG) doors also sustained damage upon contact with the runway surface.

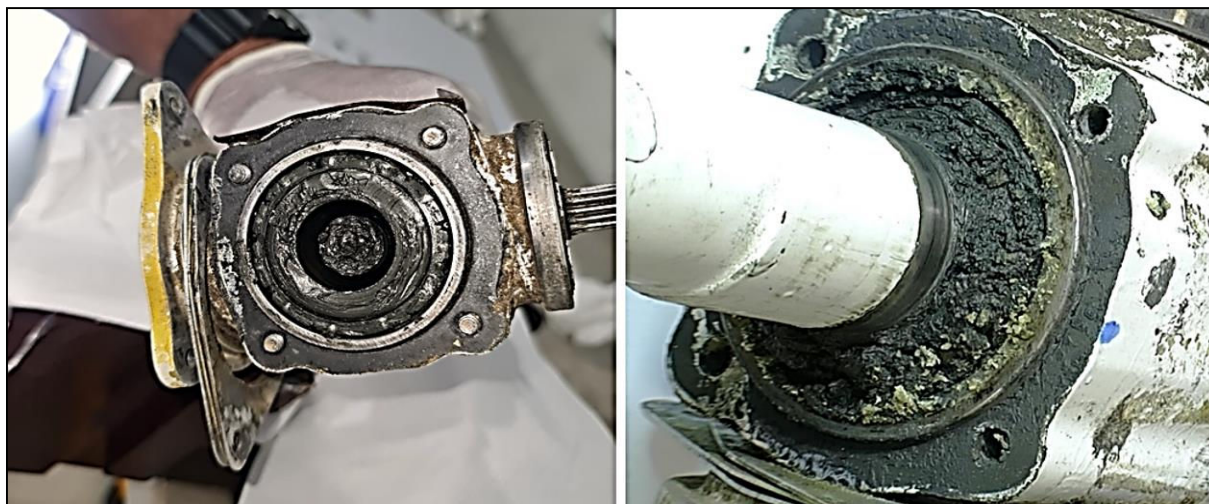
Figure 17: Inspection of the NLG Actuator at the AIC Engineering Workshop.

The Actuator was inspected by removing the Lower and Upper Cover to check for lubrication and any other abnormalities. There was evidence of grease present, but it appeared dry.

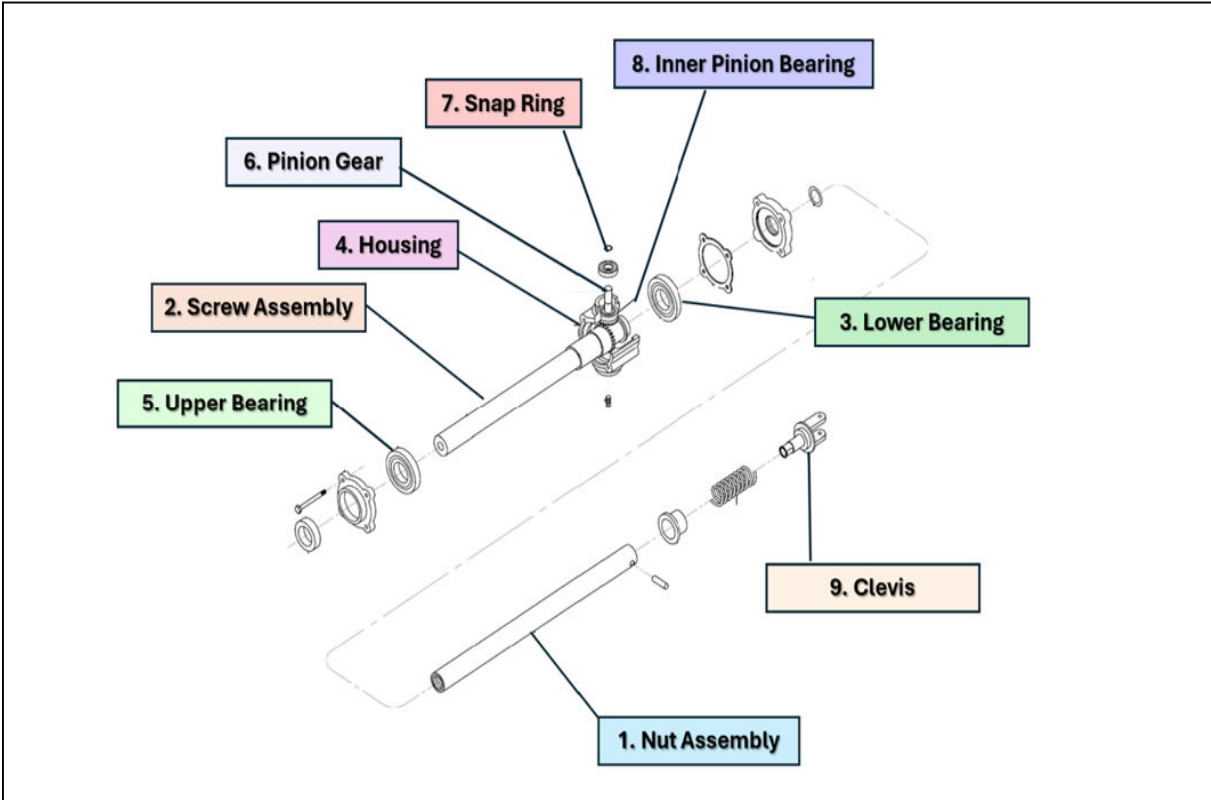
Figure 19:NLG Actuator Components Inspected.

The Manufacturer carried out a thorough teardown and inspection of the faulty NLG Actuator to examine all its components. During this process, it was confirmed that all components of the Actuator, including the Nut Assembly, Screw Assembly, Gearbox Lower Bearing, Housing, Gearbox Upper Thrust Bearing, Pinion Gear and Snap Ring, Clevis Pin, Spring and Retainer and Inner Pinion Thrust Bearing were present.
