FINAL REPORT

AIC 23 - 2001

Fokker 70

Cabin Pressurisation Event In Flight

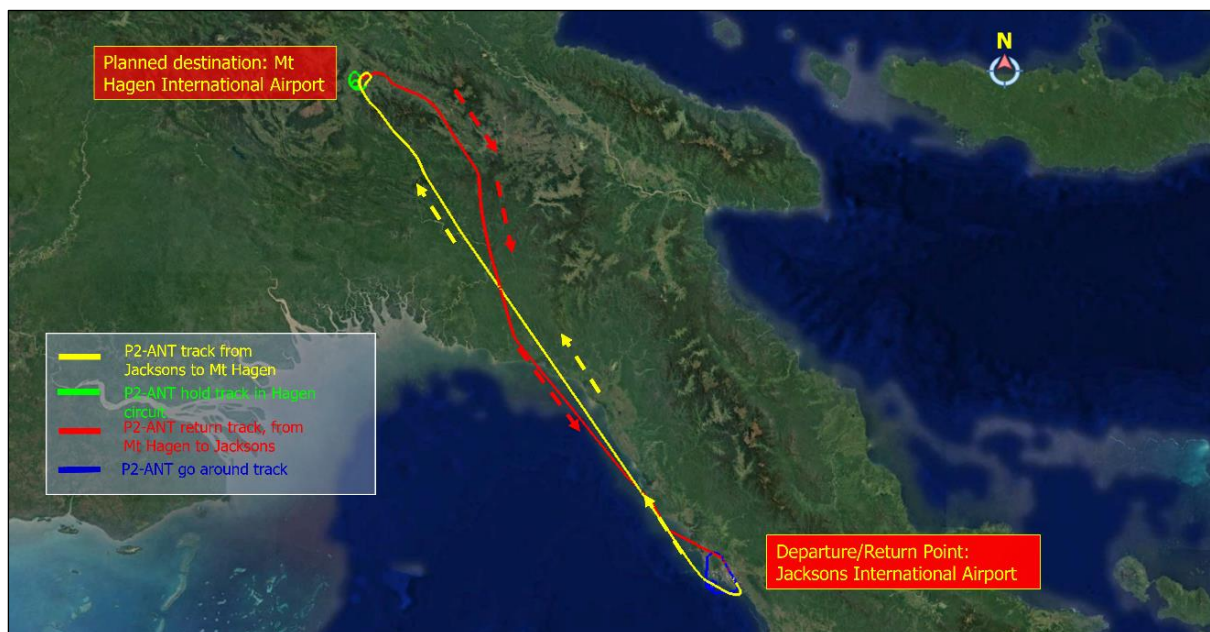
Figure 1. Depiction of occurrence flight path.

On 20 February 2023, at about 16:00 local time (06:00 UTC¹), a Fokker 70 aircraft, registered P2-ANT owned and operated by Air Niugini Limited experienced an abnormal cabin pressurisation event during final approach into Jacksons International Airport², Port Moresby, Papua New Guinea, resulting in injuries to some passengers.

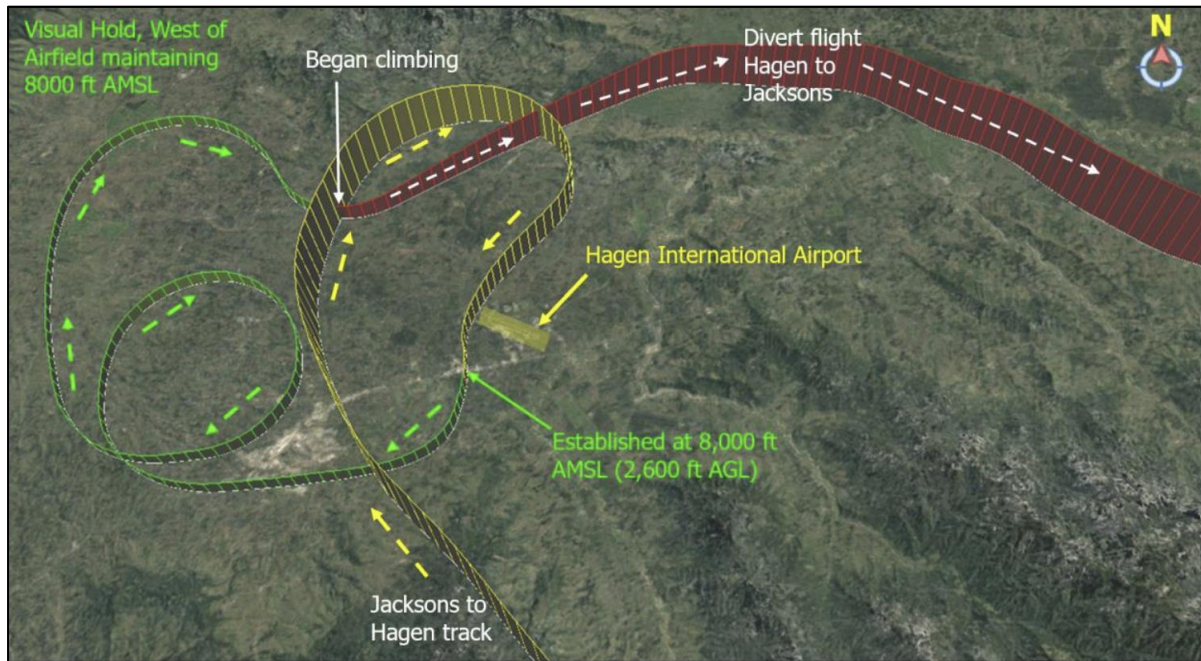
Figure 2. Depiction of the flight path in Mt. Hagen Circuit.

The crew decided to maintain 8,000 feet (ft) AMSL⁴ and hold West of the Airfield over the Mt. Hagen township, in anticipation for a reduction in the tailwind on Runway 30. At 15:05, following unfavourable wind updates from ATS, the flight crew advised ATS that due to the prevailing tailwind on Runway 30, a landing was not possible and that they had to divert back to Port Moresby. From the holding at Mt. Hagen, the aircraft began tracking East on climb from 8,000 ft AMSL. Recorded data showed that the aircraft levelled off at 31,000 ft AMSL and tracked East towards Port Moresby.

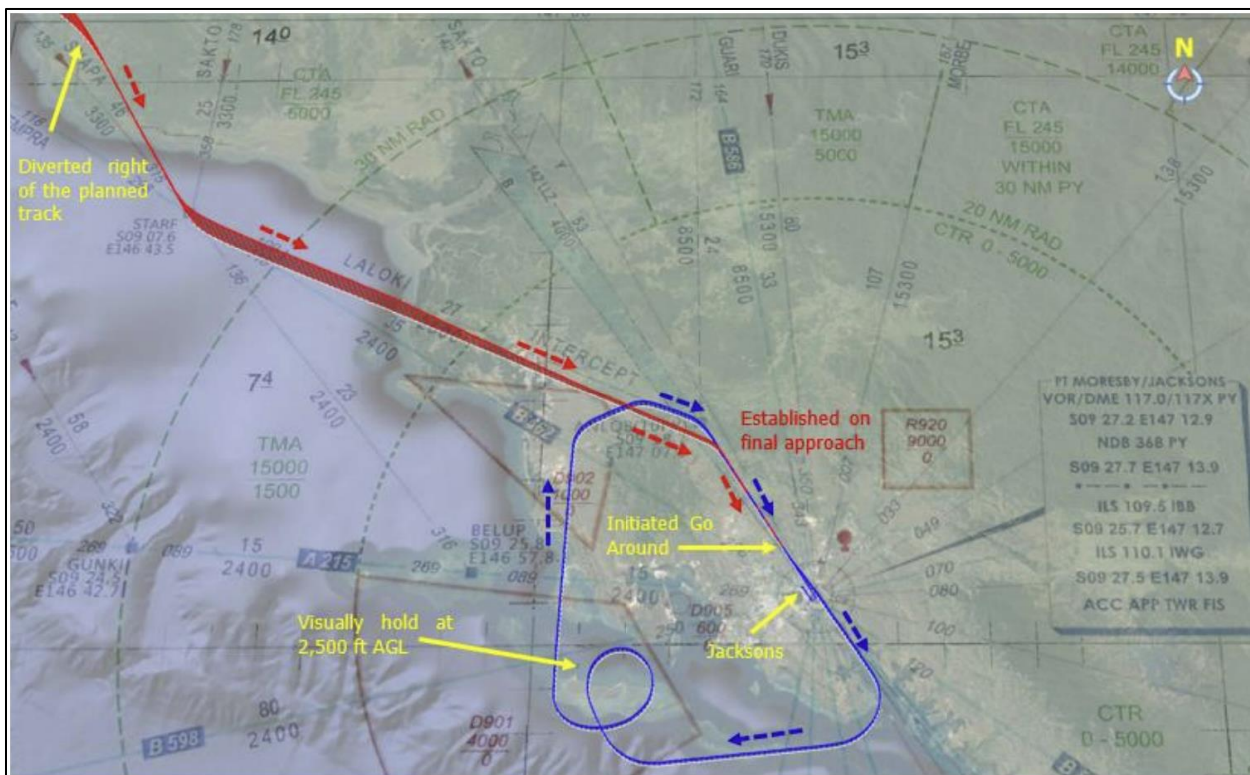
Figure 3. Depiction of the flight path from go-around to landing.

However, as the aircraft approached 1,000 ft on final approach, the flight crew observed a cabin differential pressure reading of 3.5 PSI⁹, which then continued to increase to 4 PSI. As the differential was more than the maximum allowable cabin differential for landing, 0.13 PSI, the flight crew decided to execute a go-around and hold at Daugo (D901)¹⁰ to rectify the problem.

However, Maintenance Watch was not available at the time. The flight crew observed the cabin differential pressure continue to increase to 6 PSI.

In an attempt to reduce the cabin differential, the flight crew then decided to action the *Fokker 70 Quick Reference Handbook (QRH) Abnormal Procedure* for 'Reduced Cabin Pressure Differential Procedure' (Refer Appendix A Section, 5.1.4). After completing the procedure, the flight crew observed the cabin differential begin to reduce again.
